The Impact of Marcellus Gas Development on the Rural Transportation Infrastructure

FINAL REPORT

July 31, 2013

**The Thomas D. Larson
Pennsylvania Transportation Institute**

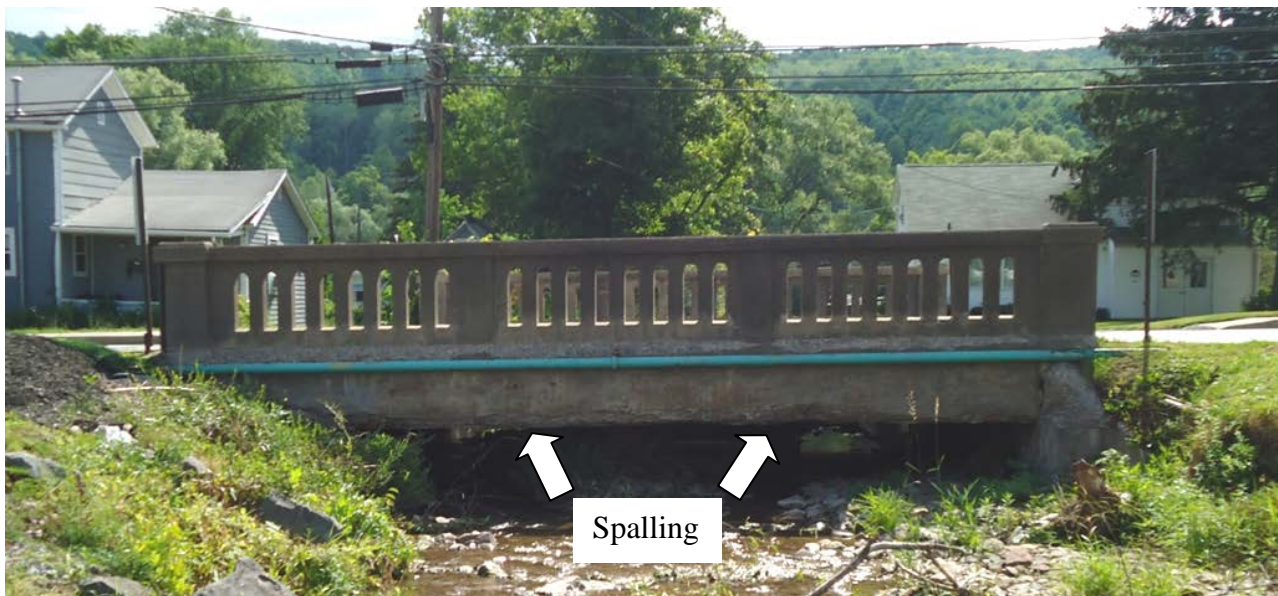
Figure 2. Bridge One Elevation

Located in Troy, Pa. along State Route 14, Bridge One is the oldest bridge that was inspected and had the highest ADT. The 32-ft (9.7-m) long single span, as shown in Figure 2, is supported by nine concrete T-beams. During the course of the Penn State inspection a number of Gas Play related trucks crossed the bridge. The reviewed PennDOT inspection report for this bridge was from 2010. The estimated average daily truck traffic, ADTT, was 1,115 as given by this report, with the ADT listed at 7,287. The bridge was listed as structurally deficient and had a sufficiency rating of 47.0.

A satisfactory condition rating of 6 was assigned to the deck. Due to the wearing surface covering the deck, only the underside of the deck could be inspected by Penn State personnel. Consistent with previous PennDOT inspection reports, random cracking and efflorescence was observed along with honeycombing, surface scale, and spalling with exposed rebar. A significant amount of spalling was observed along the deck's exterior, which can be seen in Figure 2.

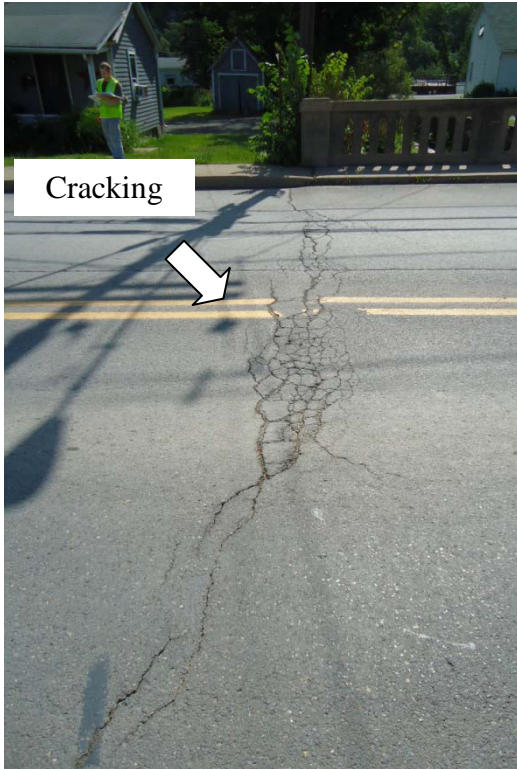
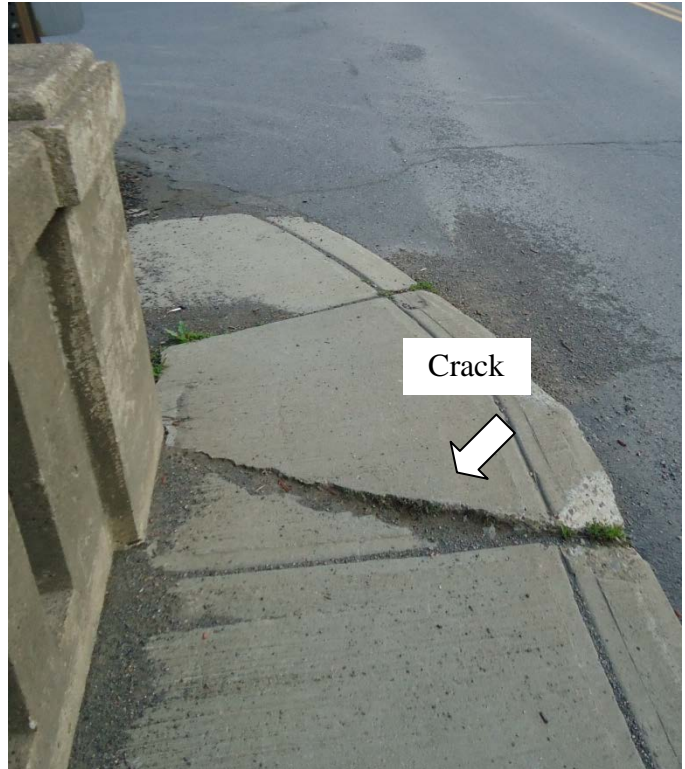
Figure 3. Bridge One Cracking along Northern Abutment

The PennDOT inspection report indicated that the wearing surface was rated 7, which indicates good condition with some minor problems. In agreement with the PennDOT inspection report, the Penn State visual inspection indicated some minor rutting and isolated longitudinal cracks in the asphalt wearing surface. Multiple cracks up to 1 inch (25.4 mm) wide existed above the northern abutment, which was also noted in the PennDOT inspection report. Figure 3a shows these cracks and Figure 3b shows the crack's propagation into the bridge's sidewalk.

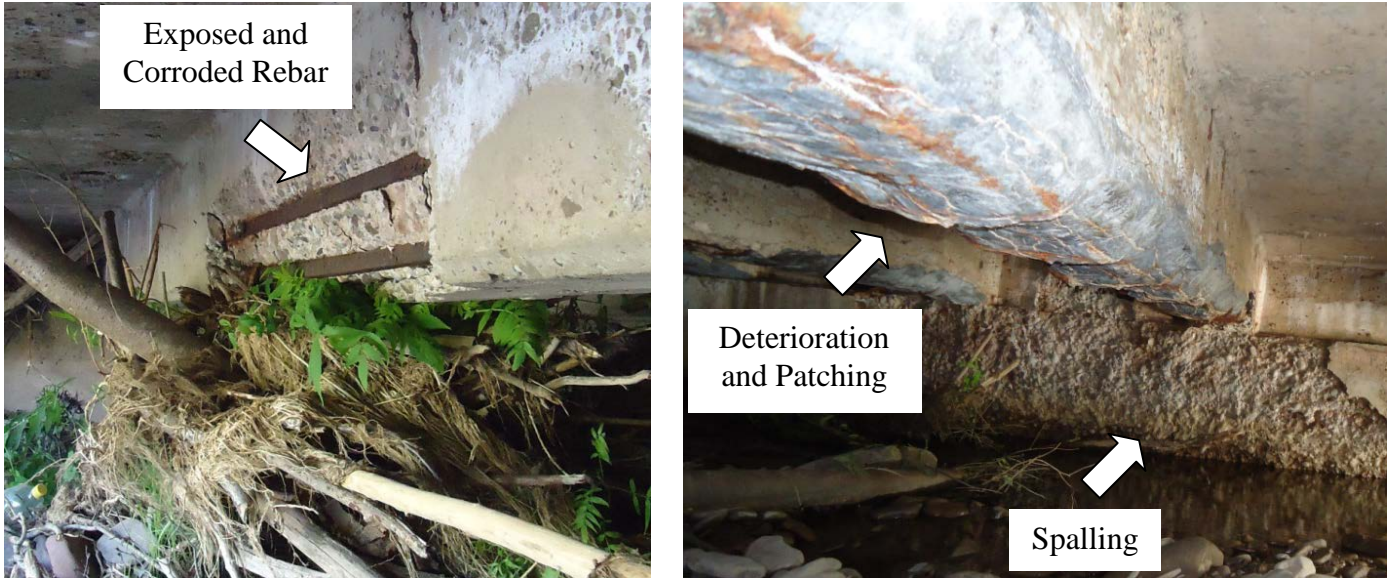
The Penn State inspection indicated that the superstructure was in very poor condition. The PennDOT inspection reports rated it a 4, indicating advanced section loss and deterioration. Penn State inspection of the concrete T-beams confirmed the poor superstructure condition. Concrete spalling and deterioration was quite prevalent. Exposed and corroded rebar was observed in several beams. Figure 4a and 4b shows an example of this deterioration in the second beam and seventh beam, respectively, as numbered from west to east. These findings were similar to those in the reviewed inspection report. The Penn State inspection indicated that some beams, particularly on the east side of the bridge, had noticeable sag that was not listed in the reviewed inspection reports. Repairs were attempted on beams six and seven in the form of patching, seen in Figure 4b.

(a) Beam One Exposed and Corroded Rebar

(b) Beam Seven and North Abutment Deterioration

The substructure also received a 4 in the reviewed PennDOT inspection report. Both abutments had a number of horizontal cracks, scaling, efflorescence, and areas of unsound concrete, and findings from the Penn State inspection were in general agreement with the reviewed PennDOT inspection report. Heavy corrosion and deterioration existed at the bearings of beams one, six, and seven, and these findings also agreed with the inspection reports. The extent of the abutment deterioration is shown in Figure 4b, which shows a section of the north abutment under beam seven.

Bridge One is relatively old, and age and location likely contribute to its poor condition. The Penn State inspection indicted that several beams were deteriorated and sagging. Additionally, the north abutment had large amounts of spalled and unsound concrete and the wearing surface and sidewalk were also observed to be deteriorated. Deterioration to several components of the bridge coupled with an apparent increase in the amount of truck traffic traversing the bridge during the Penn State inspection, with many trucks appearing to be involved in the Gas Play, should increase the extreme load cycles that the bridge sees and, subsequently, the importance of improving its condition via rehabilitation or replacement.

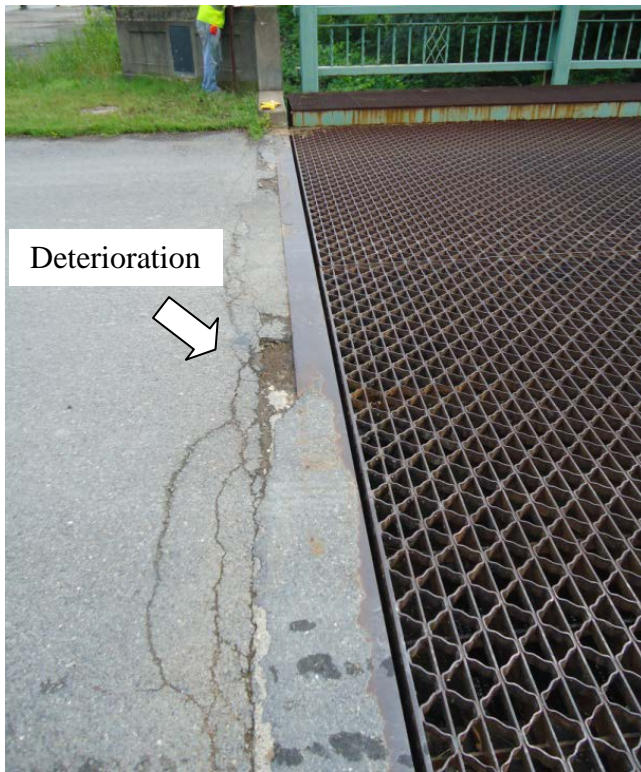
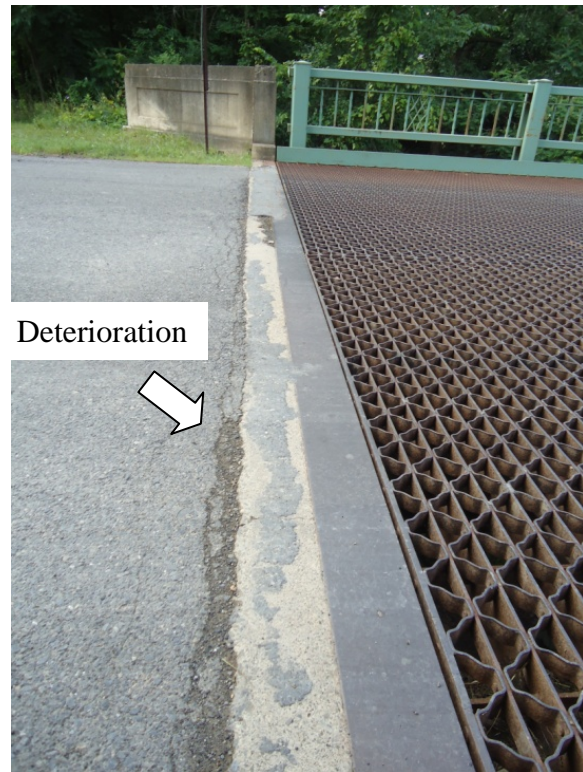
The steel grid deck, partially shown in Figure 6a and 6b, was rated a 6 in the reviewed township inspection reports, meaning it was of satisfactory condition with some minor deterioration. Heavy to moderate corrosion and several bent grid deck bars were observed. Minor corrosion and scraping was evident along the railing with corroded and bent grid deck bars prevalent along the sidewalk. These observations were in agreement with the reviewed township inspection reports. Not listed in the township inspection reports but observed during the Penn State inspection was damage to the asphalt at the approach slab to bridge transition along both the west and east ends of the bridge, shown in Figure 6a and 6b, respectively. Up to ¼ inch (6.35 mm) of settlement was measured adjacent to the east abutment.

(a) West Transition Pavement Damage

(b) East Transition Pavement Damage

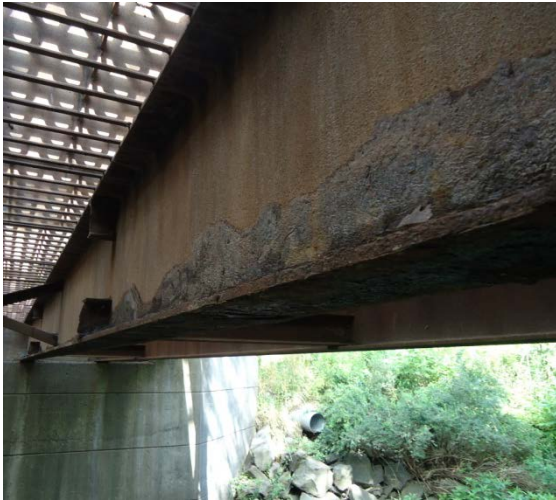
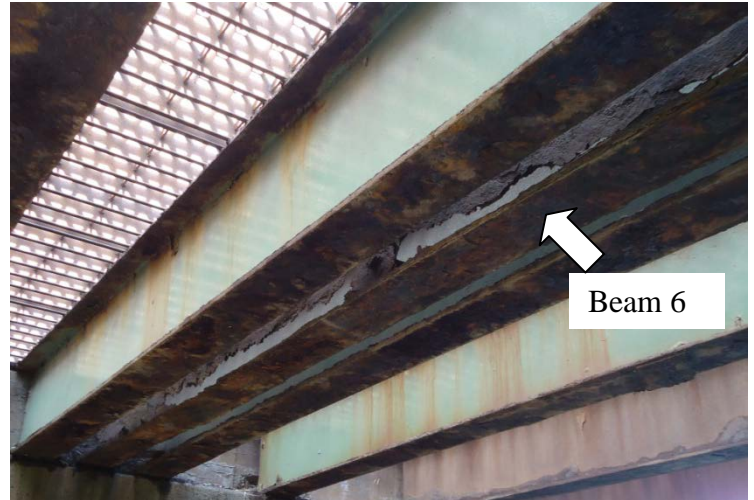
The bridge superstructure, made up of 11 steel beams, received a rating of 4 in the reviewed township inspection reports, indicating poor condition. Six of the 11 beams, as noted in the reviewed township inspection reports, were newer and likely replaced during the 2001 rehabilitation. Those beams were observed during the Penn State inspection to be mostly in satisfactory condition with minor corrosion and some section loss. The remaining four beams had considerable corrosion. Figure 7a shows Beam 10 (labeled from south to north) with considerable corrosion. Beam Three had several areas of section loss in the bottom flange and the web near the west abutment. Beam Six, shown in Figure 7b, was observed during the Penn State inspection to be severely corroded and was considered not to carry load, as noted by the reviewed inspection reports. Cross-frames showed moderate surface corrosion. Bearings plates had heavy corrosion and minor section loss, with several anchor bolts having considerable section loss. These findings were all consistent with the reviewed township inspection reports.

(a) Beam Ten Corrosion

(b) Beam Six Corrosion and Section Loss

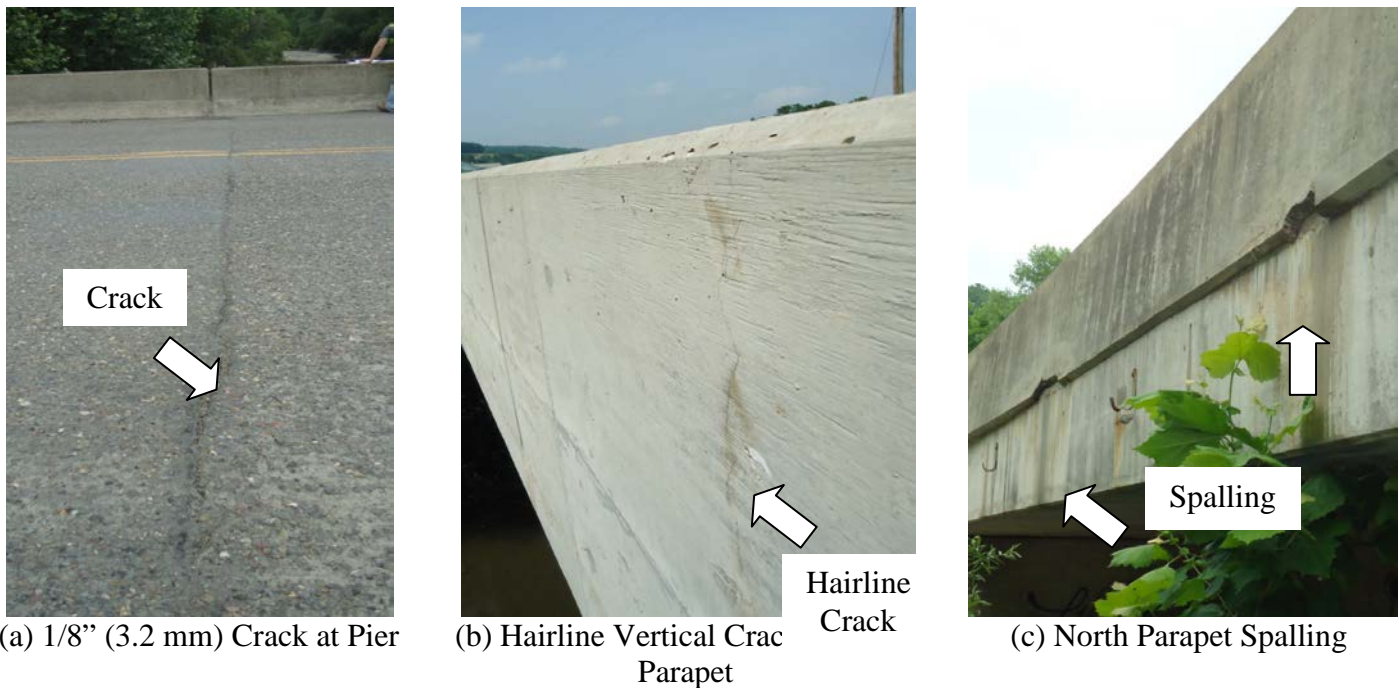
Figure 9. Bridge Three Wearing Surface and Parapet

The parapets received a rating of 6 in the reviewed PennDOT inspection reports, meaning they were adequate. Areas of vehicle-related scrapes, honeycombing, and vertical hairline cracking were noted in the PennDOT reports. These items were observed during the Penn State inspection in a few isolated areas. Not included in the PennDOT inspection reports were observed areas of spalling of the parapet at the deck intersection. Instances of parapet vertical hairline cracking and spalling are shown in Figure 9b and 9c, respectively.

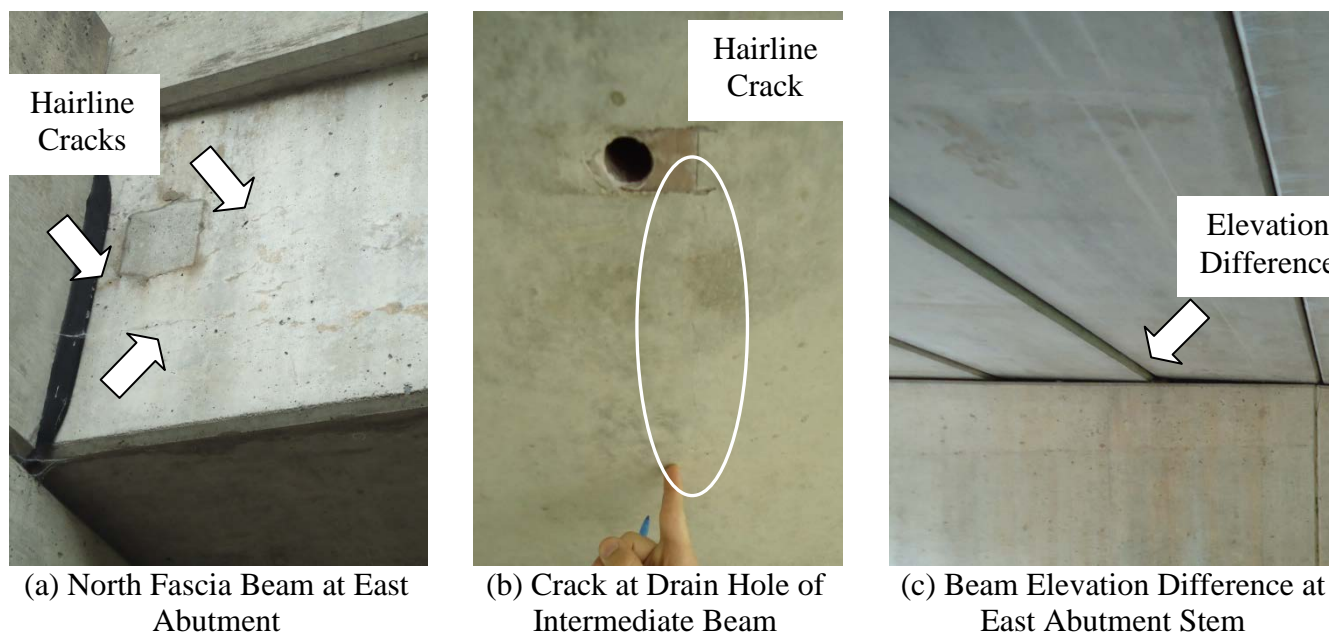
Figure 10. Bridge Three Beam Condition

The Penn State inspection indicated instances of cracking and staining, as documented in the reviewed PennDOT inspection reports. Most cracking was hairline and located along the fascia. These cracks often formed around grout used to cover tendon tensioning ducts. An example of this is shown in Figure 10a, which displays a patch along the north fascia at the west abutment. The beam undersides generally had few hairline cracks observed during the Penn State inspection. Figure 10b shows one such crack extending from a drain hole in an intermediate beam. Efflorescence between beams was observed, as noted by PennDOT inspection reports. The elevation difference at the stem of the beams listed in the PennDOT inspection reports was observed, shown in Figure 10c, though the twist mentioned in the reports was not evident during the Penn State inspection.

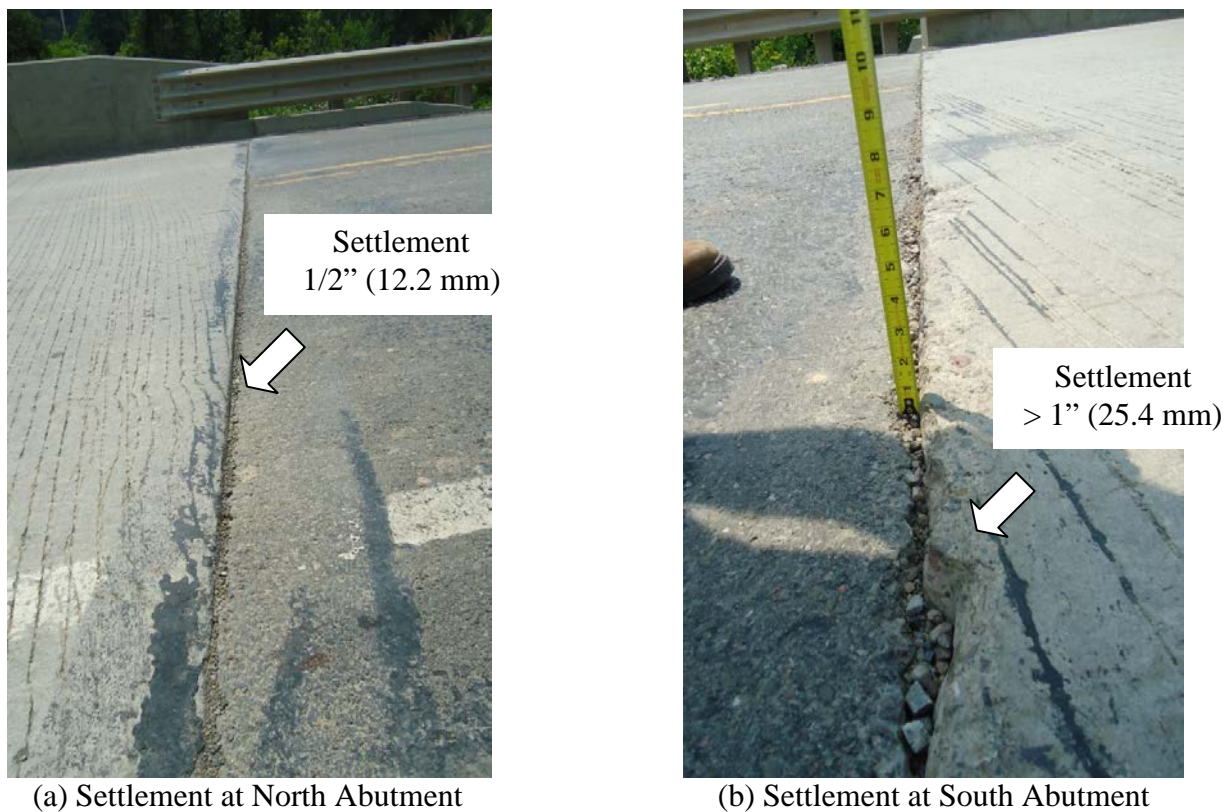
Figure 12. Bridge Four Transitions

The bridge's wearing surface and deck received ratings of 8 and 9, respectively, in the reviewed PennDOT inspection reports. The only deficiencies noted in the reports were isolated longitudinal cracks and isolated surface edge spalls along the deck. These problems were also observed during the Penn State inspection. Not mentioned in the reports were areas of rutting and wear of the wearing surface noticed during Penn State inspection. Additionally, approach slab settlement was observed at both abutments. The north end had some areas of settlement up to ½ inch (12.7 mm) and the south had instances of settlement greater than 1 inch (25.4 mm). Figure 12a and 12b display settlement adjacent to the north and south abutments, respectively.

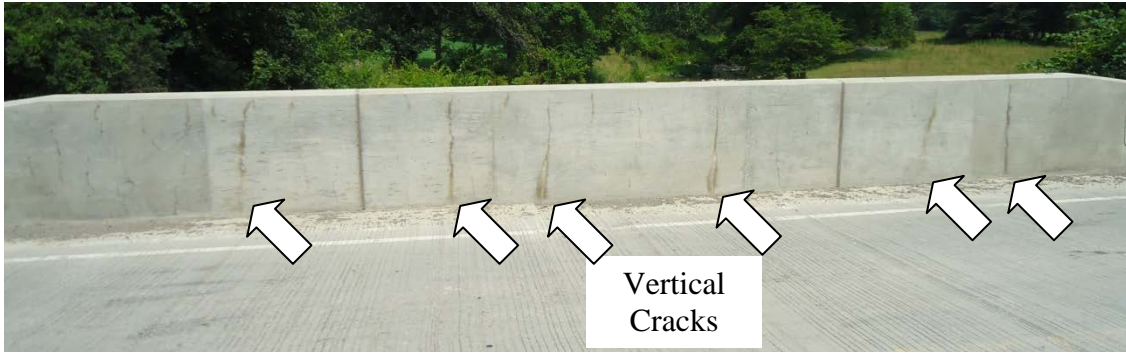
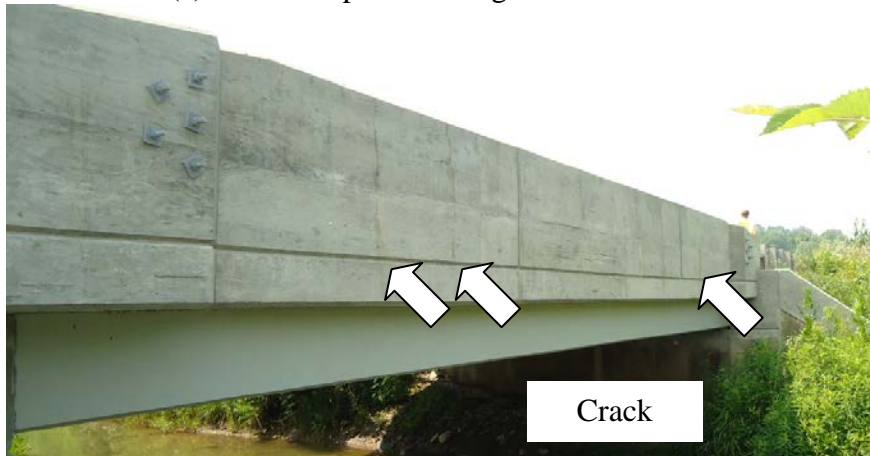
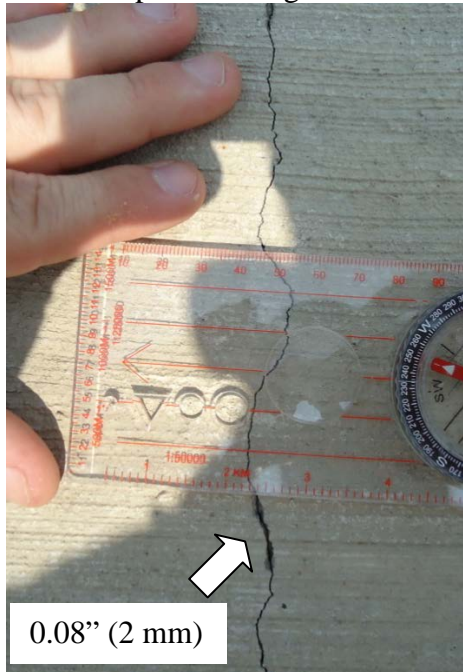
The concrete parapets were, as discussed, replaced during the 2009 rehabilitation and received a rating of 8, with only isolated hairline cracks and limited efflorescence listed as deficiencies in the PennDOT inspection reports. The Penn State inspection indicated several full-height, through-thickness vertical cracks at multiple locations in both parapets. Map cracking was also evident. The width of the cracks typically ranged from hairline to slightly greater than 1/16 inch (1.6 mm). Some cracks are visible in Figure 11 and, in general, they indicated that moisture was intruding into the parapet at their locations, as water staining was visible in nearly all cracks. Figure 13a shows the cracking in the east parapet. Figure 13b shows crack penetration through the thickness of the parapet. Finally, Figure 13c shows the width of the typical cracks that were observed. The maximum width in this photo is 0.08 inch (2 mm).

(a) West Parapet Cracking view from East

(b) West Parapet Cracking view from West

(c) Typical Parapet Cracking Width, 0.08" (2 mm) maximum

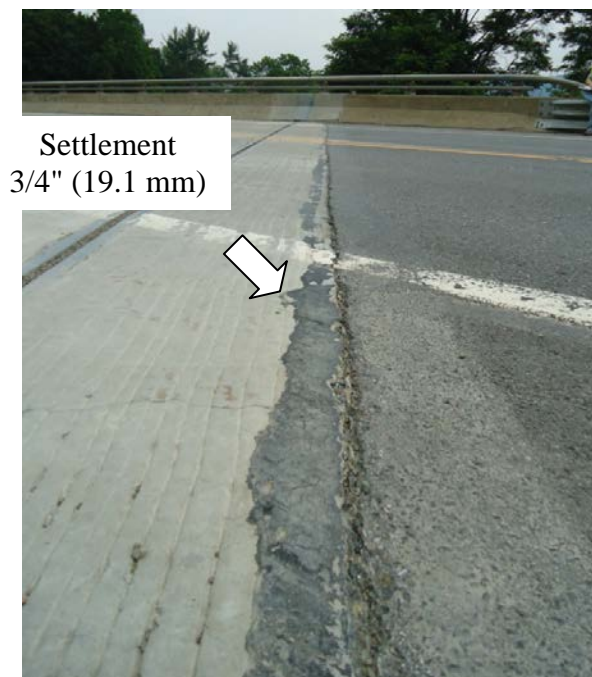
revealed several hairline longitudinal and transverse cracks in wearing surface areas mentioned in the reviewed PennDOT inspection reports. In general, the deck and wearing surface were observed during the Penn State inspection to be in good condition and in agreement with the PennDOT inspection reports. Exceptions noted during the Penn State inspection consisted of some minor rutting in the travel lanes and up to 3/4 inch (19.1 mm) of settlement in the approach slab at the south abutment, shown in Figure 15. The parapet also had minor vertical cracks and scrapes, findings that were in agreement with the PennDOT inspection report.

Figure 15. Bridge Five Settlement at South Abutment

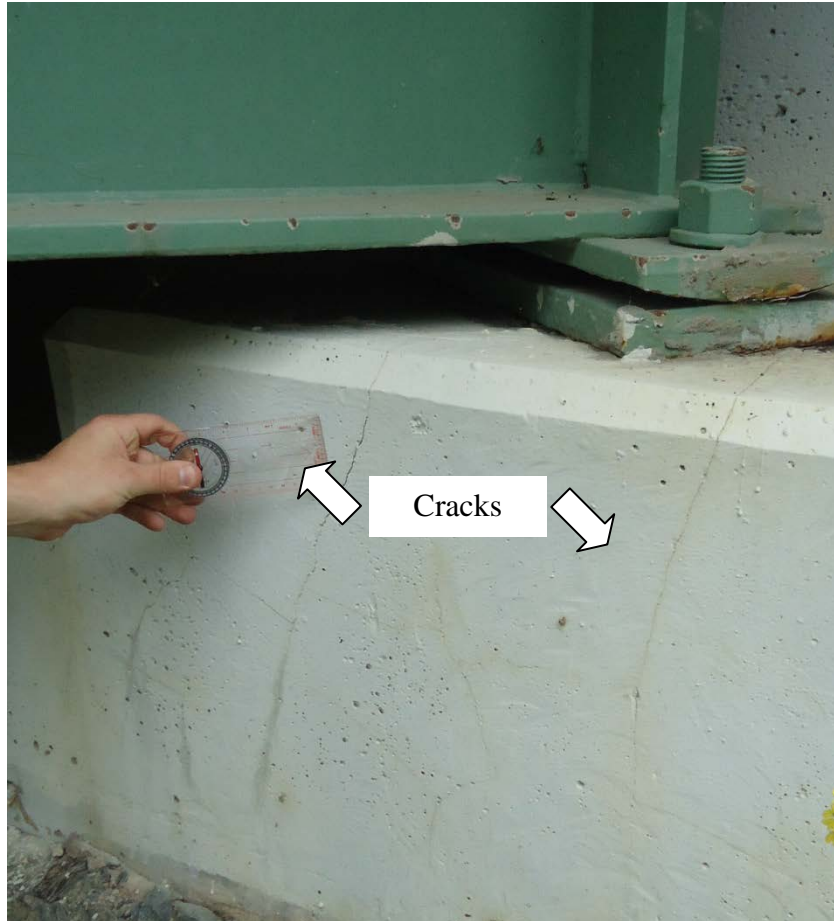
The substructure also received a rating of 7 in the reviewed PennDOT inspection reports, indicating good condition. The top 2 ft (0.6 m) of each abutment was replaced during the 2009 rehabilitation. The Penn State inspection yielded similar observations as the reviewed PennDOT inspection reports. Random hairline vertical and longitudinal cracks were seen in both abutments as well as some staining in the north abutment. The only additional instance of deterioration identified during the Penn State inspection but not listed in the reviewed PennDOT inspection reports was cracking of the west fascia girder's seat in the south abutment, as shown in Figure 16.

Figure 16. Bridge Five Cracking of the West Fascia Girder Seat at the South Abutment

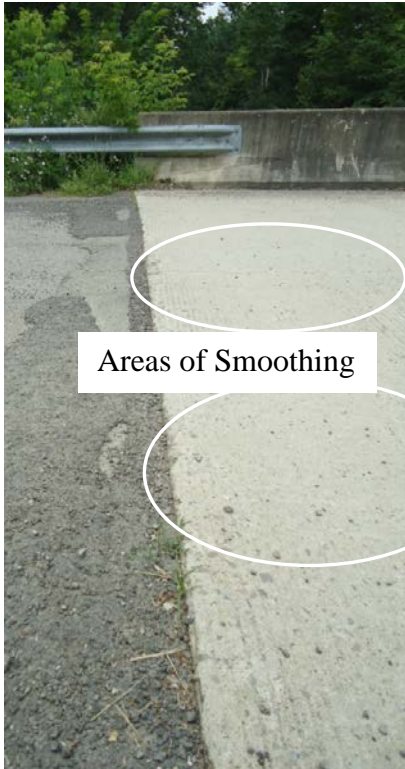
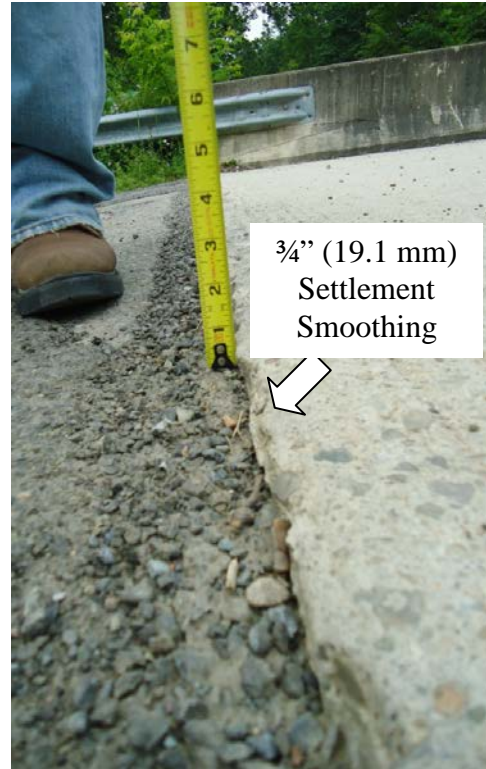
The bridge wearing surface and deck were both given ratings of 5 in the reviewed township report, which indicates that all structural elements are sound but may have some minor section loss. Findings from the reviewed township inspection report were very similar to observations made during the Penn State inspection. The deck was observed during the Penn State inspection to have exposed construction joints and some hairline cracks. The Penn State inspection also indicated that the wearing surface had heavy wear and smoothed surfaces with exposed aggregate, as shown in Figure 18a. A few minor popouts and surface spalls were also present. Settlement of up to $\frac{3}{4}$ inch (19.1 mm) of the approach slab, displayed in Figure 18b, was observed at the south abutment during the Penn State inspection. No assessment of parapet condition was given in the township inspection report and, during the Penn State inspection, they were observed to have a number of hairline vertical cracks and efflorescence, as shown in Figure 17.

(a) Smoothing of Wearing Surface

(b) Settlement above South Abutment

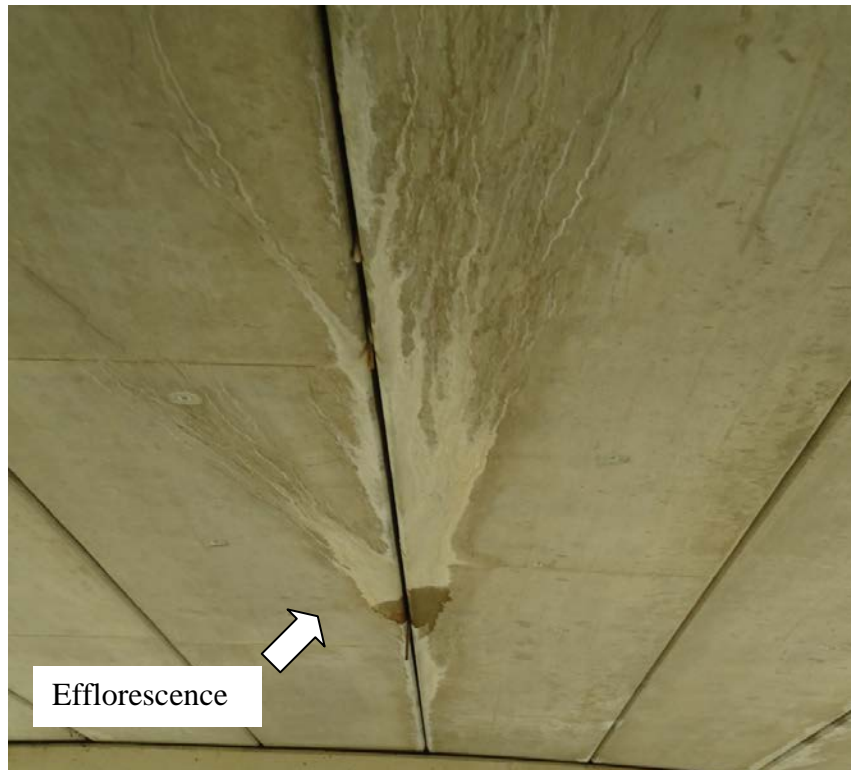
The reviewed township inspection report assigned a rating of 7 to the superstructure, indicating good condition. The fascia box beams had various hairline longitudinal and map cracks with efflorescence along their exterior faces. Beams two and three, numbered west to east, had hairline longitudinal cracks at the north abutment. The condition of the superstructure as observed during the Penn State inspection was generally identical to the description provided in the reviewed township inspection report, with one possible exception. Efflorescence between beam joints was mentioned and listed as minor in the reviewed inspection report. Efflorescence and staining observed during the Penn State inspection (Figure 19) appeared more prevalent and likely had increased since the last inspection. This could possibly be indicative of a failing joint between adjacent beams.

Figure 19. Bridge Six Efflorescence between Beam Three and Four

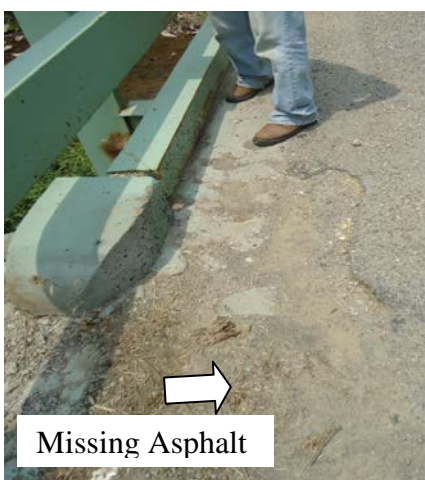
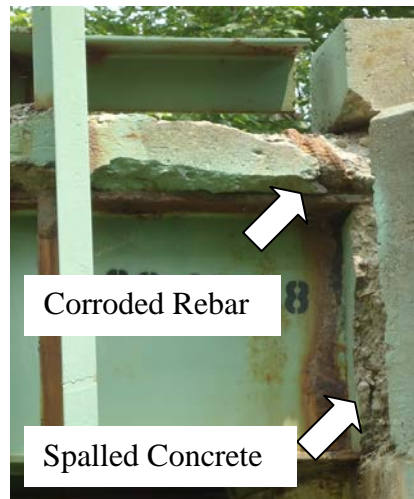
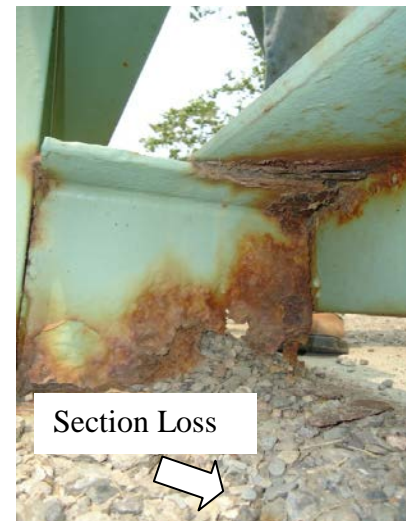
Figure 21. Bridge Seven Deck and Wearing Surface

Satisfactory ratings of 6, meaning some minor deterioration exists, were assigned to both the wearing surface and deck in the reviewed PennDOT inspection reports. The Penn State inspection indicated that the wearing surface had areas of rutting and pumping asphalt. A section of asphalt adjacent to the railing was missing, as shown in Figure 21a. The deck had several areas of edge spalling and delaminated concrete. Rebar at the south edge of the bridge was exposed and corroded, as shown in Figure 21b. The deck underside also had areas of spalling and longitudinal and transverse cracks with efflorescence. The metal railing of the bridge was rated a 4 in the reviewed PennDOT inspection reports, indicating poor condition with advanced section loss. It was observed during the Penn State inspection to have heavy corrosion and areas of complete section loss at connection plates to the deck, as shown in Figure 21c. Field observations during the Penn State inspection were largely in agreement with deficiencies noted in the reviewed PennDOT inspection reports.

(a) Missing Asphalt Along Railing

(b) Spalled Concrete and Exposed Rebar

(c) Railing Connection Plate Section Loss

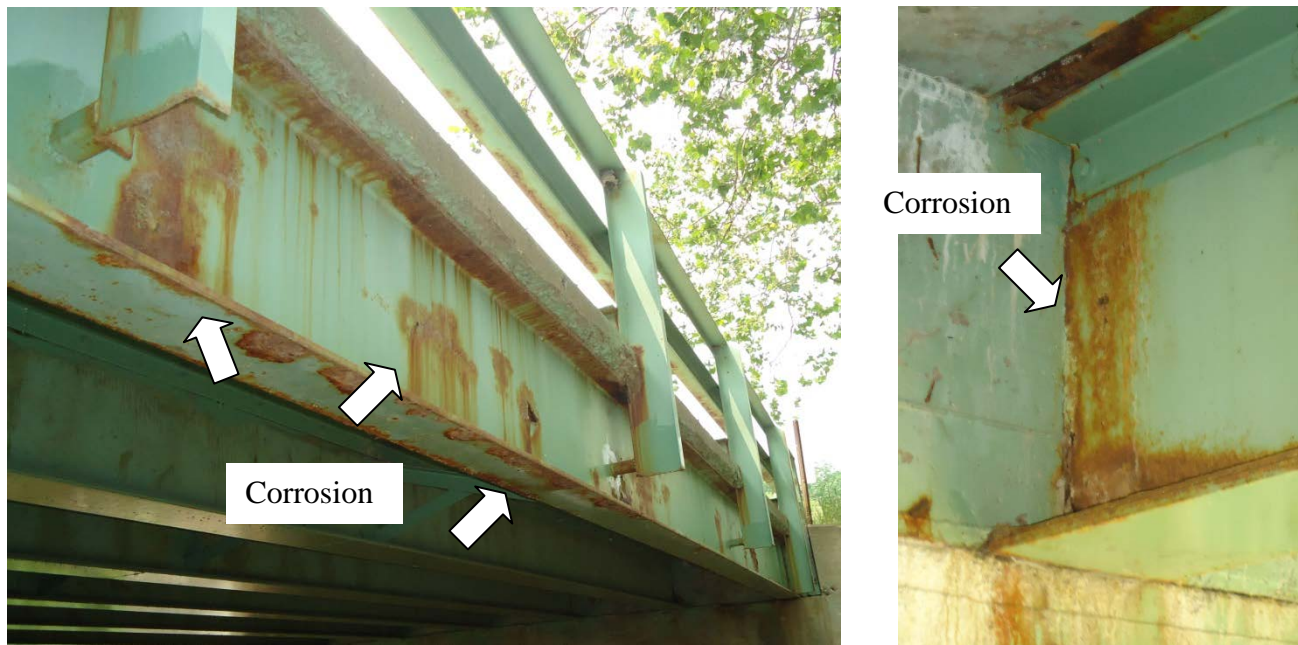
The superstructure was rated a 6 in the reviewed PennDOT inspection reports, which indicated satisfactory condition with some minor deterioration. Corrosion was observed during the Penn State inspection to be prevalent on the beams, especially the fascia beams, and in some locations on the beams near the abutments, as depicted in Figure 22a and 22b, respectively. Compared to the fascia beams, interior beams generally had less corrosion. The condition of the superstructure as observed during Penn State inspection did not appear to significantly change compared to the reviewed PennDOT inspection reports.

(a) North Fascia Corrosion

(b) Corrosion of Interior Beam at East Abutment

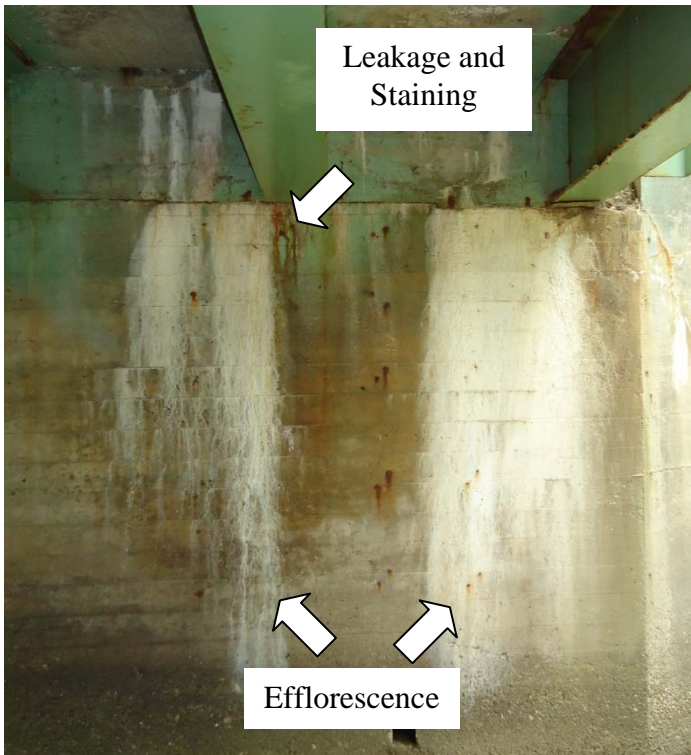
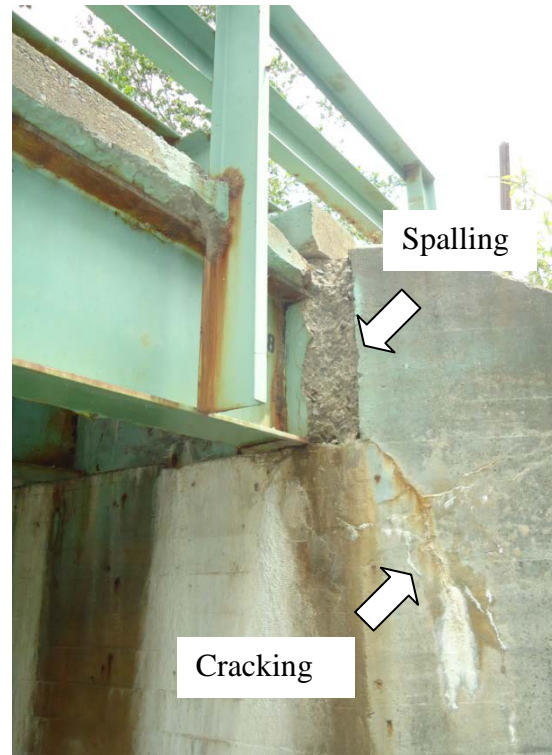
The substructure received a rating of 5 in the reviewed PennDOT inspection reports, indicating fair condition with some section loss. Observations made during the Penn State inspection were similar to the PennDOT inspection reports. Large areas of leakage, efflorescence, and corrosion staining from the beams were present on both abutments. Multiple hairline and map cracks were observed in addition to surface spalling. Figure 23a details an example of the observed leakage and efflorescence and Figure 23b shows an example of cracking and spalling in the east abutment. Light to moderate scaling of the concrete at the waterline was observed for both abutments during the Penn State inspection.

(a) Leakage, Staining and Efflorescence

(b) Cracking and Spalling

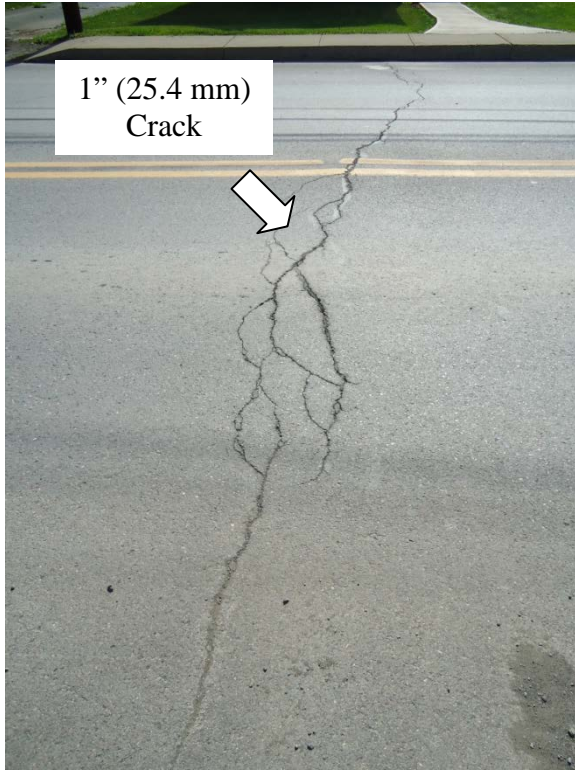
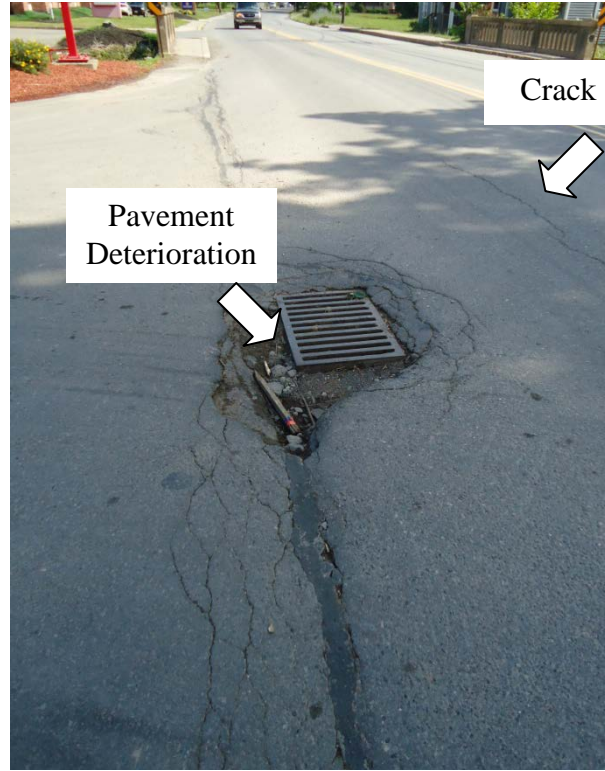
The inspection performed by Penn State personnel indicated that the south approach roadway had several cracks. Figure 24a shows a full-width, 1-inch (25.4-mm) wide transverse crack. The southbound lane also had considerable pavement deterioration and cracking emitting from a storm drain, as shown in Figure 24b. Large longitudinal cracks were observed in both lanes and shoulders, as shown in Figure 24b.

(a) 1" (25.4 mm) Wide Transverse Crack

(b) Pavement Deterioration and Longitudinal Cracks

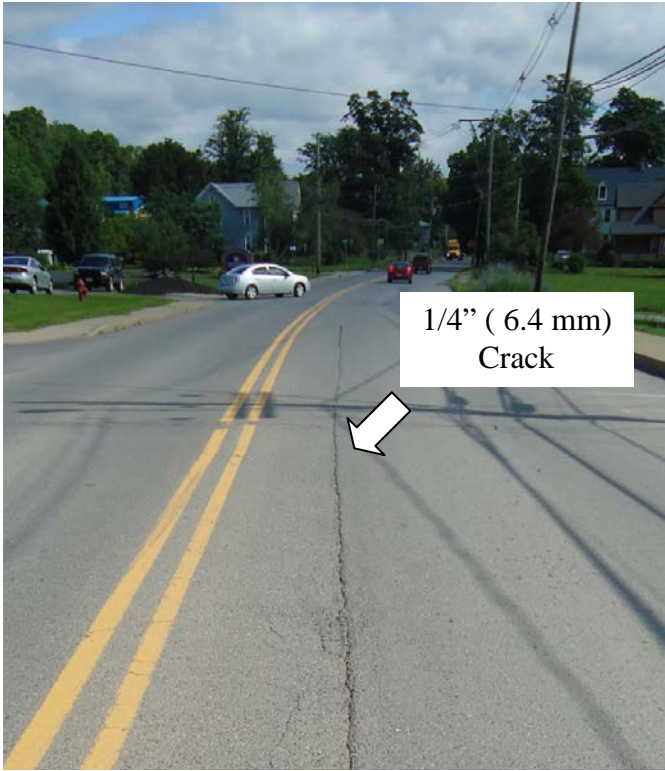
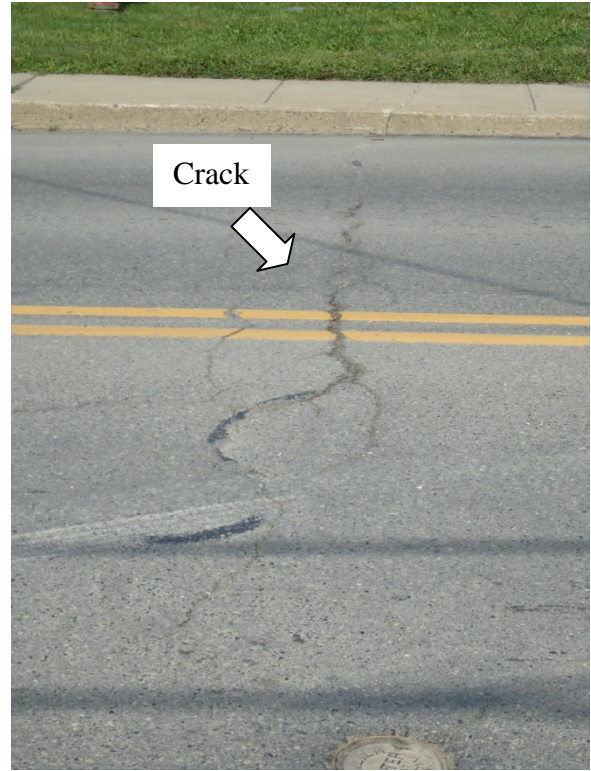
The north approach also had a large number of cracks. Several longitudinal cracks, ranging from 1/8 inch to 1/4 inch (3.2 to 6.4 mm) wide were observed. The largest longitudinal crack extended away from the examined region in the northbound lane and continued across the bridge wearing surface. Multiple transverse cracks, up to 1 inch (25.4 mm) wide, were also observed during the Penn State inspection. Typical longitudinal transverse cracks are presented in Figure 25a and 25b, respectively.

(a) Northbound Lane 1/4'' (6.4 mm) Wide Longitudinal Crack

(b) Typical Transverse Crack

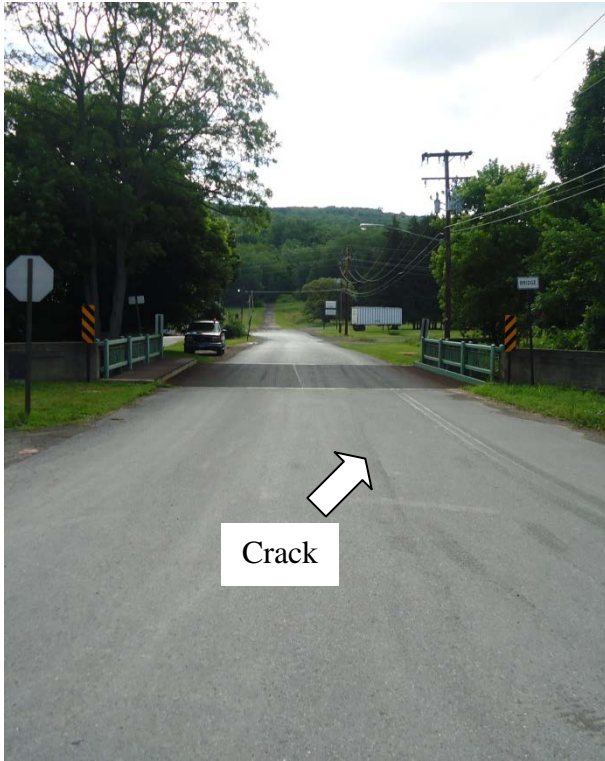
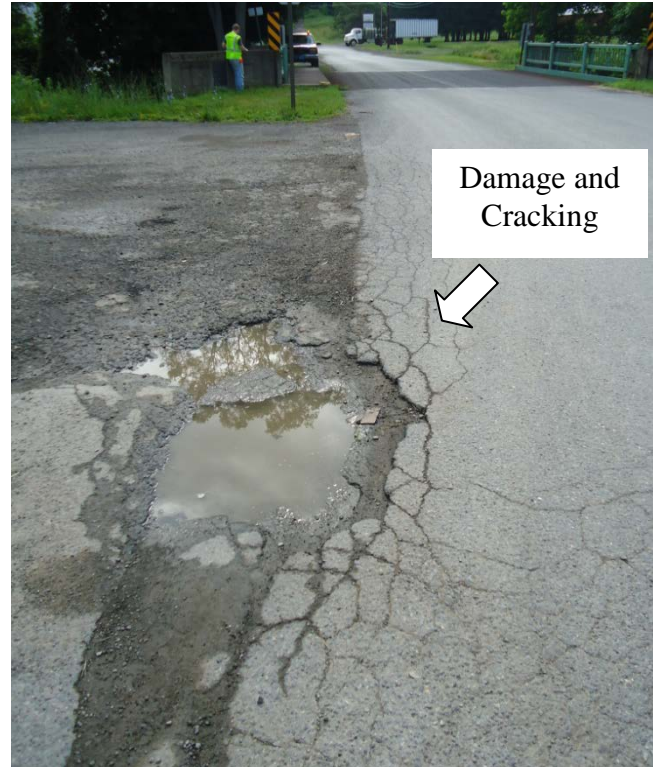
The west approach was inspected by Penn State personnel to the intersection with Pennsylvania State Route 14, a distance that was less than 100 ft (30.5 m). A single longitudinal crack existed in the eastbound lane, shown in Figure 26a. Significant pavement damage and cracking was observed along the edge of the westbound lane, as shown in Figure 26b.

(a) Eastbound Lane Longitudinal Crack

(b) Westbound Lane Edge Pavement Damage and Cracking

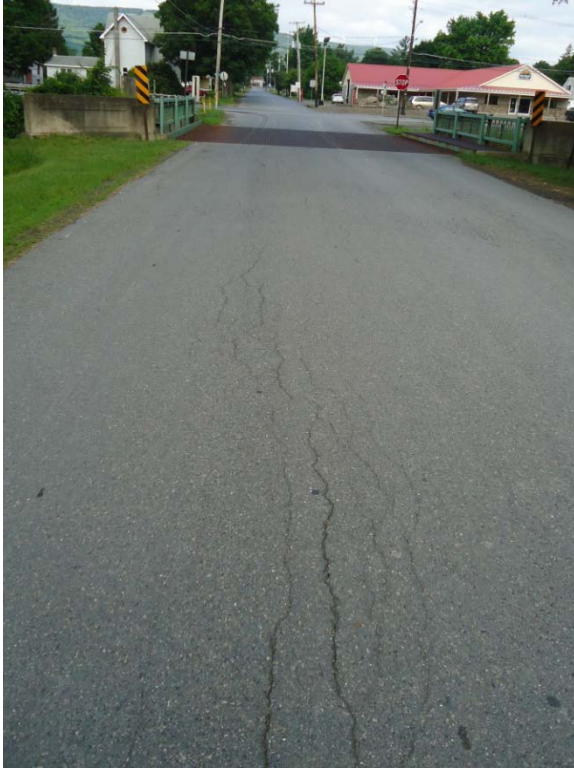
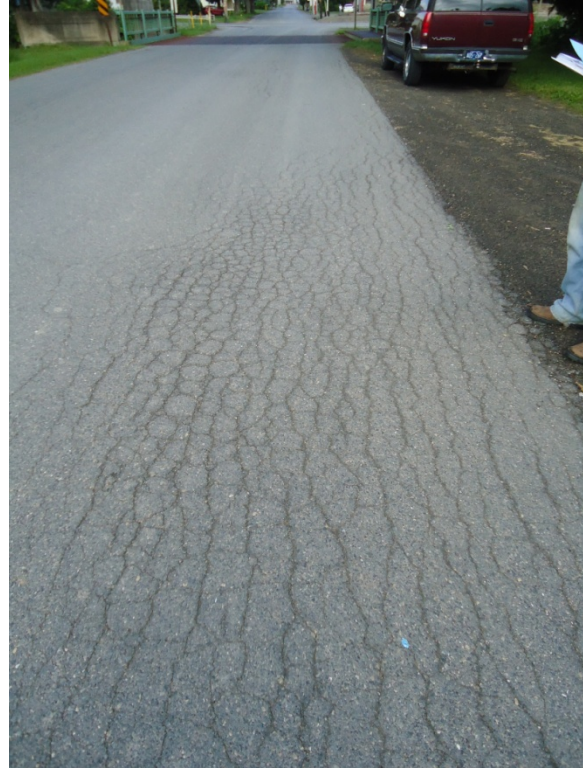
The east approach was observed by Penn State personnel to be similar in condition to the west approach. The eastbound lane contained multiple longitudinal cracks with some extending to the bridge. Figure 27a shows longitudinal cracks in the eastbound lane. The westbound lane contained a large area of map cracking and pavement deterioration at the shoulder. Figure 27b displays the westbound lane's most significant area of damage. Longitudinal cracks were also present in the westbound lane and typically were offset 2 ft (0.6 m) from the edge of the pavement.

(a) Eastbound Lane Longitudinal Cracks

(b) Westbound Lane Edge Pavement Damage and Cracking

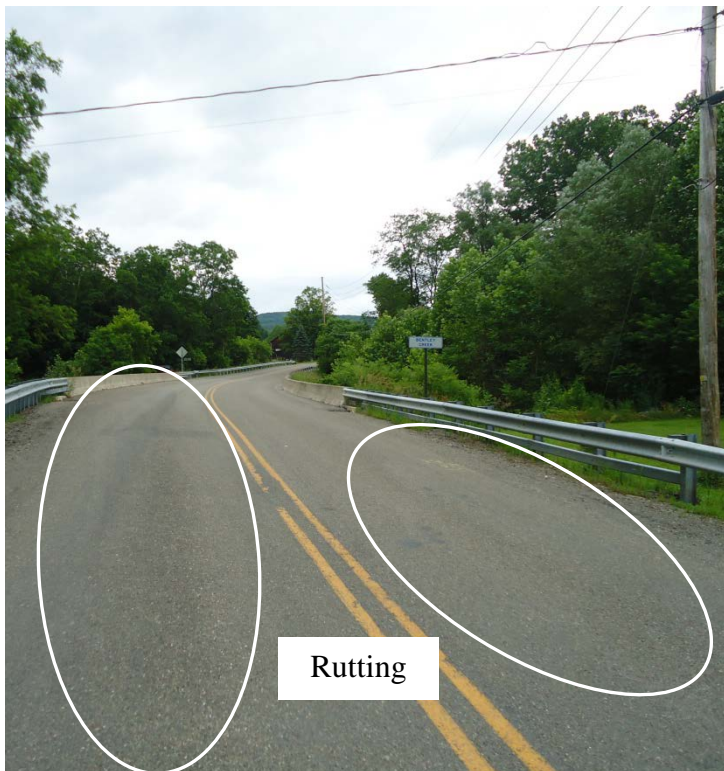
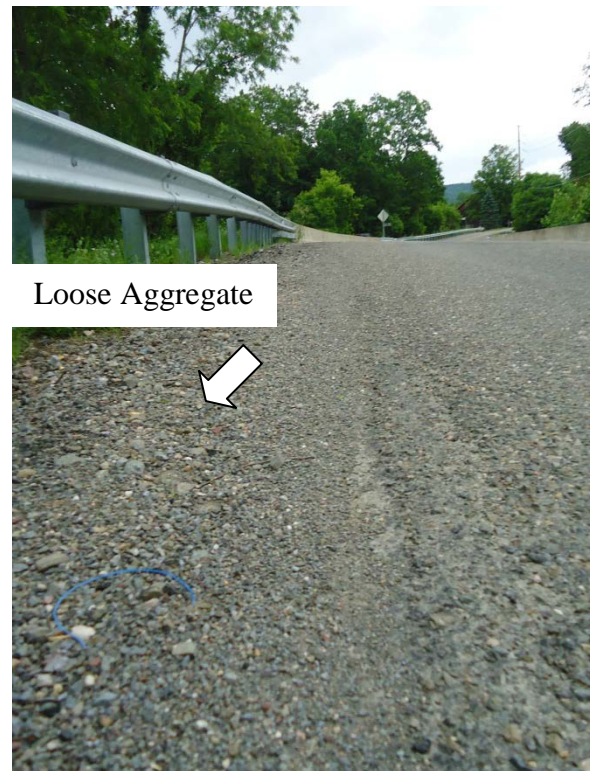
The roadway west of Bridge Three was also observed to be generally in good condition during the Penn State inspection. Both lanes had minor rutting. As noted in the inspection report, areas of loose aggregate were observed, typically near the shoulders. Figure 28a shows west approach rutting and 28b north shoulder loose aggregate.

(a) Rutting

(b) Shoulder Loose Aggregate
