The Impact of Marcellus Gas Development on the Rural Transportation Infrastructure

FINAL REPORT

July 31, 2013

**The Thomas D. Larson
Pennsylvania Transportation Institute**

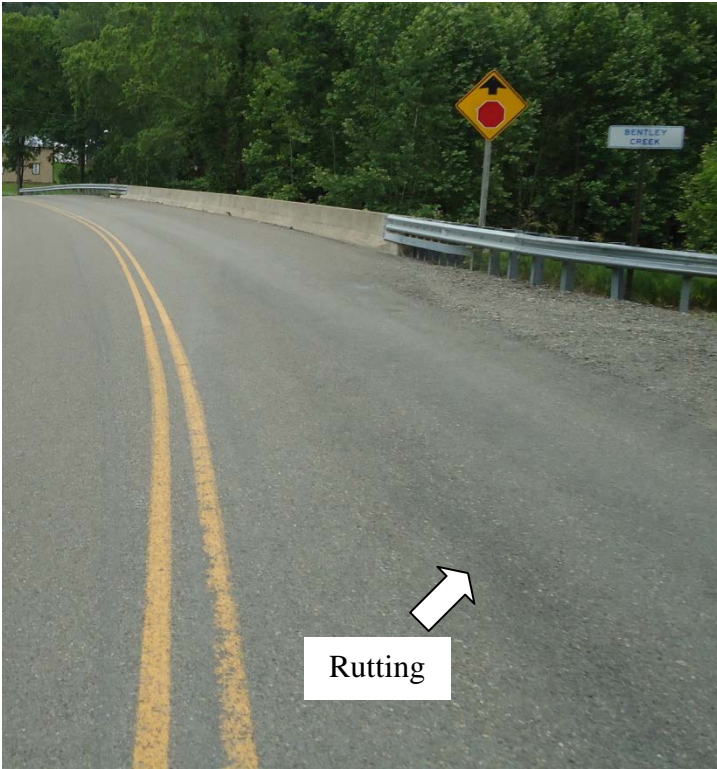
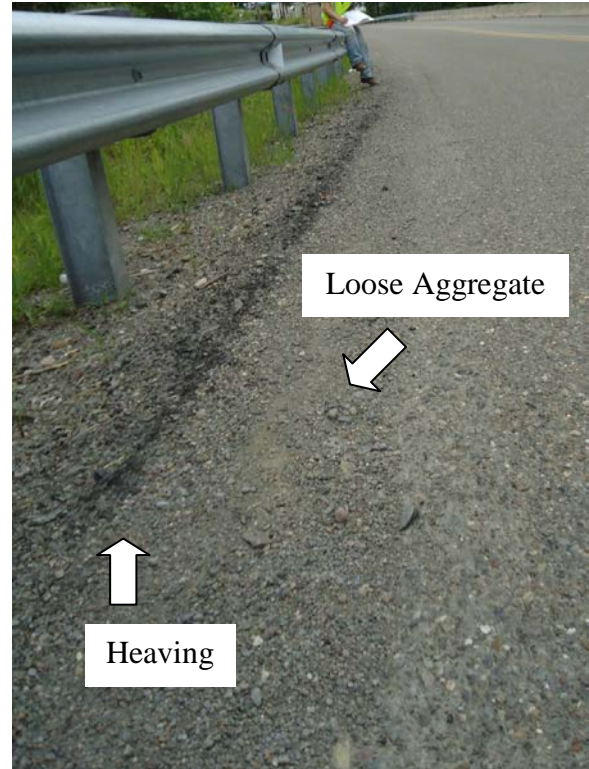
The east approach was observed to be of similar condition during the Penn State inspection. Rutting was slightly more significant than the west approach. Ruts up to 2 inches (50.8 mm) deep and 10 inches (254 mm) were measured in the eastbound lane, as shown in Figure 29a. Loose aggregate and heaving were also prevalent along the shoulders, as shown in Figure 29b.

(a) Eastbound Lane Rutting

(b) Loose Aggregate and Heaving

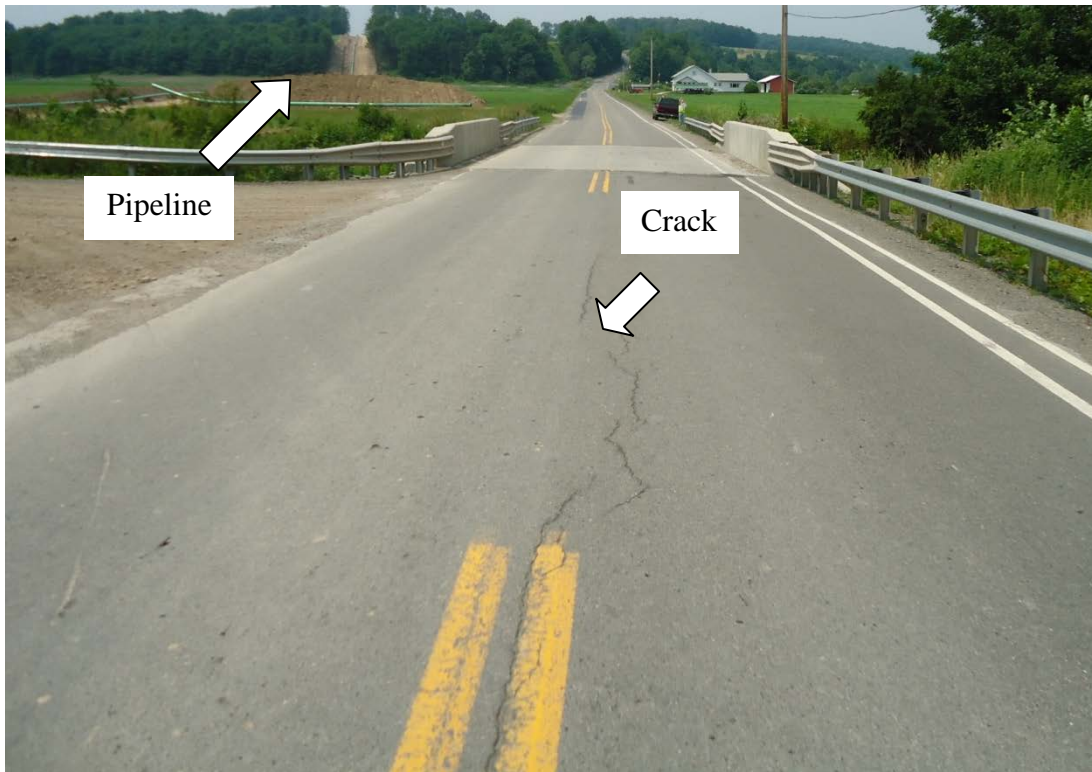
The south approach roadway was typically observed to be in good condition during the Penn State inspection. Some minor spalling and wear of the pavement was observed. Minor rutting was present in both lanes. Multiple longitudinal cracks had developed along the road centerline, as depicted in Figure 30. The north approach was very similar to the south approach. Minor rutting and wear of the pavement was evident. Longitudinal cracks similar to those in Figure 30 were observed.

Figure 30. Bridge Four South Approach Longitudinal Cracks at Roadway Centerline

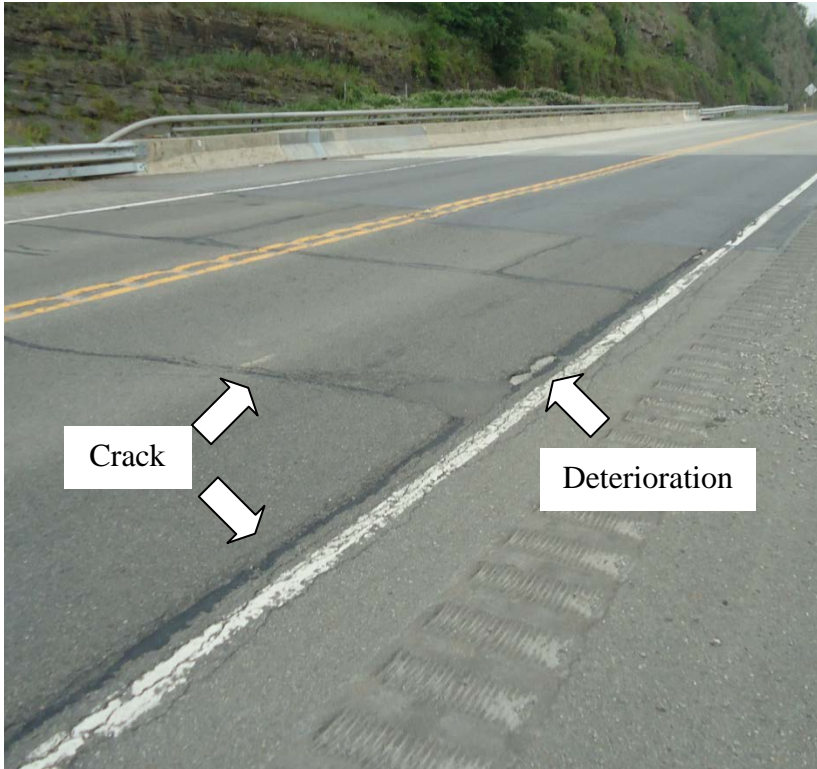
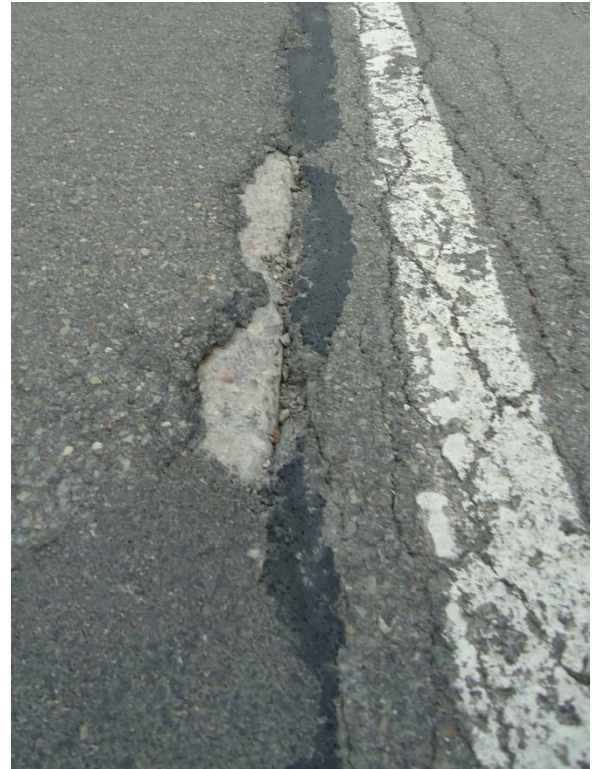
(a) Transverse and Longitudinal Cracking

(b) Pavement Deterioration at Roadway Edge

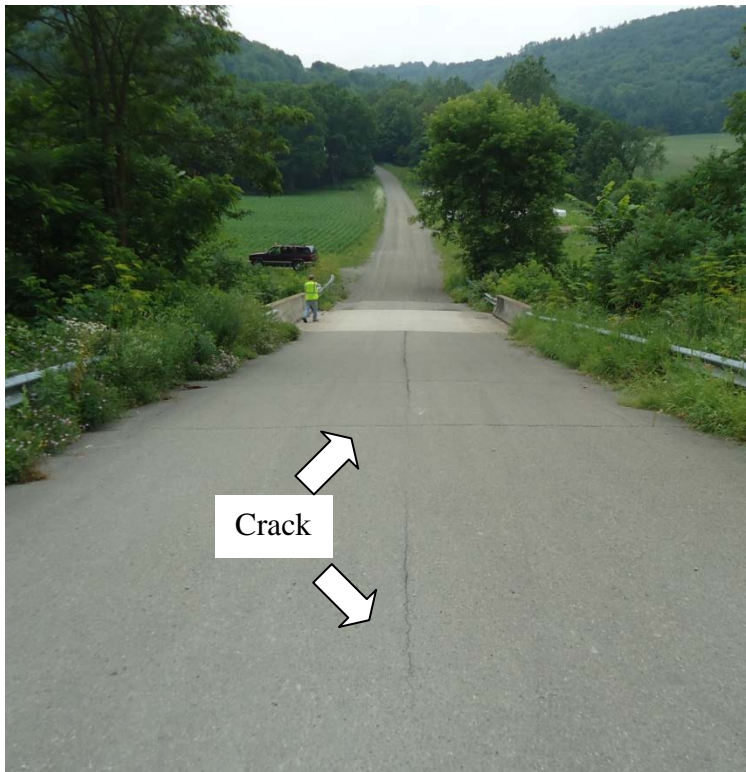
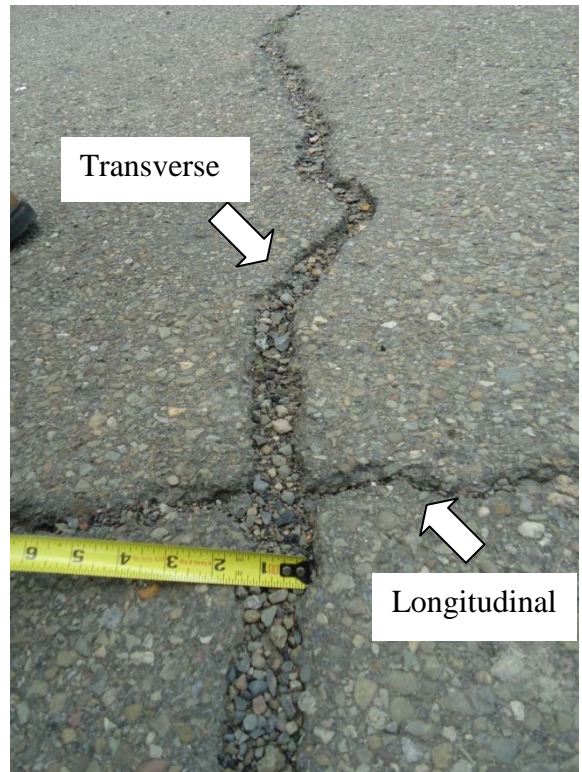
(a) Longitudinal and Transverse Cracks

(b) Typical Crack Width

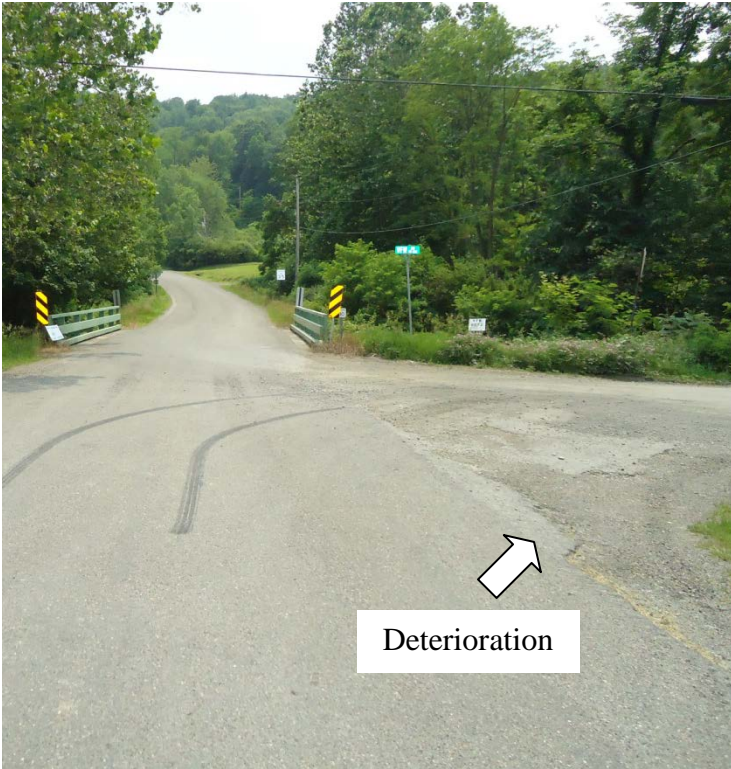
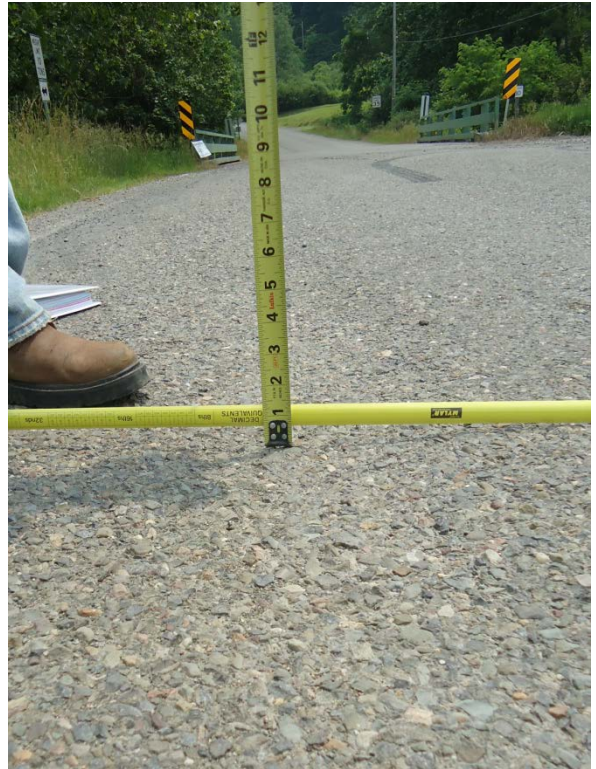
(a) Deterioration at VFW Road Intersection

(b) Typical Rutting Depth

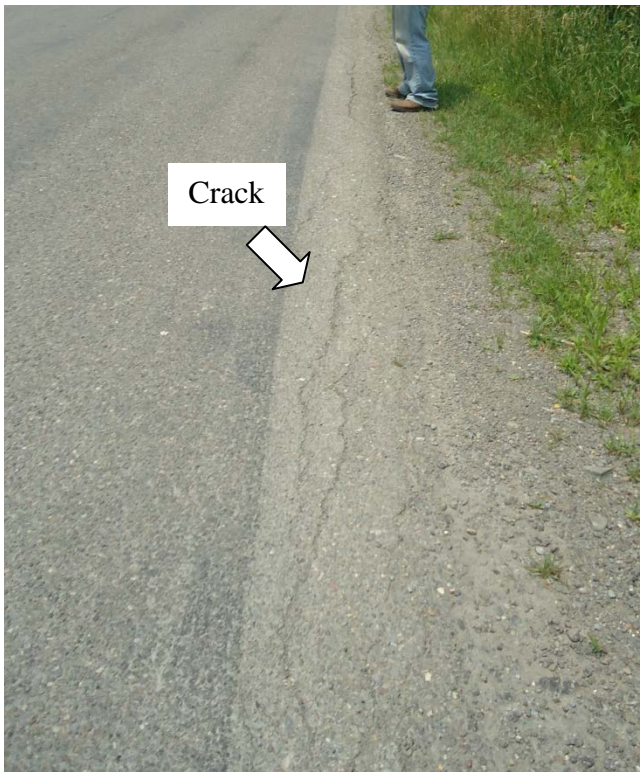
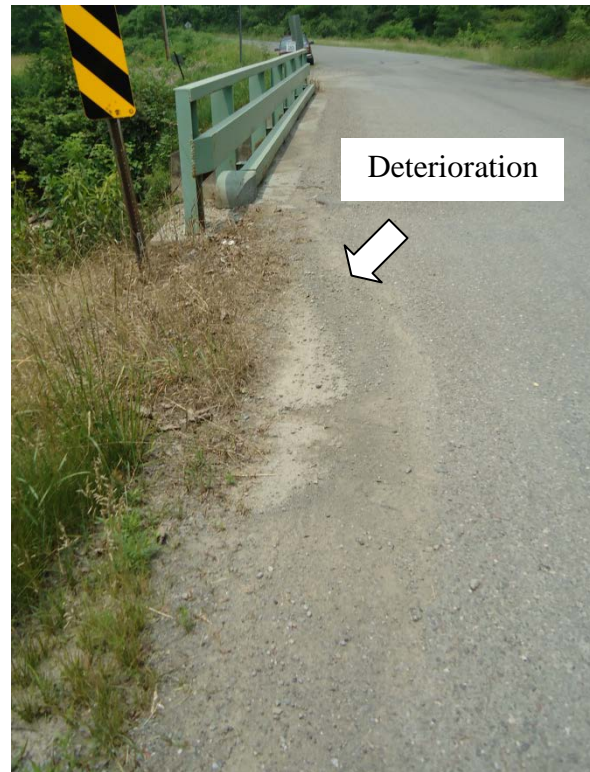
(a) Shoulder Longitudinal Cracking

(b) Pavement Deterioration at Bridge Transition

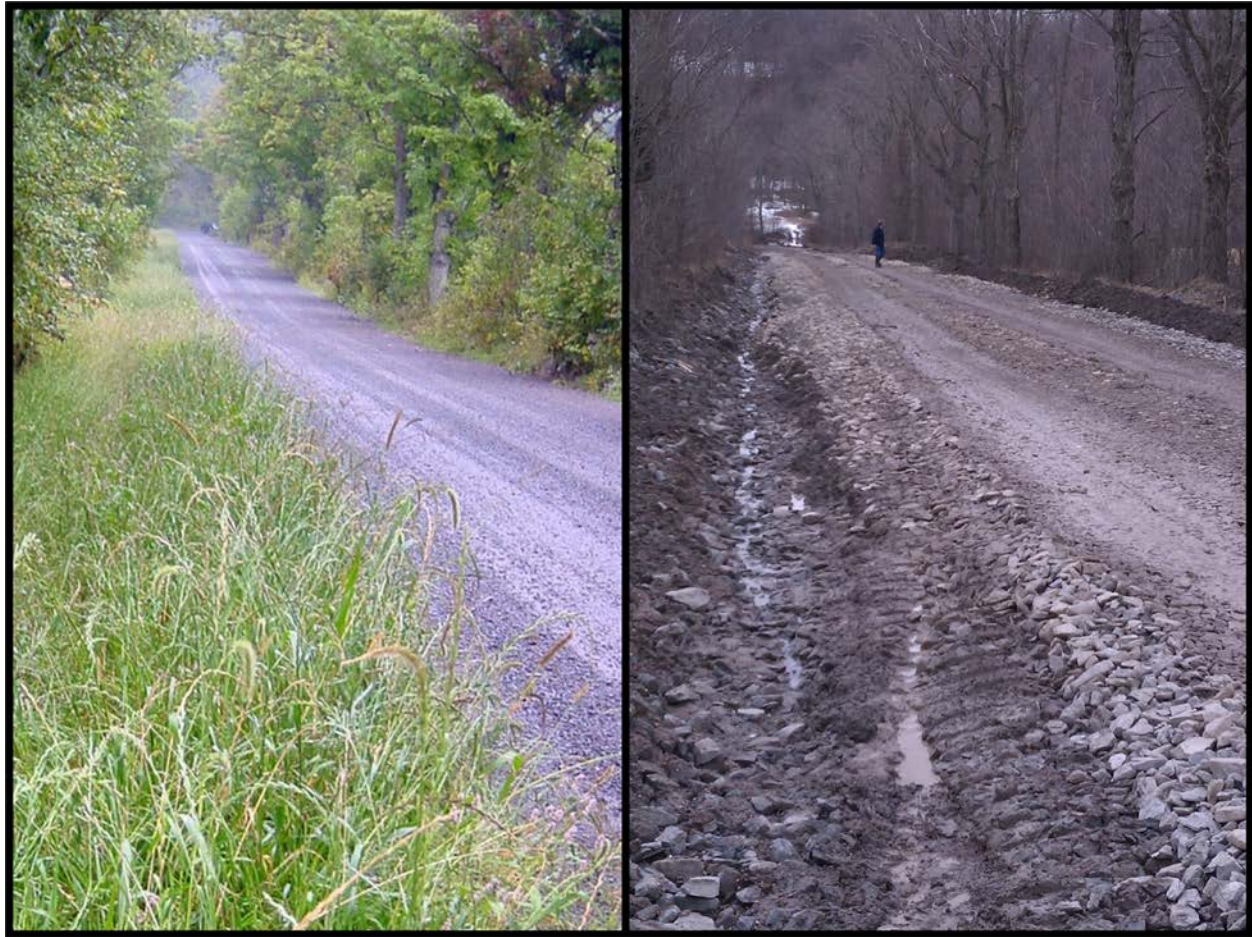
Figure 36a,b. Side by Side Comparison of a Well-Implemented Gravel Road [a] before the Heavy Gas Truck Traffic and [b] after Exposure to the Heavy Traffic
