# Study of a Pipe-Scanning Robot for use in Post-Construction Evaluation during Horizontal Directional Drilling

<b>1. Report No.</b> UVA 2013-05	<b>2. Government Accession No.</b>	<b>3. Recipient's Catalog No.</b>	
<b>4. Title and Subtitle</b> Study of a Pipe-Scanning Robot for use in Post-Construction Evaluation during Horizontal Directional Drilling		<b>5. Report Date</b> June 2015	
		<b>6. Performing Organization Code</b>	
<b>7. Author(s)</b> Lindsay Ivey Burden and Frank Morris		<b>8. Performing Organization Report No.</b>	
<b>9. Performing Organization Name and Address</b> University of Virginia Thornton Hall Charlottesville, VA 22904-4742		<b>10. Work Unit No. (TRAIS)</b>	
		<b>11. Contract or Grant No.</b>	
<b>12. Sponsoring Agency Name and Address</b> US Department of Transportation Research & Innovative Technology Admin UTC Program, RDT-30 1200 New Jersey Ave., SE Washington, DC 20590		<b>13. Type of Report and Period Covered</b> Final 7/1/13 – 6/30/14	
		<b>14. Sponsoring Agency Code</b>	
<b>15. Supplementary Notes</b>

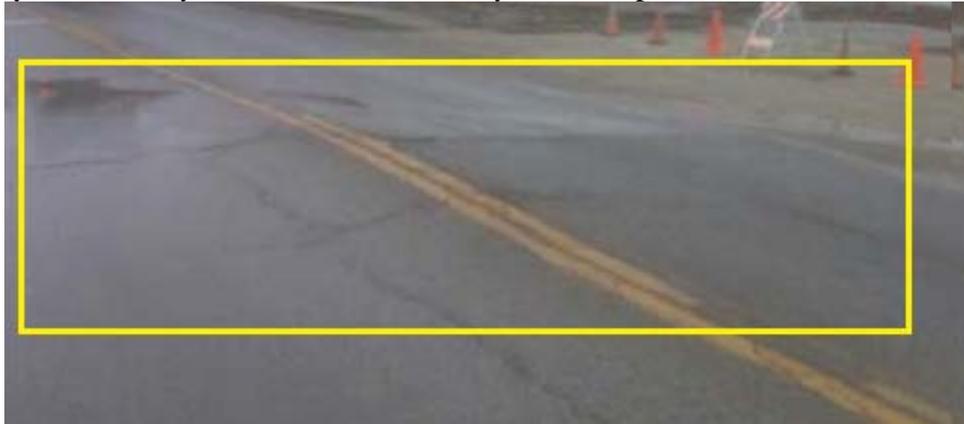
A case study, that took place in Newton, Illinois by Youssef Hashash and Jamie Javier, displays asphalt failure due to HDD construction. The project site had variable soil conditions: a mix of rock and soft fills. An 18-inch reamer bit drilled the open borehole, and dual 6-inch PVC waterlines were installed. Shortly after construction, heaving of the roadway caused mounding of the surface asphalt. Figure 7 displays the highlighted basal upheave of the roadway, creating

bumpy driving conditions. The conditions worsened with a crack in the waterline, and the municipality immediately remediated the roadway with an open-cut trench.

**Figure 7. Newton, Illinois HDD Failure (Hashash and Javier, 2011).**

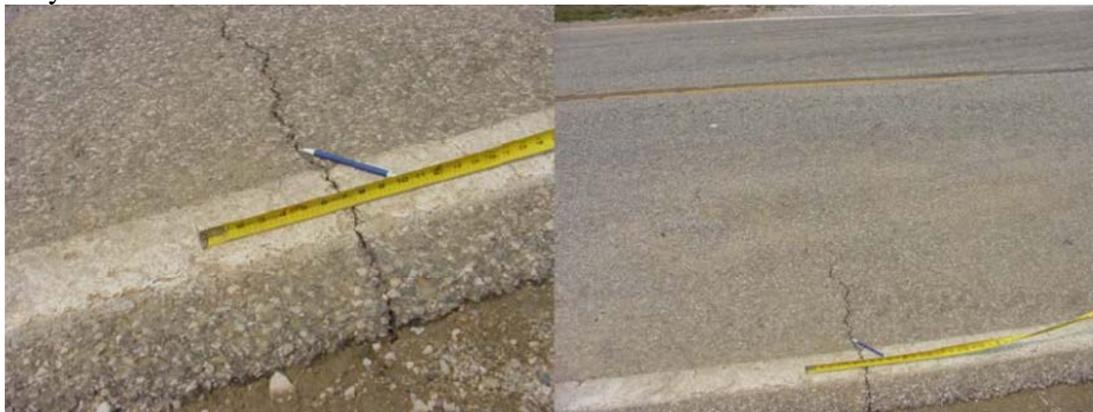
A similar case study by Hashash and Javier took place in Salem, Illinois. A steel 8-inch casing was installed beneath an existing roadway using trenchless methods, and cracking of the existing roadway occurred. Moisture, on either side of the cracking, was noted, for drilling fluid was the most likely cause of the surface moisture cracking. Figure 8 depicts longitudinal cracking in the direction of the utility. Hydrofracture is the probable cause of failure in this case. If FutureScan or GPR had been used on the project sites, the infrastructure failures could have been pre-determined, and issues would have been addressed on-site. The radar gram (FutureScan or GPR results) would indicate anomalies in the cracked region. In the case of the Newton, Illinois project site, FutureScan results would indicate a larger ream-hole diameter than was drilled. In addition, dielectric permittivity values of water may have been sensed close to the ground surface by either device.

**Figure 8. Salem, Illinois HDD Failure (Hashash and Jamie Javier, 2011).**

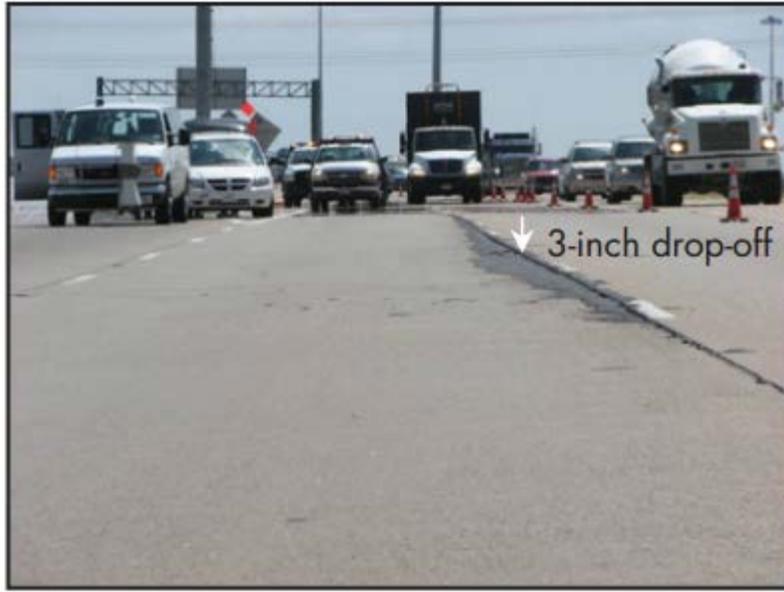
The Texas Department of transportation used GPR technologies to locate voids and reduce further damage to existing facilities. GPR was successful in locating a 1,080 cubic-foot void beneath U.S. 290 near Austin, Texas (Chen, 2010). A section of U.S. 290, southwest of Austin, was built on top of an MSE (Mechanically-Stabilized Earth Wall). An underground drain pipe, spanning longitudinal (parallel) to lanes, broke at a joint, causing soil fines to wash out of the pipe itself. Thus, a large void formed below the roadway surface. Subsidence and cracking at the surface indicated soil failure below existing grades. Settlements of up to 3-inches were observed. Figure 9 displays the large subsidence between traffic lanes.

**Figure 9. Settlement of the Roadway (Chen, 2010).**

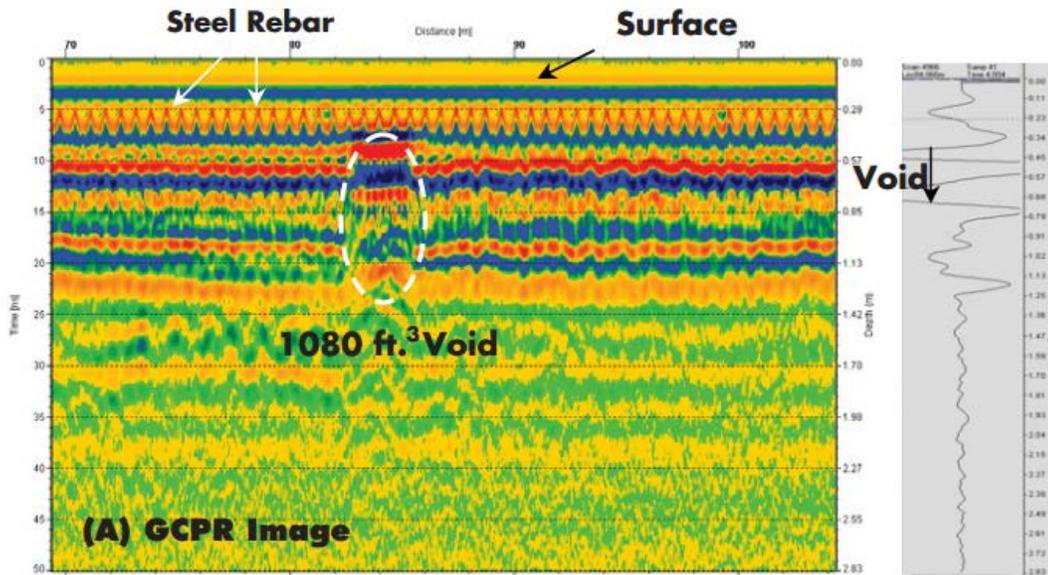
After evaluating the site using a 400 Megahertz antenna GPR system, an inversion of voltage was noticed on the radar gram in Figure 10 (Chen, 2010). The void dimensions were listed as such: 6 feet deep, 15 feet long, and 12 feet wide (Chen, 2010).

**Figure 10. Radar Gram Results for U.S. 290 near Austin, T.X. (Chen, 2010).**

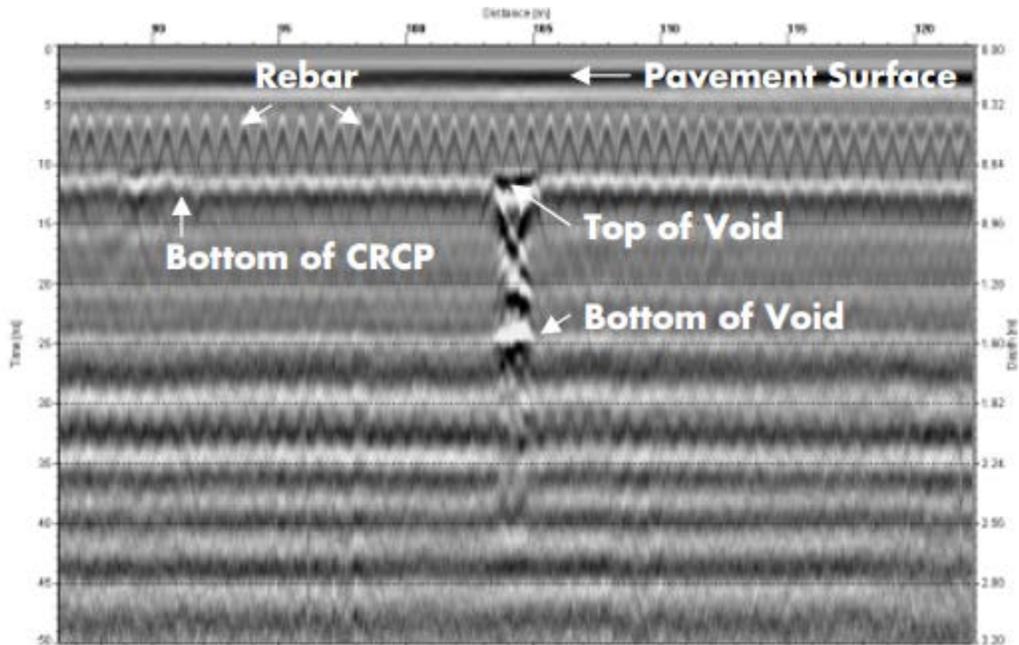
Chen outlines an additional case study in Amarillo, Texas, concerning Interstate 40 (I-40). Similarly, a storm drain pipe had failed and soil fines were observed seeping out of the asphalt surface. After using GPR to survey the area, anomalies were noted on the radar gram in Figure 11.

**Figure 11. Anomalies from I-40 in Amarillo, Texas (Chen, 2010).**

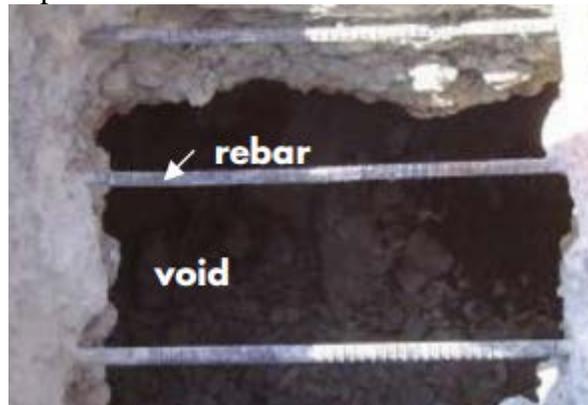
A section of the roadway was cut, and a 135 cubic foot void was realized (Chen, 2010). Figure 12 depicts the cut roadway, revealing a large void beneath the roadway surface. Remediation included grouting the void space.

**Figure 12. Void beneath I-40 detected by GPR (Chen, 2010).**

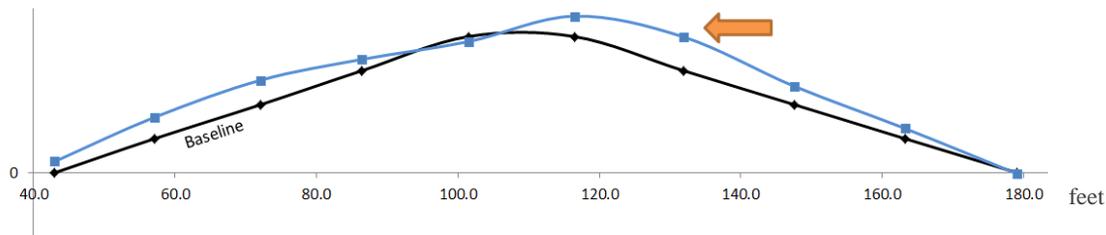
A heaving trend was noticed during reaming. Two (2) sets of elevation data were recorded during reaming stages of the project. The average of the two sets of data is depicted below. Figure 25 is a cross-sectional view of the roadway during reaming, based on an exaggerated scale. The critical point, which appears approximately 150-feet from the north end of the pipe, experiences 1-inch of upheave. Heaves, ranging from 0.33-inches to 1.0-inch, are realized in Figure 25.

**Figure 25. Roadway Movement during reaming.**

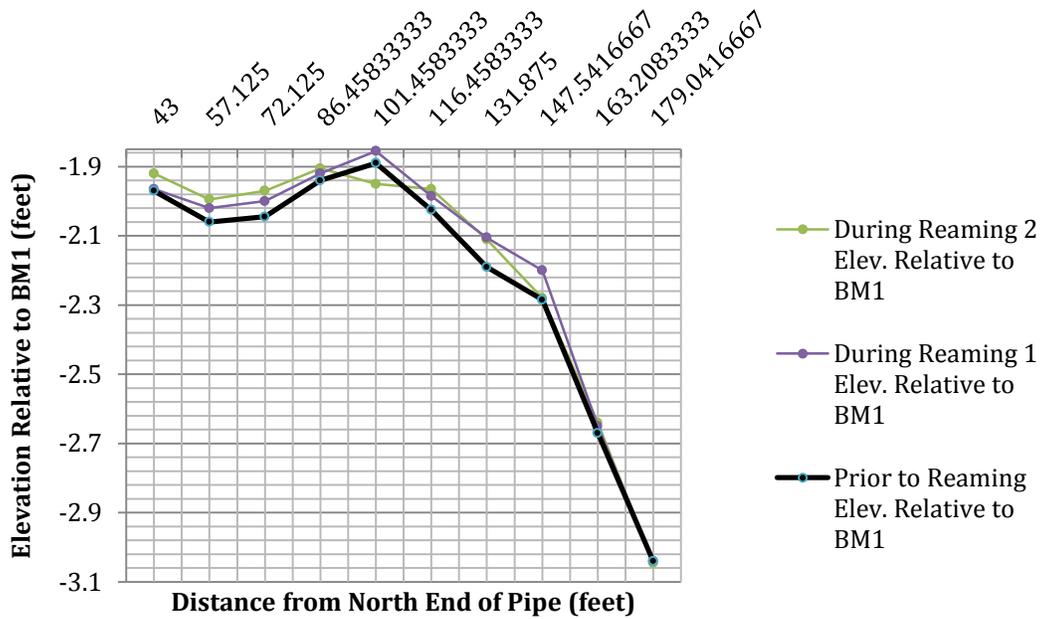
the north outlet of the pipe. The low point could be caused by surveying error. The basal upheave shown in Figure 26 is likely caused by drilling fluid pressures and the force of the reaming bit or by hydrofracture.

**Figure 26. Average Reaming Schemes.**

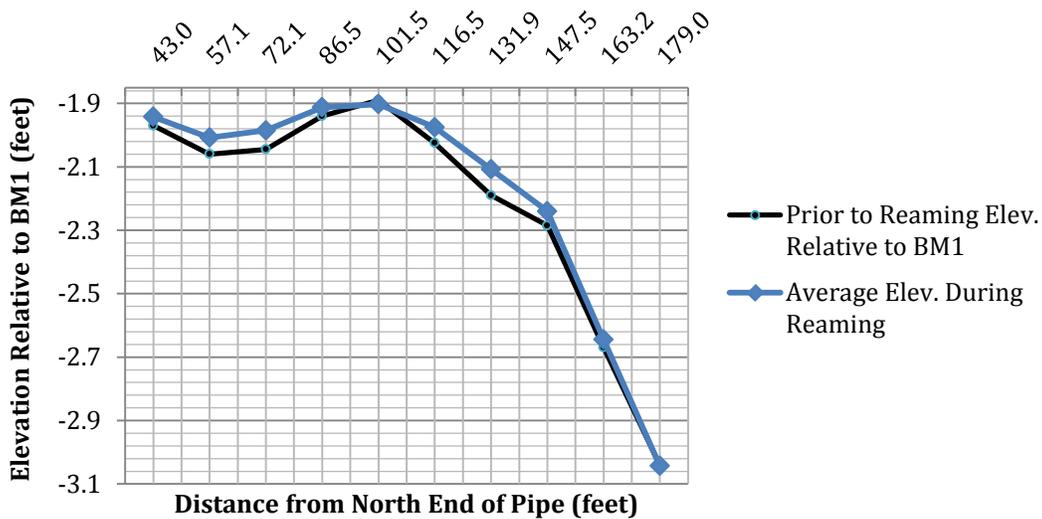
Figure 27 displays the average of the two sets of reaming data versus the elevation data taken prior to drilling. Surveying error is minimized by averaging the sets of relative elevations. Notice that there still is a general upheave trend.

**Figure 27. Average Reaming Schemes.**

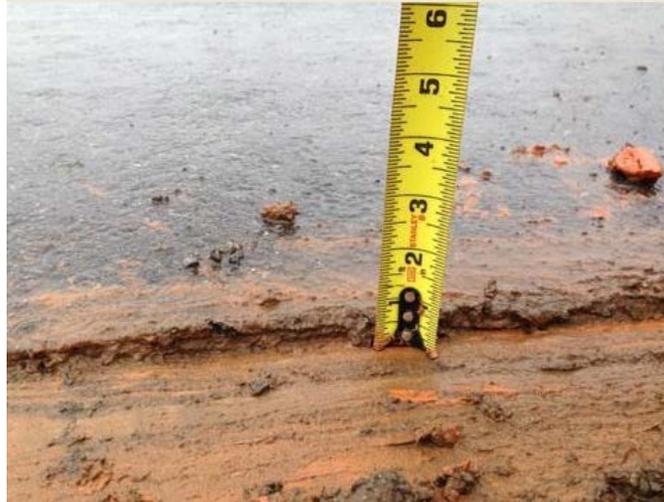
The drilling fluid pressures may have caused hydrofracture to occur within the soil above the pipe. Throughout reaming, heaving of the asphalt relative to the concrete gutter was noted. In Figure 28, approximately 3/4-inch of heave was noted between the south curb and concrete gutter.

**Figure 28. Heaving of Asphalt relative to Curb and Gutter (Photo by Lindsay Ivey Burden).**

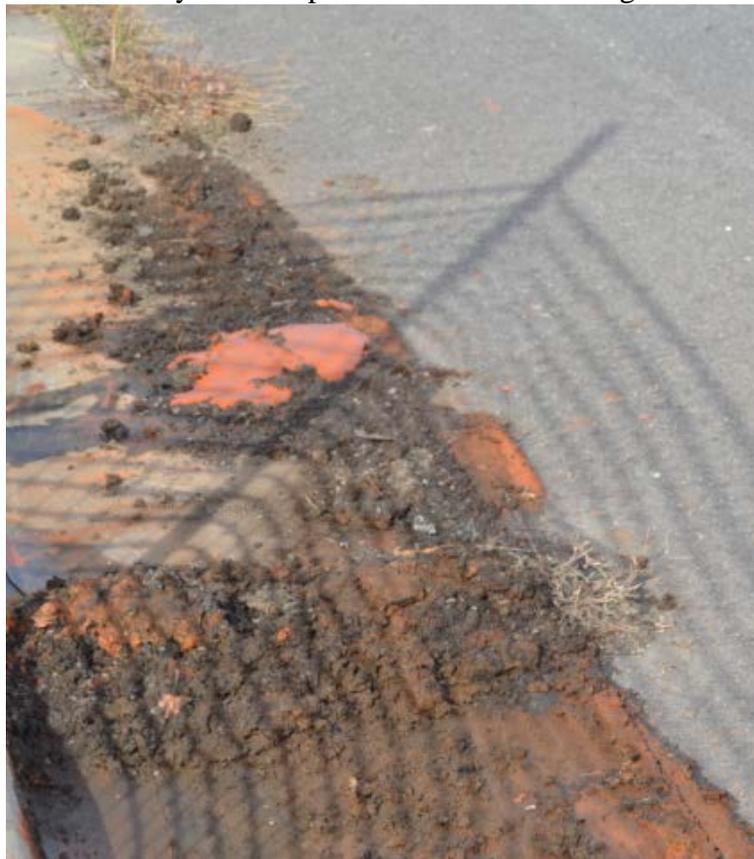
While pushing the auger to the north end (During Reaming 2), drilling fluid started to come out of the edge of the asphalt on the south end (Figure 33). Moisture migrating from cracks or discontinuities in roadways is characteristic of hydrofracture. During hydrofracture, drilling fluid pressures exceed natural soil pressure of outer borehole walls, and cracks in the vertical direction begin forming. Fluid migrates through these cracks toward the ground surface. Drilling fluid comes to the surface to relieve hydrostatic pressures as shown in Figure 29.

**Figure 29. Drilling Fluid migrating to the roadway surface (Photo by Frank Morris).**

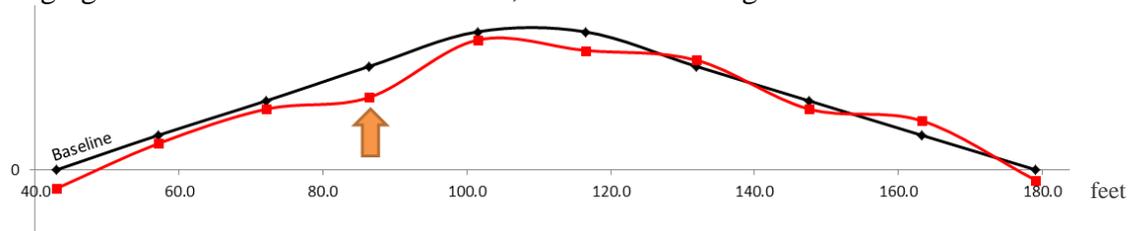
The next set of elevations were logged on October 31<sup>st</sup>, 2013, the day after reaming and pulling the pipe, and plotted in Figure 30. Figure 30 is a cross-sectional view of the roadway the day after reaming, based on an exaggerated scale. The critical point, which appears approximately 90-feet from the north end of the pipe, experiences 0.90-inches of settlement. Settlements, ranging from 0.24-inches to 0.90-inches, are realized in Figure 30.

**Figure 30. Roadway Movement after pipe insertion.**

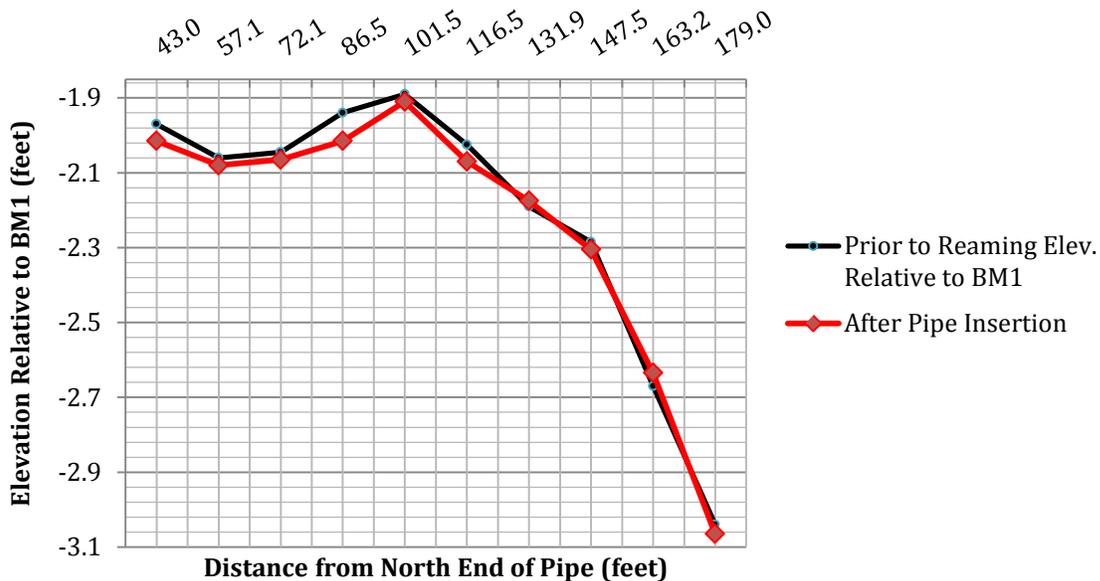
The actual elevation data is plotted in Figure 35, relative to Benchmark 1. A general settling trend is noticed in Figure 31. By this time, the borehole has had time to recede, and a slight amount of settlement occurred in the meantime. Potential weaknesses caused by hydrofracture and increased water content had likely caused the hole to recede. Note that October 31, 2013 was also the date in which FutureScan results were obtained.

**Figure 31. Elevations recorded the day after drilling operations.**

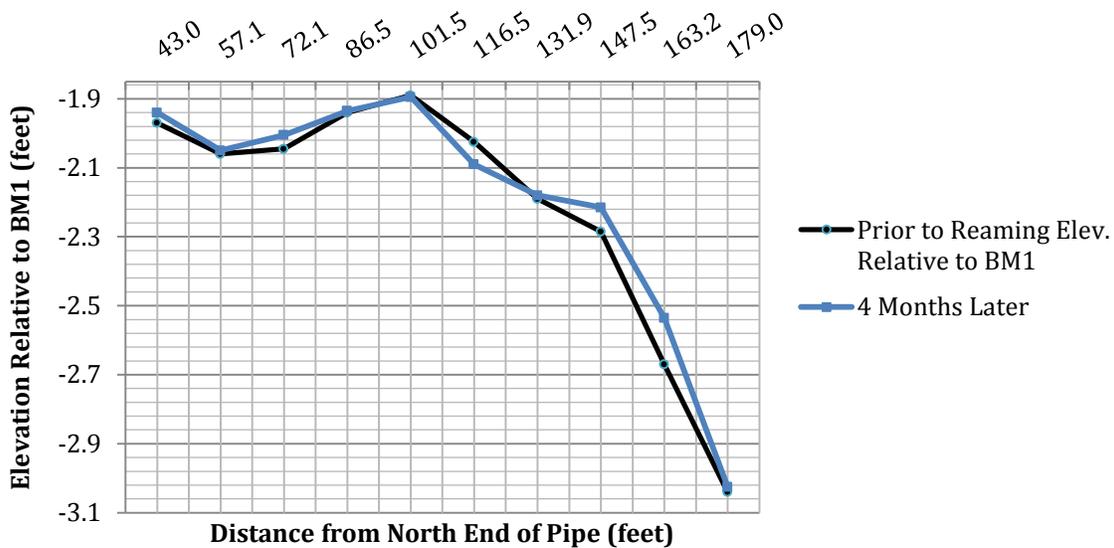
Referring to Figure 33, heaving is noticed from 43-feet south of north end to 87-feet south of north end. Heaving is also noticed 132-feet south of north end to 179-feet south of north end. A settling trend is noticed in the middle: 101.5-feet to 132-feet south of north end.

**Figure 33. Elevations recorded 4-months after project completion.**

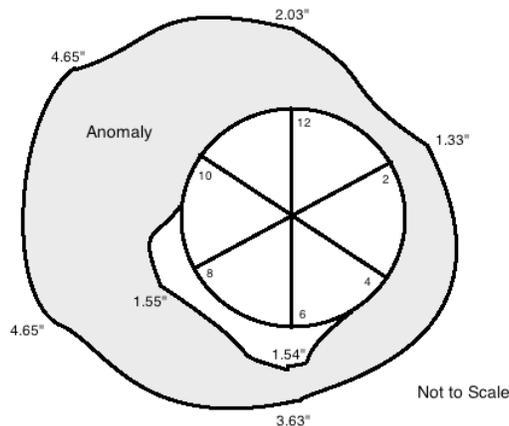
**Figure 49. Anomaly detected by FutureScan near the middle of the piping system.**
