Evaluating Resistance of Hot Mix Asphalt to Reflective Cracking Using Geocomposites

1. Report No. PSU-2008-04		2. Government Accession No.		3. Recipient's Catalog No.	
4. Title and Subtitle Evaluating Resistance of Hot Mix Asphalt to Reflective Cracking Using Geocomposites			5. Report Date January 28, 2013

6. Performing Organization Code		
7. Author(s) Mansour Solaimanian			8. Performing Organization Report No. LTI 2013-08		
9. Performing Organization Name and Address Thomas D. Larson Pennsylvania Transportation Institute Transportation Research Building The Pennsylvania State University University Park, PA 16802-4710			10. Work Unit No. (TRAIS)

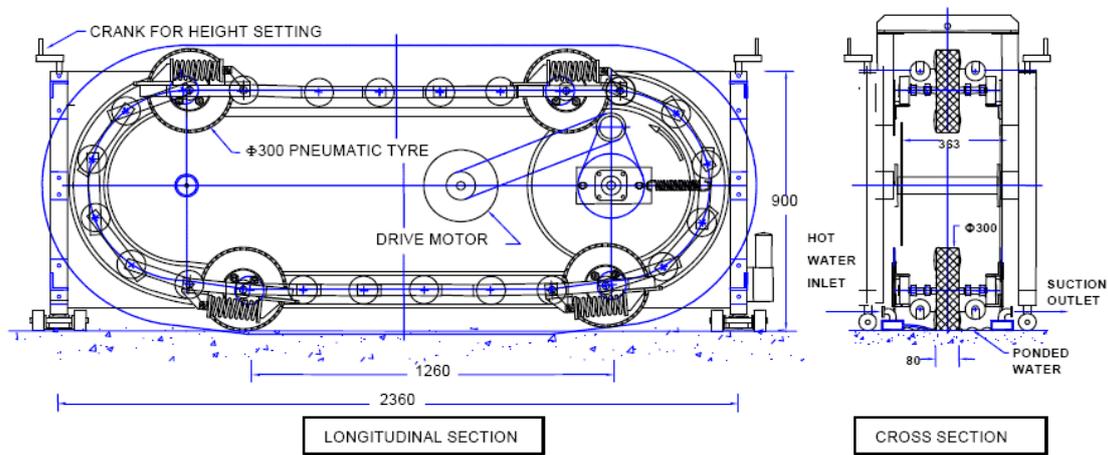
Figure 1 Schematic of MMLS3.

The MMLS3, shown in Figure 1, is an accelerated pavement testing device that applies unidirectional trafficking to the pavement in a controlled laboratory environment or on full-scale pavements in the field. The MMLS3 has four tires, each with diameter of 12.0 inches and width of 3.1 inches. The actual wheel path generated by the MMLS3 is about 54 inches long. The load exerted by each wheel of the MMLS3 is 225 lbf with a corresponding tire pressure of 90 psi. The traffic speed was set to 7,200 axles (wheels) per hour, or two axles (wheels) per second.

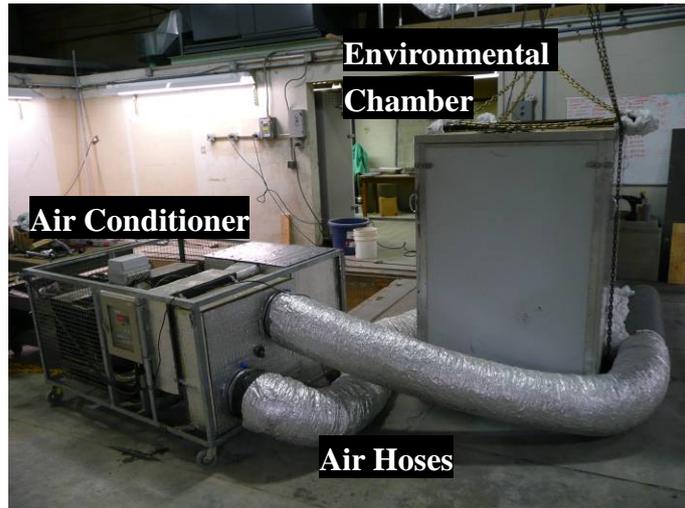
Figure 2 The air conditioner and environmental chamber.

The air conditioner and environmental chamber in Figure 2 were used to maintain the temperature inside the chamber while testing. The air conditioner can send cool or hot air at a specified temperature into the insulated environmental chamber through two air hoses. A thermocouple connected to the air conditioner on one side can measure the air temperature inside the chamber and send feedback to the air conditioner to adjust the air temperature.

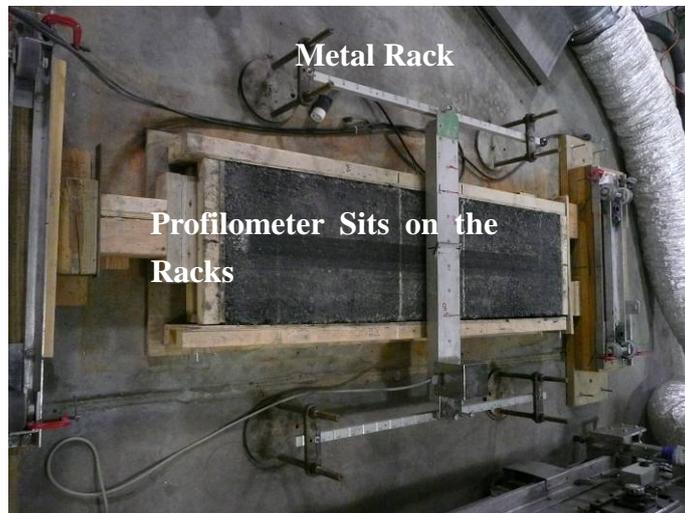
Figure 3 The profilometer.

For measuring the transverse surface profile, the electronic profilometer, presented in Figure 3, was used. During profiling, the meter was supported by two metal racks on both sides of the test set-up. The profilometer was connected to a computer to save the surface profile readings.

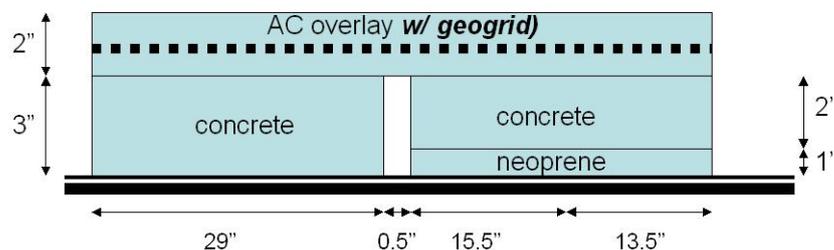
1st Test Setup of the 1st Testing Configuration

Figure 4 First setup of the first configuration (geogrid placed in between asphalt overlay).

Figures 4 and 5 show the cross-sectional and dimensional plots of the two setups of the first testing configuration. The underlying concrete slab consisted of two adjacent sections (slabs). One section was 3 inches thick and placed directly on firm ground. The other section was 2 inches thick with a 1-inch-thick neoprene pad underneath. The idea supporting this set-up was to aggravate vertical movement at the joint expediting reflective cracking. Differential movement at the joint could also induce higher shear stresses at the asphalt section right on the joint. However, the experiment did not support this assumption. After loading with MMLS3, cracking at joint was noticed, initiating at the top and migrating downward due to the imposed cantilevered condition.

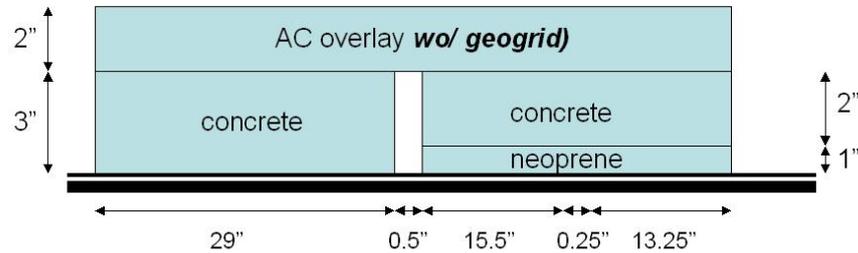
2nd Test Setup of the 1st Testing Configuration

Figure 5 Second setup of the first configuration
(asphalt overlay without geogrid).

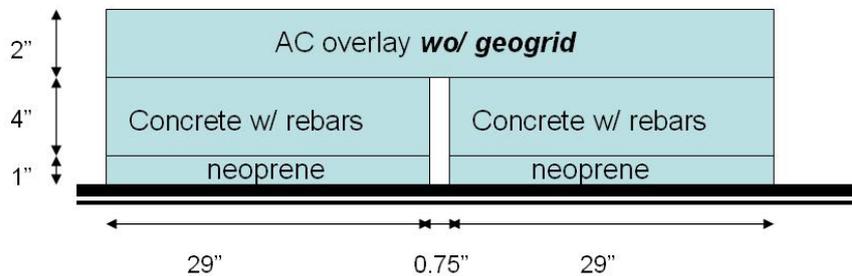
1st Test Setup of the 2nd Testing Configuration

Figure 6 First setup of the second configuration
(asphalt overlay without geogrid).

Figures 6 and 7 show the cross-sectional and dimensional plots of the two setups of the second testing configuration. In this configuration, concrete slabs were made 4 inches thick with rebars in order to prevent any damage to the slabs during the asphalt overlay compaction. Also, beneath each of the 4-inch concrete slabs was a 1-inch-thick neoprene pad. The purpose of the design in this configuration was to simulate the reflective crack that happens from the bottom of the asphalt overlay in the field. The joint between the two concrete slabs was increased from $\frac{1}{2}$ inch to $\frac{3}{4}$ inch to increase the possibility of cracking.

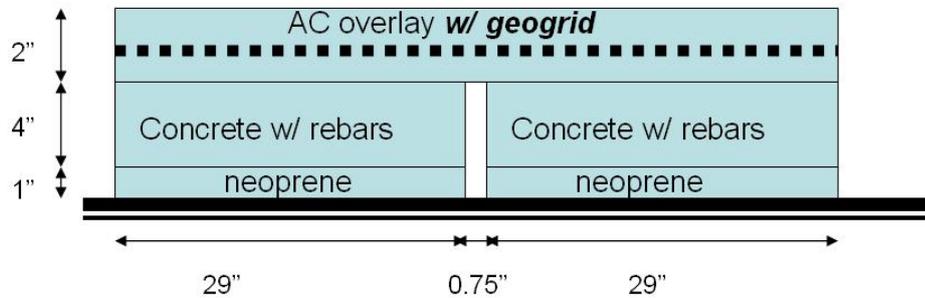
2nd Test Setup of the 2nd Testing Configuration

Figure 7 Second setup of the second configuration (geogrid placed in between asphalt overlay).

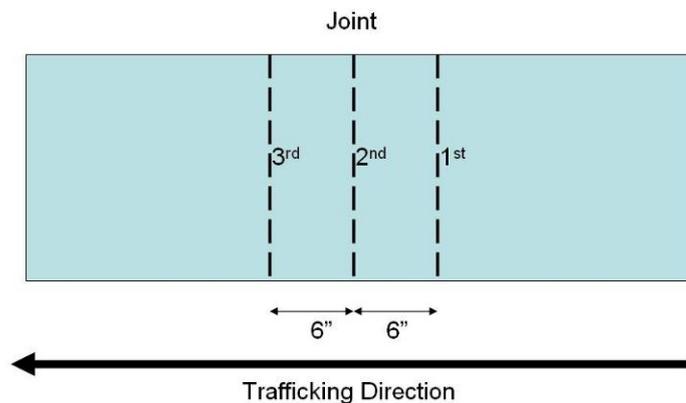
Positions for Profile Measurement

Figure 8 Three profile-measuring positions.

Each setup from both types of testing configurations was placed properly so that the tires of the MMLS3 could travel directly at the center strip of each setup. A total of three measurements were made on three locations of each setup, as shown in Figure 8. The first and third measurements were 6 inches away from the second measuring position, which was at the joint.

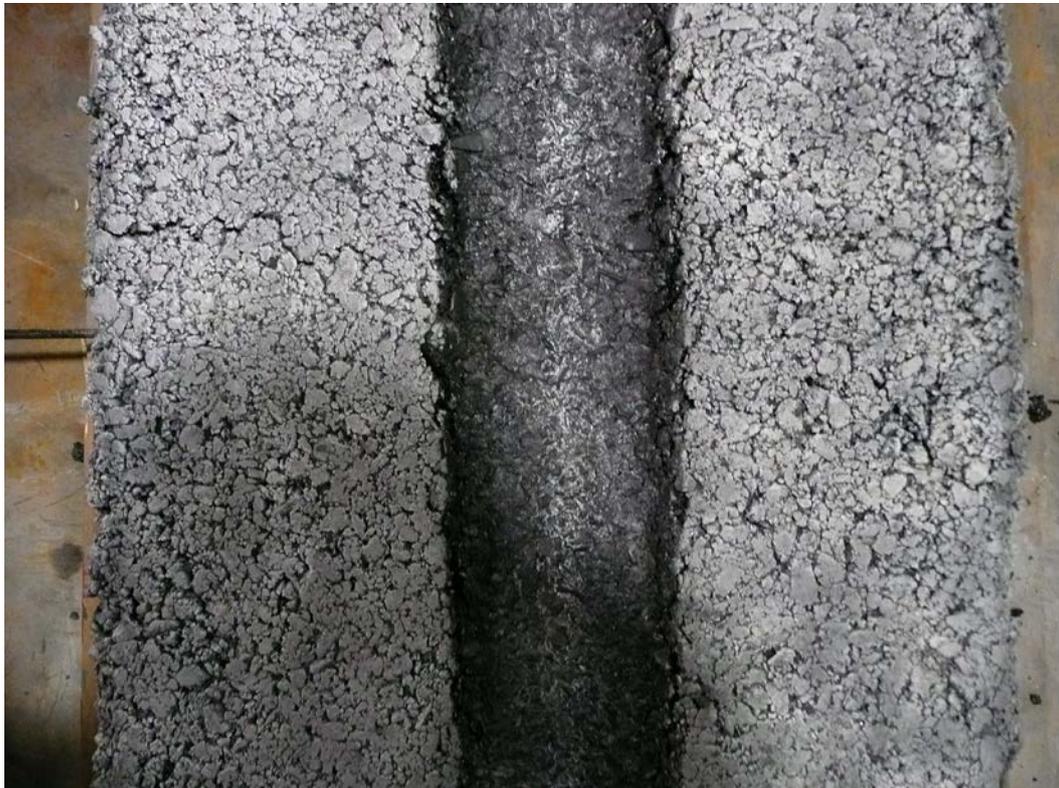
Figure 9 Crack at the middle joint position for the control setup of the first configuration after 400,000 trafficking cycles.

As mentioned previously, the asphalt overlay was investigated for signs of distress and cracking at specific cycle intervals. For the first configuration, the control setup without using geocomposite exhibited top-down cracking at the vicinity of the joint after experiencing 20,000 trafficking cycles, while the experimental setup with geocomposite in the overlay showed top-down cracking at similar position after 150,000 cycles. The crack width for both setups was almost the same, and approximately 0.3 to 0.4 mm. Figures 9 and 10 exhibit the surface condition of the slabs after 400,000 cycles of trafficking.

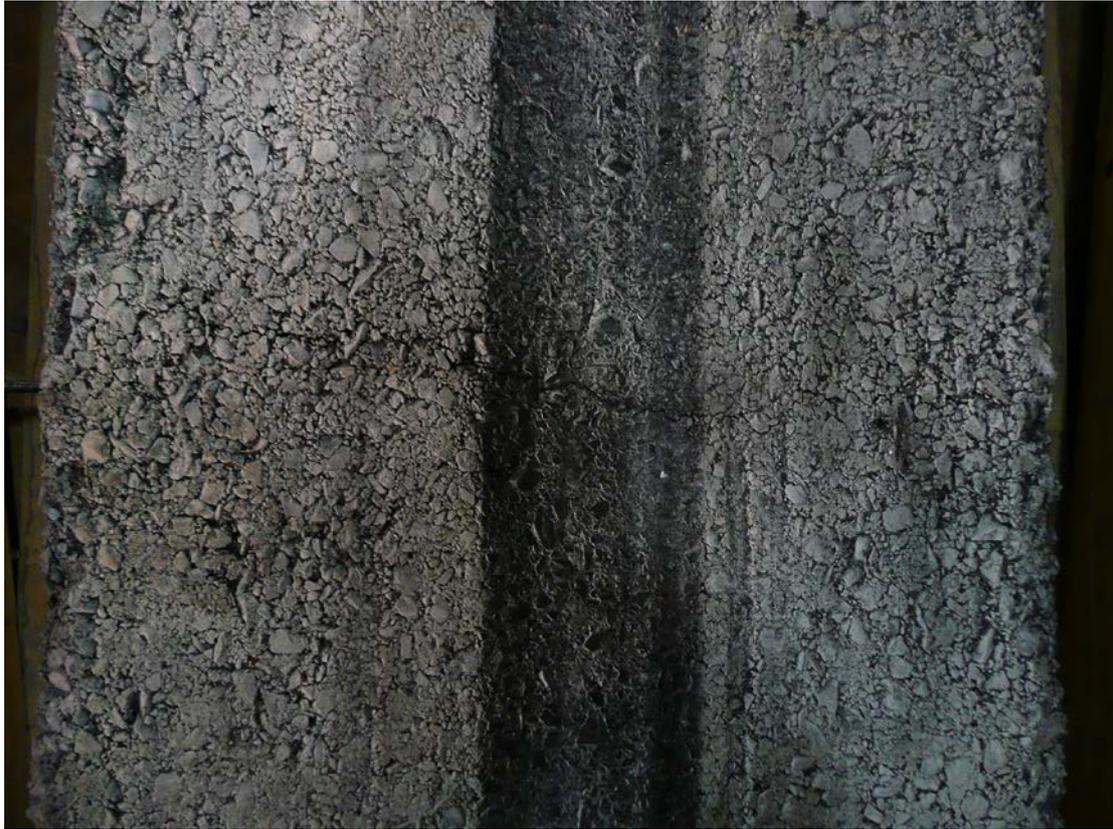
Figure 10 Crack at the middle joint position for the experimental setup of the first configuration after 400,000 trafficking cycles.

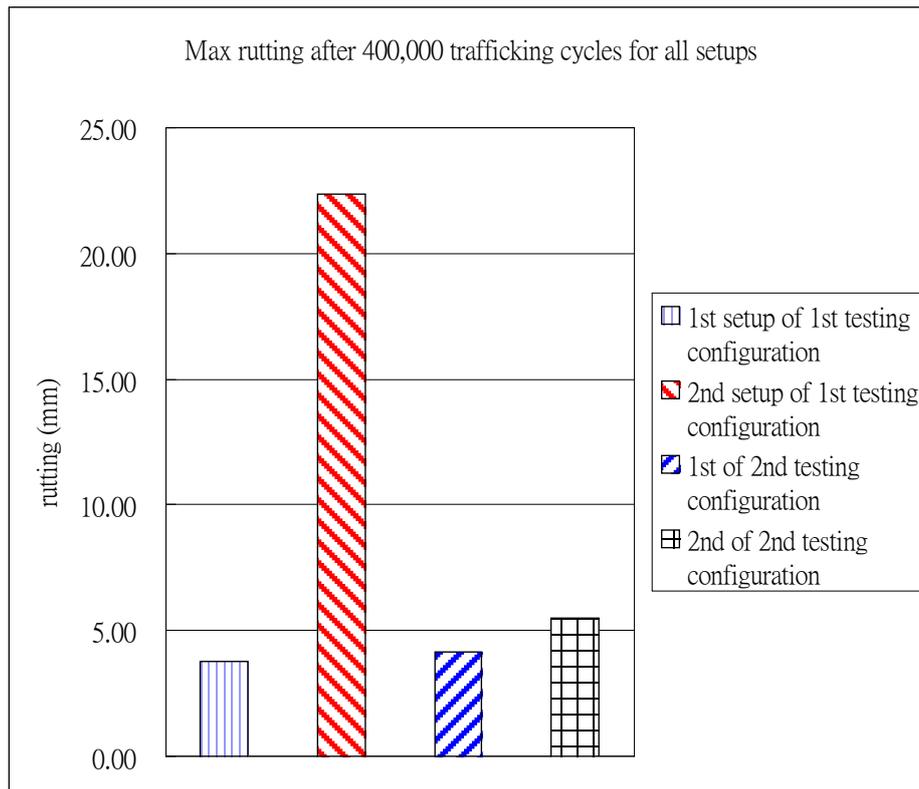
Figure 11 Max rutting for all setups after 400,000 trafficking cycles.

Table 7 and Figure 11 show the rutting magnitude for all setups from both testing configurations. It can be seen that, for the first testing configuration, up to 150,000 cycles, the rutting levels are comparable and no significant difference is observed. After 150,000 cycles, a significant increase was observed in the rutting level of the setup with no geocomposite. While the usage of geocomposite might have helped in reducing the development of rutting, the significant increase in the setup with no geocomposite could be because of support removed at 150,000 cycles. Unfortunately, exact comparison is not possible because for the second setup (i.e., the one with no geocomposite), with resumption of loading after 150,000 cycles, the wooden supports at the sides were not placed back and this support removal certainly caused an increase in the rutting level. At the time, removal of supports was conducted just for the sake of convenience, not accounting for the potential significant impact of this action on the mat

deformation. For the second configuration (i.e., with uniform thickness of concrete slab), no significant difference was observed in the rutting levels between the system with geocomposite versus the system without geocomposite.

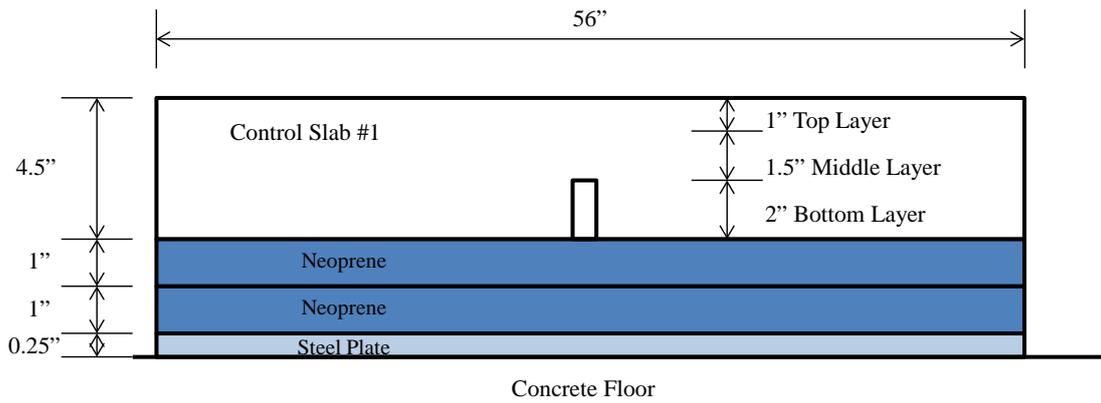
Figure 12 Configuration for slab #1 of Phase II during the first 400,000 loading cycles.

Figures 12 and 13 show the cross-sectional and dimensional plots of the first testing configuration under Phase II. The asphalt overlay was 2.5 inches thick bonded to the underlying asphalt concrete, which was 2 inches thick, with a vertical groove 0.5 inches wide.

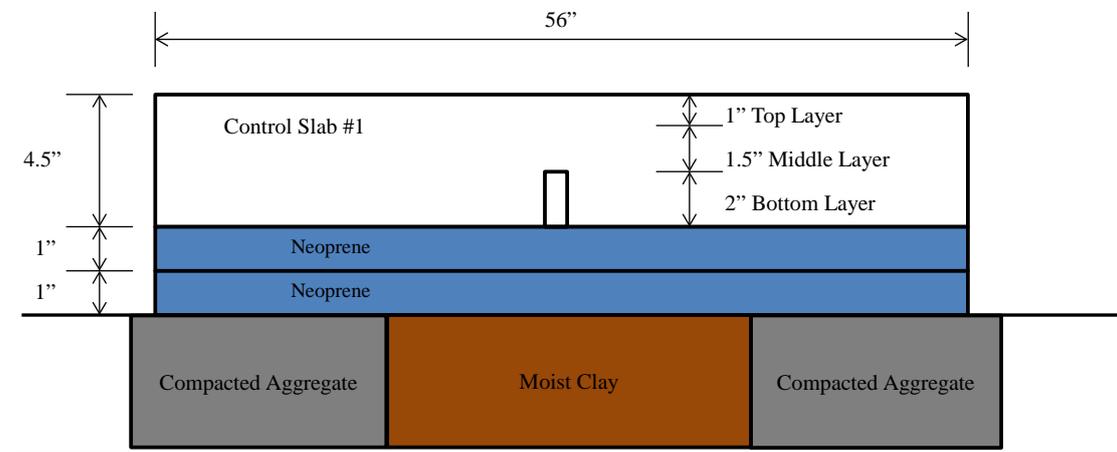
Figure 13 Configuration for slab #1 of Phase II during between 400,000 and 650,000 loading cycles.

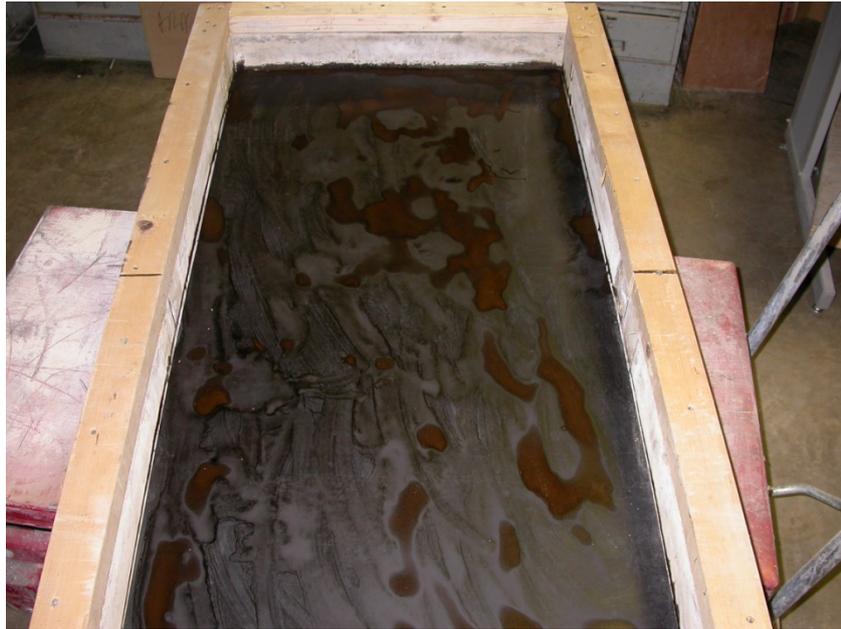
Figure 14 Control slab #1 of Phase II after tack coat application.

Before compacting the bottom layer of the first control slab, a thin coating of fast curing tack was applied to the neoprene to help prevent the HMA from moving while compacting (Figure 14). A small piece of wood ½ inch thick by 2 inches tall was screwed inside the mold in the center, and in the horizontal direction, to replicate a joint crack.

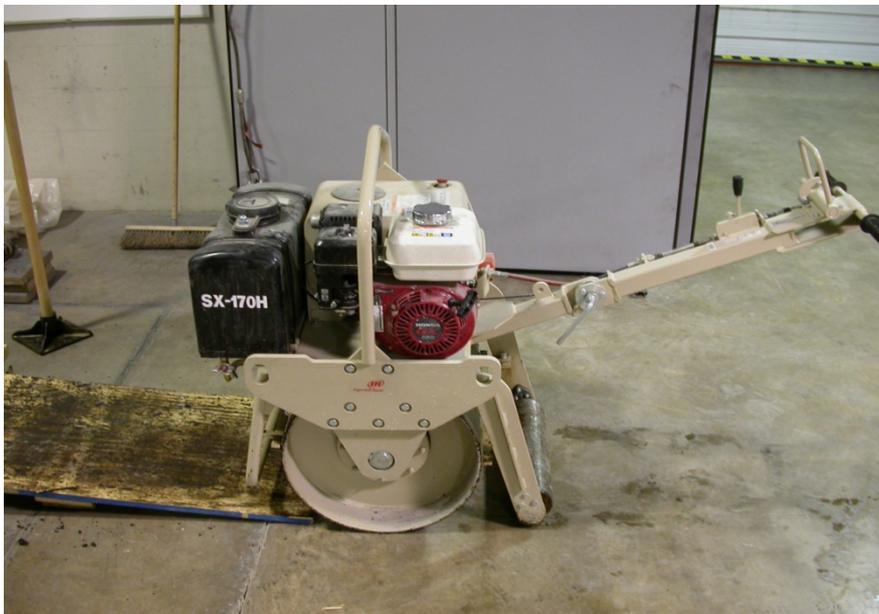
Figure 15 Ingersoll Rand roller used for compacting samples.

The HMA was acquired from HRI Inc., a standard Superpave 9.5-mm mix design. The bottom layer was compacted to a thickness of 2 inches using an Ingersoll Rand Single Drum Vibratory Roller, model SX-170H. The roller weighs 780 lb and produces a compaction force of 2,000 lb, at 4,460 vibrations per minute. The roller's drum width is 18 inches and has a maximum compaction depth of 9 inches (Figure 15). After the bottom layer was cool, the piece of wood was removed to form the joint crack, and the crack was filled in with soft Styrofoam to prevent any hot-mix from filling in the crack during the compaction of the next layer.

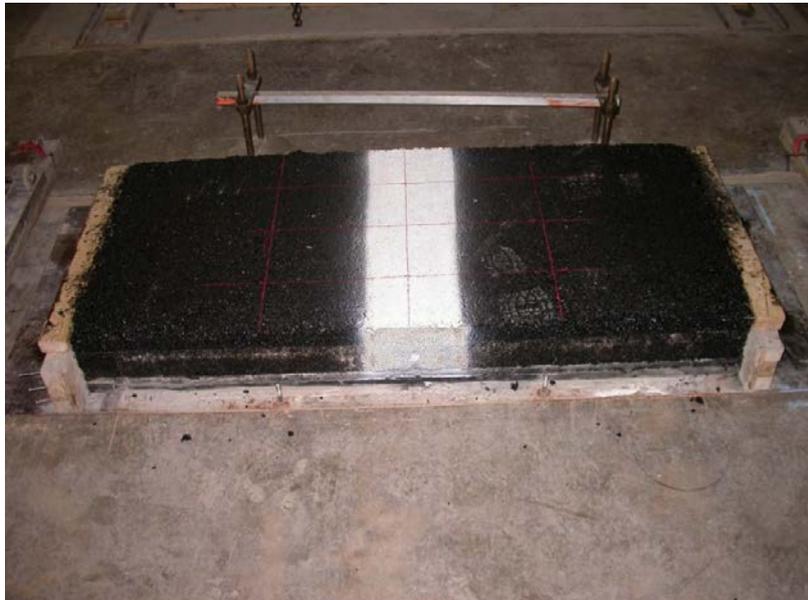
Figure 16 Slab setup in place before trafficking.

The whole slab setup was moved to the area of the MMLS3, as seen in Figure 16. A series of gridlines were put on top of the slab in order to take PSPA (Portable Seismic Property Analyzer) readings and transverse profiles of the slab. The slab was tested with the two 1-inch layers of neoprene in place, on top of the ¼-inch-thick steel base plate, which sat on the concrete floor at CITEL.

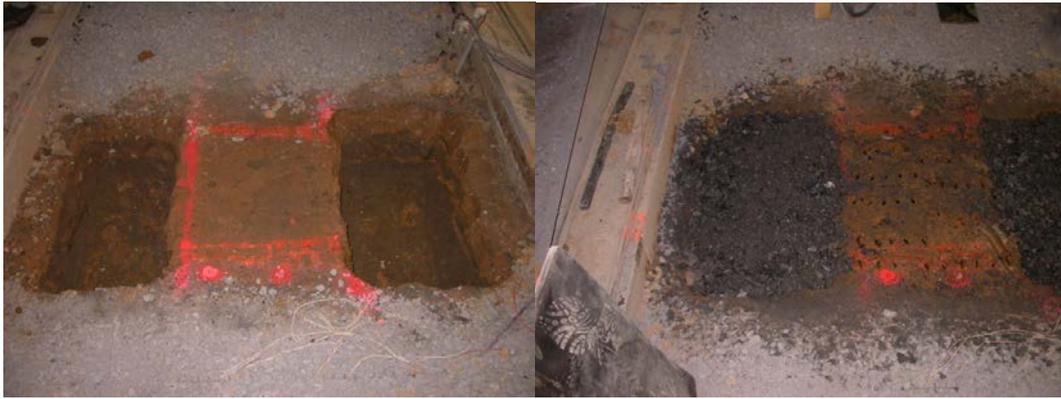
Figure 17 Test pit with soil removed and soil replaced with aggregate.

Since cracking could not be induced in the slab while trafficking on the concrete floor, the slab was moved into the test pit at CITEL by using a Bobcat Skid Steer. The Skid Steer used a forks attachment to move the slab into place and then the slab was slid off of the steel plate using the forks. The soil from the ends of the test pit was removed and replaced with aggregate to produce stiff supported ends of the slab and a weak center area under the slab. The center had a poor clay soil base with a moisture content of 24%, as seen in Figure 17.

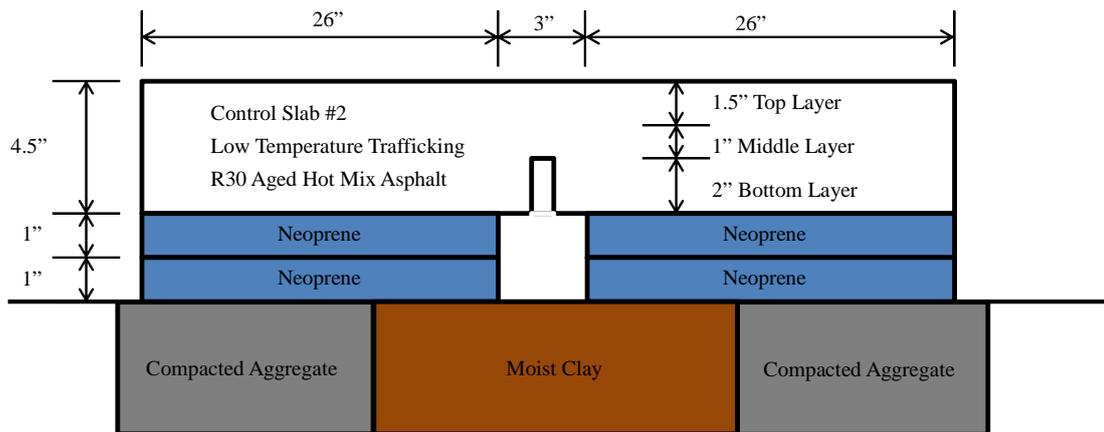
Figure 18 Configuration of slab #2 of phase II after 400,000 cycles to 465,000 cycles of load. During the first 400,000 cycles, the neoprene was continuous.

As the first slab under Phase II did not show any cracking after 625,000 cycles, the decision was made to stiffen the asphalt mix through laboratory aging before compaction, and conduct the loading at a cooler temperature. Both aging and lowering of the temperature helped make the mix exhibit more brittle behavior in response to load. Figures 18 and 19 show the slab cross section and configuration at different loading stages.

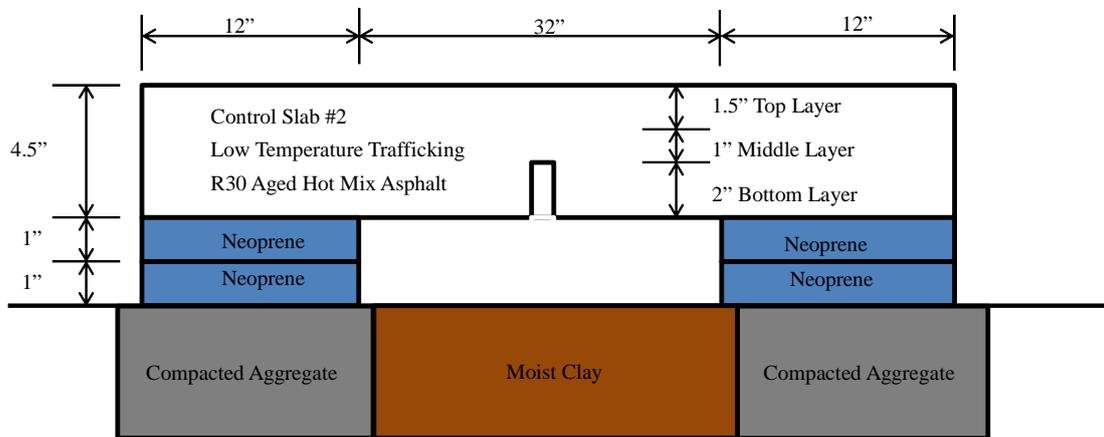
Figure 19 Configuration of slab #2 of phase II after 465,000 cycles to 510,000 cycles.

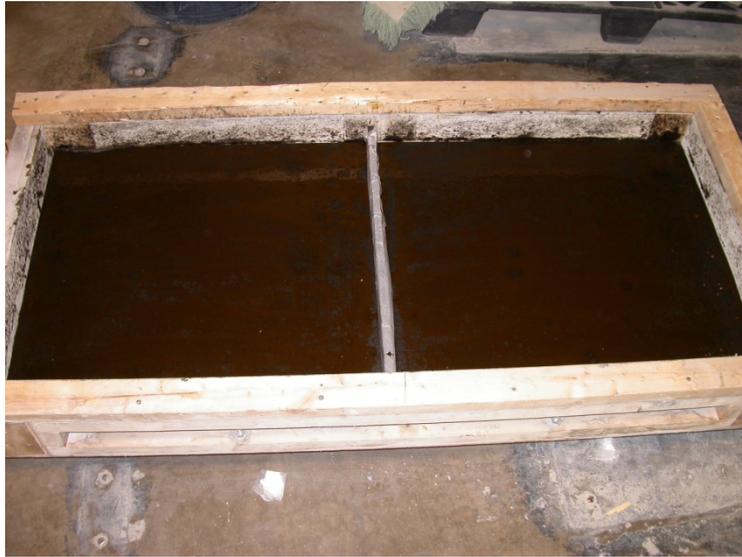
Figure 20 Second control slab with steel bar in place.

For this slab, it was decided that a piece of steel bar stock, ½ inch thick by 2 inches tall, would be used to induce the groove instead of the wood used in the last slab (Figure 20). The steel bar was kept in place for compaction of all three layers and then was removed when the slab was transferred to the test pit. The same HMA from HRI Inc. was used to construct the slab, but it was long-term aged for the top 2-inch layer. The same layer thicknesses were used from the previous slab. The same rolling pattern was used for compaction of the slab as for the previous. After compaction of all three layers, the slab was cooled to room temperature before transfer to the test pit. The wooden frame of the mold was removed and

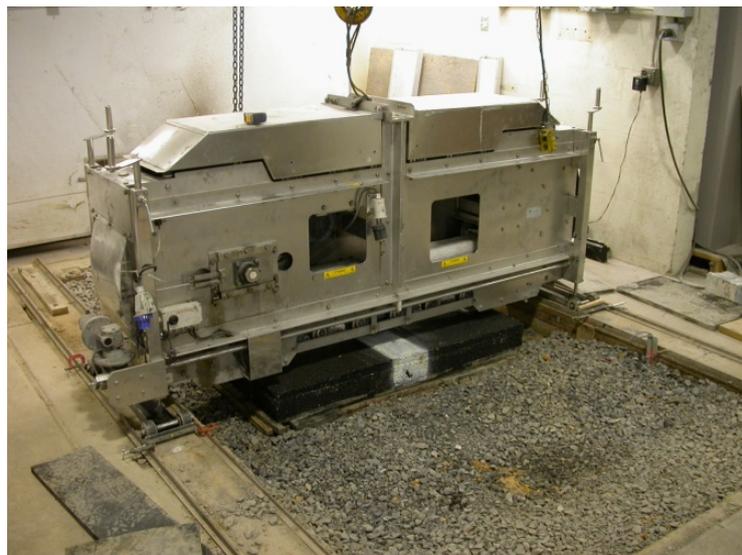
Figure 21 MMLS3 sitting on the asphalt slab in the test pit.

The moisture content of the clay base, taken before transferring the slab into the test pit, was 19%. The slab was then transferred into the test pit the same way as the previous slab using the Skid Steer with forks attachment. The two neoprene layers used under the slab were identical in size and matched the size of the slab, continuous with no separation. After the slab was transferred into the test pit, the MMLS3 was installed on top of the slab and the contact pressure was adjusted (Figure 21). Two small holes were drilled in the side of the slab and two thermocouples were glued into place to record the temperature of the slab during trafficking. Then the white environmental enclosure was set on top of the MMLS3 and any air spaces were filled in with tarps to prevent cold air from escaping during trafficking (Figure 22).

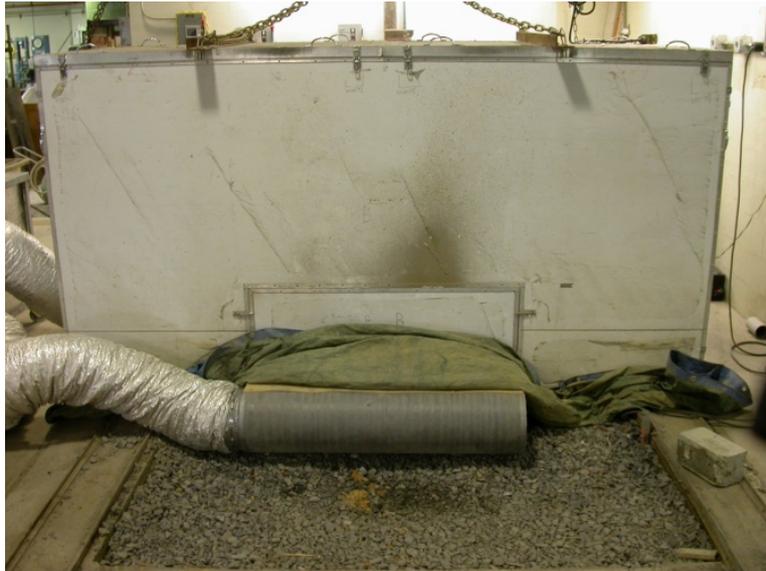
Figure 22 The MMLS3 and environmental enclosure.

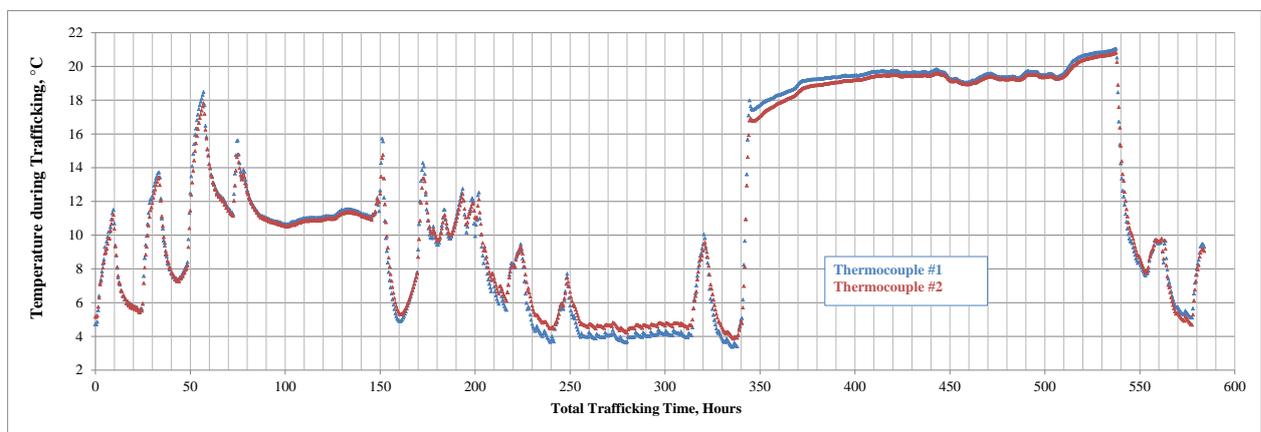
Figure 23 Temperature data during trafficking.

The chiller unit was turned on and run for 24 hours before trafficking was started. At the start of trafficking the temperature of the slab was around 5°C. Trafficking was started and pictures were taken at every stoppage while looking for cracks. Trafficking was done in increments of 5K cycles for the first 25K cycles and then was performed at 15K-cycle increments for the rest of 375K cycles. After 190K cycles the slab temperature was above the desired testing temperature, so trafficking was stopped and the HVAC repair person was called to look at the chiller unit. The chiller unit had a small leak and was leaking coolant. The leak was repaired, but the chiller unit was still not achieving the desired cold temperatures. The repairman then noticed that the defrost cycle of the chiller unit was not working properly, so a new bypass valve was installed to turn on the defrost cycle every hour to melt any ice that was building up on the cooling coils inside the machine. This repair took several days, as can be seen on the temperature chart in Figure 23. Trafficking was resumed after the temperature of the slab was below 5°C and the final cycles were finished for a total of 400K cycles.

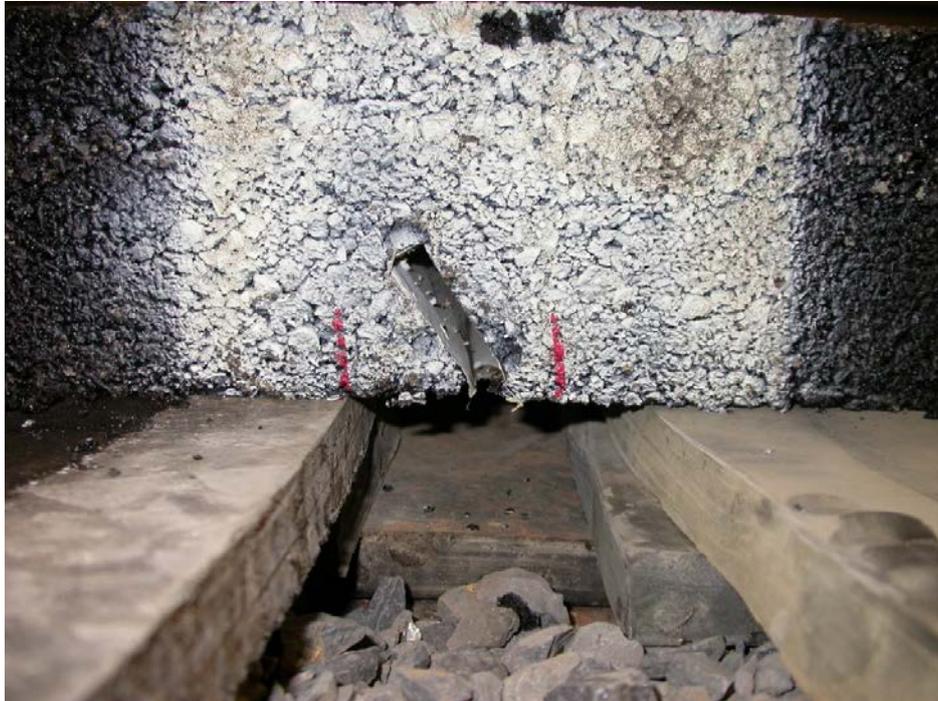
Figure 24 Photograph of the 3-inch gap under the slab.

It was decided to remove the neoprene from the center of the slab, directly under the man-made crack and then continue trafficking (Figure 24). The full-size pieces of neoprene were removed from under the slab and were replaced with smaller pieces to create a 3-inch-wide gap directly under the man-made crack.

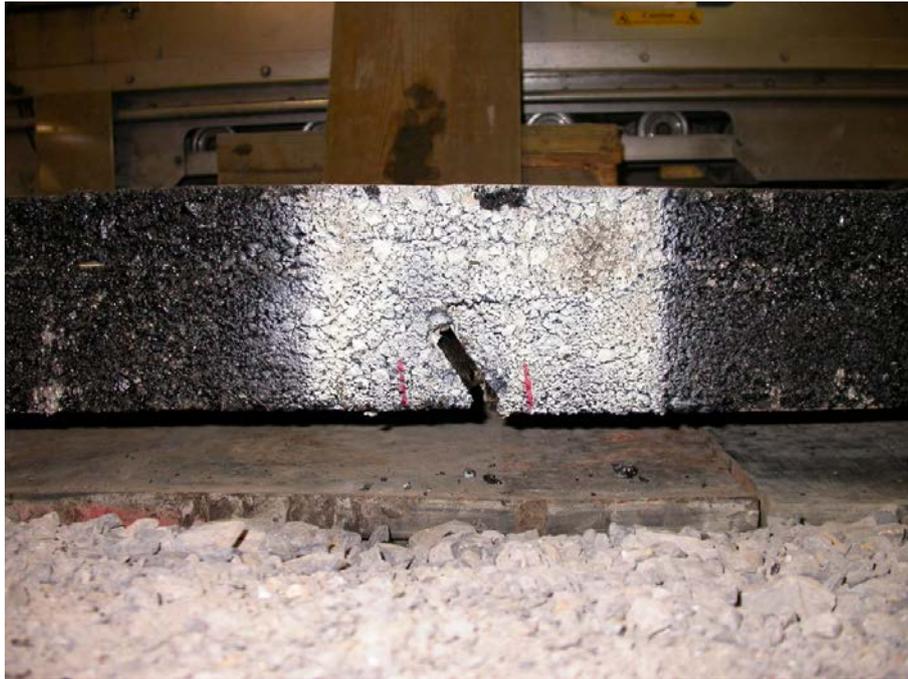
Figure 25 Slab with 32-inch gap.

An additional 15K cycles of trafficking was performed on the slab with the 3-inch gap under the slab with the enclosure removed to watch for cracking. After the 15K cycles of trafficking there were no signs of cracking. The slab then sat for 48 hours with the 3-inch gap, until it was decided to run another 50K cycles at 5°C. After the 50K cycles there were no signs of cracking. At this point, while this was not part of the study's testing plan, it was decided to widen the 3-inch gap to 32 inches to induce cracking. The neoprene from under the slab was again replaced with smaller sections to form a 32-inch gap under the slab, only having the neoprene 12 inches from each end (Figure 25). The slab sat overnight to cool back down to the test temperature of 5°C, and it was noticed the next morning that the slab layers had started to separate to the right of the man-made crack (Figure 25). The final 50K cycles of trafficking was started with the large section of slab being unsupported in the middle. It was noticed that the slab broke sometime before 45K cycles were completed (Figure 26). Three core samples were drilled from the slab, one from the wheel path and two from outside the wheel path, to determine the air voids. After testing the air voids, the core from the wheel path had an air void of 11.0%, and both cores from outside the wheel path had air voids of 11.6%.

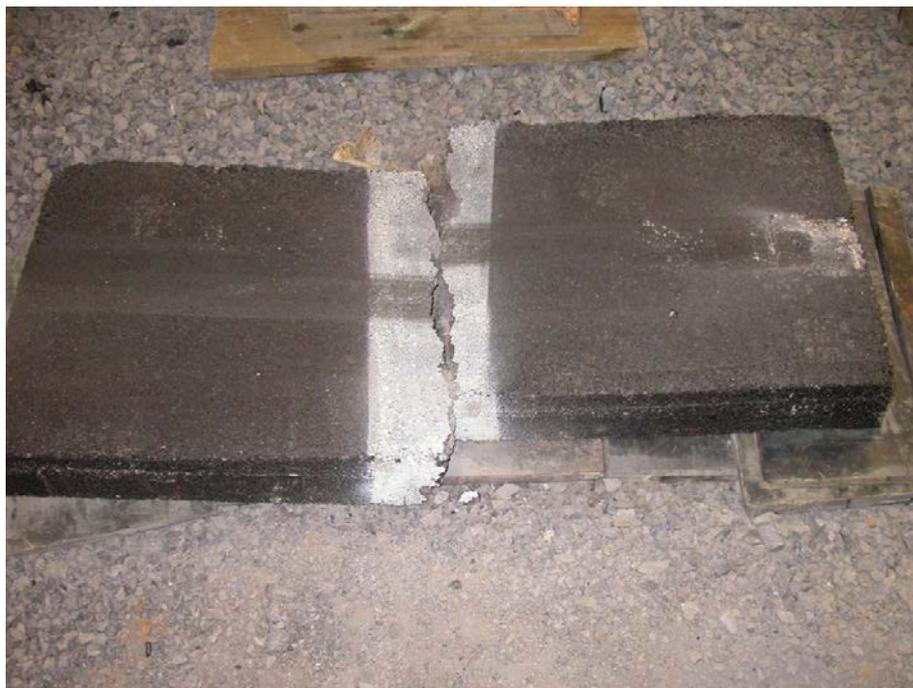
Figure 26 Slab after complete failure.
