The Impact of Marcellus Gas Development on the Rural Transportation Infrastructure

FINAL REPORT

July 31, 2013

**The Thomas D. Larson
Pennsylvania Transportation Institute**

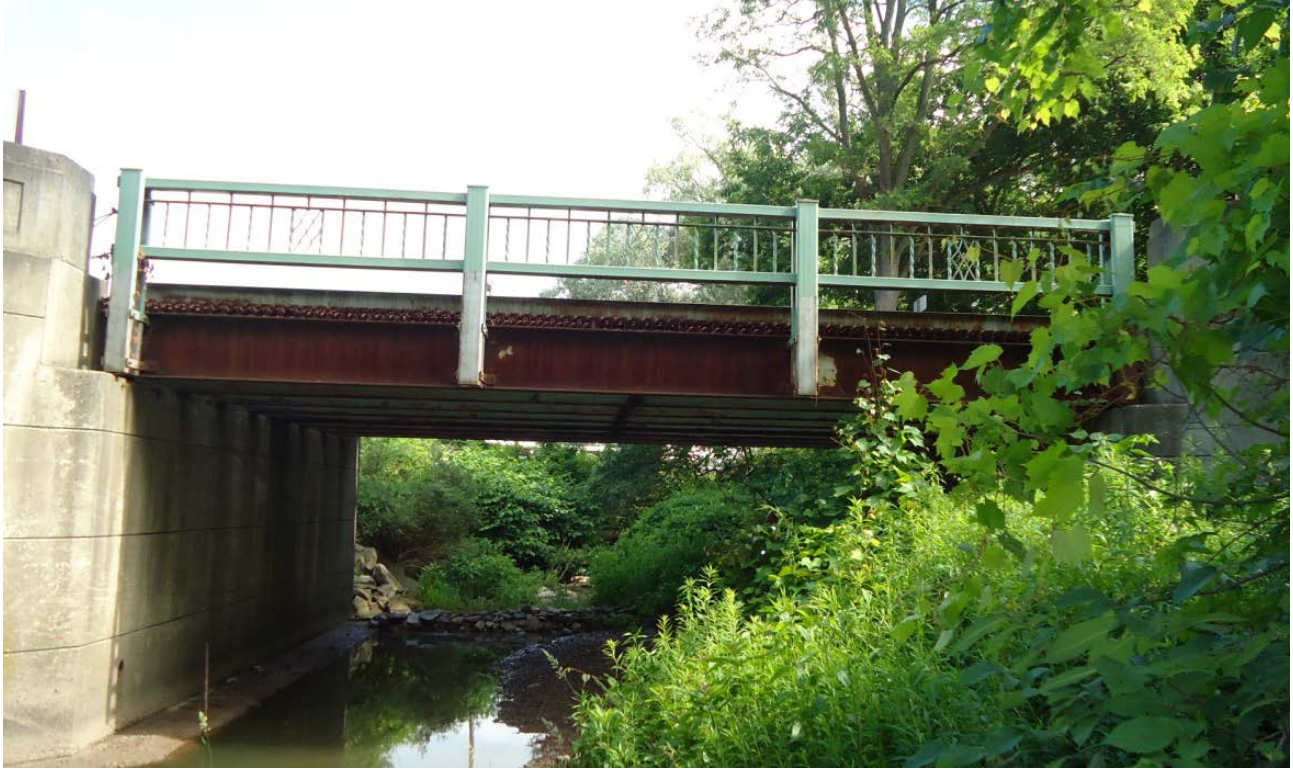
Figure 5. Bridge Two Elevation

Bridge Two, shown in Figure 5, is a Troy Township owned, 35-ft (10.7-m) long, steel girder, open grid deck, single-span bridge. It is located in Troy, Pa., along Eureka Drive directly off of State Route 14. The bridge was built in 1963 and was rehabilitated in 2001. Its sufficiency rating was listed at 46.1, deeming it structurally deficient. The ADT was given at 800 with no information provided on the ADTT. During the Penn State inspection, trucks were observed passing over the structure, though they were not likely related to the Gas Play. The trucks observed were all departing from a large industrial facility located close to the bridge. 2009 was the year of the latest reviewed township inspection report.

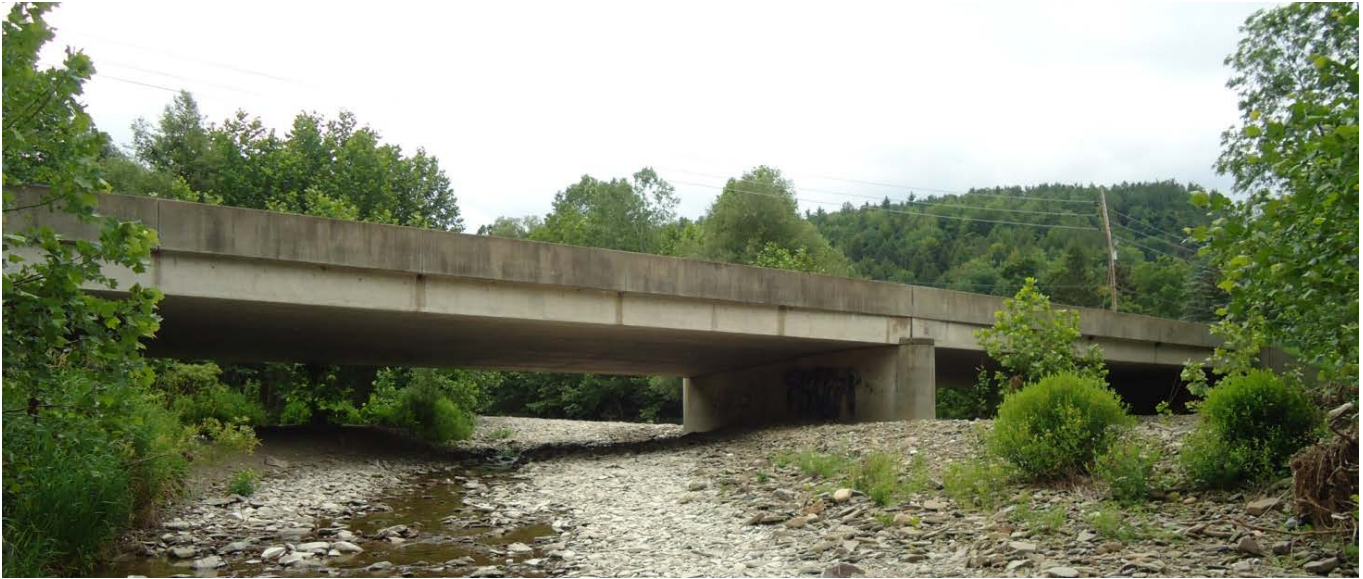
Figure 8. Bridge Three Elevation

Bridge Three is a 156-ft (47.5-m) long, two-span, prestressed concrete, adjacent box beam bridge. It is located in Ridgebury, Pa., along State Route 4024, adjacent to the Berwick Turnpike. An elevation view of the bridge is shown in Figure 8. The bridge's sufficiency rating was the lowest of all the selected bridges, at 40.5, and it was identified as being structurally deficient. The ADT was listed at 683, with 7 percent being truck traffic. A storage site for drilling equipment was located a few hundred feet from the bridge, indicating this bridge likely supported intermittent truck traffic related to the Gas Play. The most recent PennDOT inspection report was from 2010.

The bridge’s wearing surface and approach roadway were resurfaced with a bituminous overlay in 2009. The wearing surface received a rating of 8 in the PennDOT inspection reports that followed the resurfacing. A $\frac{1}{8}$ -inch (3.17-mm) transverse crack, not noted in the inspection report, was observed during the Penn State inspection directly over the pier, as shown in Figure 9a. Otherwise, the wearing surface inspection was in agreement with the reviewed PennDOT inspection reports. The bridge’s non-composite deck received a rating of 6 in the PennDOT inspection reports, though neither the top nor the underside was visible during the Penn State inspection.

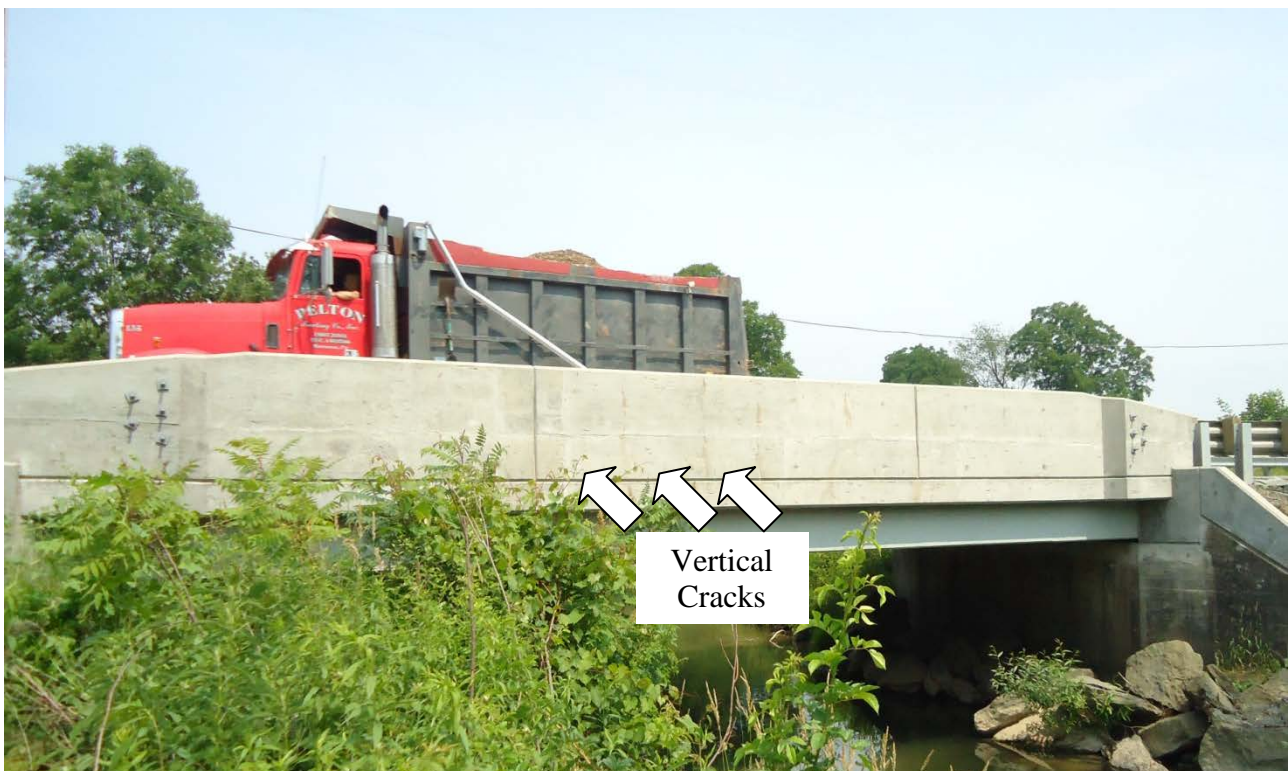
Figure 11. Bridge Four Elevation

Bridge Four is a 44 ft (13.4 m) long, prestressed, spread, single-span, concrete, box beam bridge. The original structure, built in 1953, was rehabilitated in 2009, when the deck, wearing surface, parapets, superstructure and abutments caps were replaced. Reflective of the recent rehabilitation, the bridge had a sufficiency rating of 84.5, indicating it was in good condition. The bridge is located on State Route 4013 in West Burlington, Pa. A number of trucks that appeared to be involved with the Gas Play were observed crossing the bridge during the Penn State inspection, although the ADT of 1,113 provided on the reviewed PennDOT inspection reports had a 4 percent truck composition. Additionally, a pipeline assumed to be associated with the Gas Play was being installed close to the bridge, as shown in Figure 31. Figure 11 provides an elevation of Bridge Four looking west with a truck containing aggregate, likely related to the Gas Play, shown traversing the bridge. 2010 was the year of the latest reviewed PennDOT inspection report.

The bridge's wearing surface and deck received ratings of 8 and 9, respectively, in the reviewed PennDOT inspection reports. The only deficiencies noted in the reports were isolated longitudinal cracks and isolated surface edge spalls along the deck. These problems were also observed during the Penn State inspection. Not mentioned in the reports were areas of rutting and wear of the wearing surface noticed during Penn State inspection. Additionally, approach slab settlement was observed at both abutments. The north end had some areas of settlement up to ½ inch (12.7 mm) and the south had instances of settlement greater than 1 inch (25.4 mm). Figure 12a and 12b display settlement adjacent to the north and south abutments, respectively.

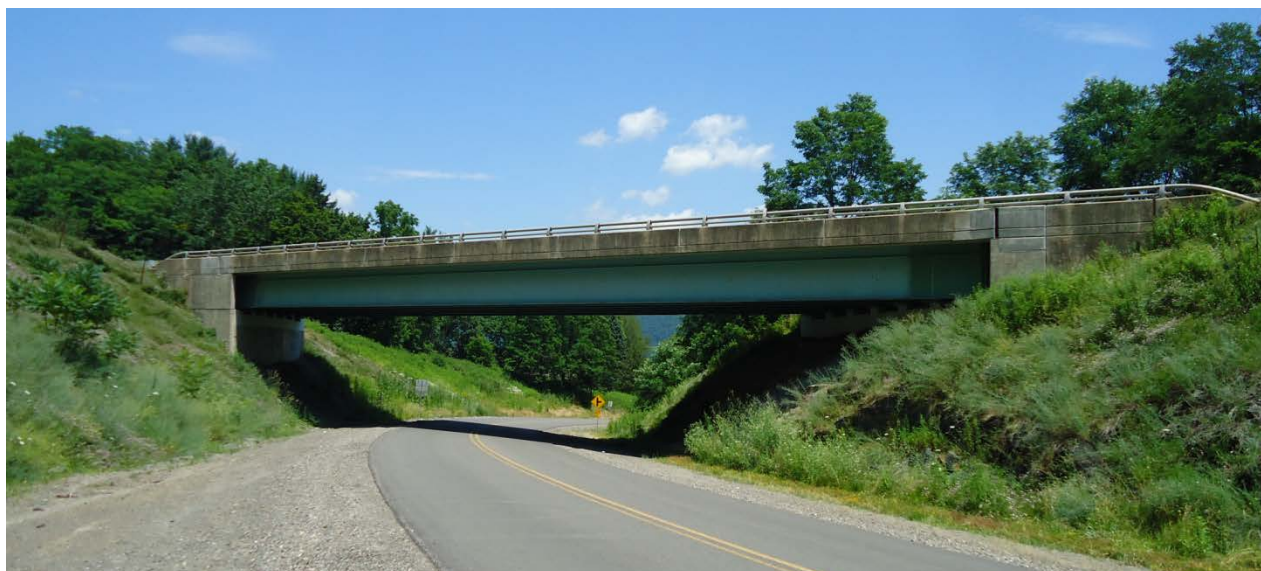
Figure 14. Bridge Five Elevation

Bridge Five, located in Towanda, Pa., along State Route 220, is a seven steel beam, single-span bridge having a 133-ft (40.5-m) span. The bridge was built in 1974 and was rehabilitated in 2009. The reviewed PennDOT inspection reports assigned it an excellent sufficiency rating of 98.1 in 2010. Traffic observed during the Penn State inspection consisted of a number of trucks, some of which were likely related to the Gas Play. The ADT was 2,241 and the ADTT 76 in the reviewed PennDOT inspection reports. Figure 14 shows the western elevation of Bridge Five.

The deck and wearing surface were both given ratings of 8 in the reviewed PennDOT inspection reports, meaning they were in very good condition. A concrete overlay was placed in 2009. The Penn State inspection

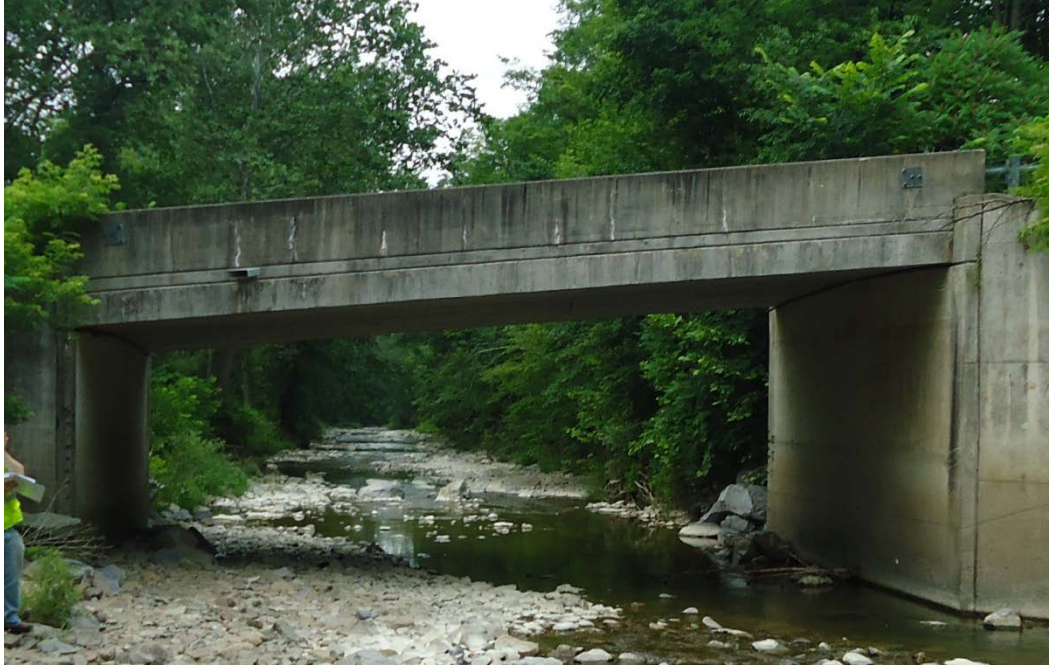
Figure 17. Bridge Six Elevation

Bridge Six is owned by and located in Rome Township, Pa., along Harmony Hill Road. The bridge is a single, 48-ft (14.6-m) span and is supported by seven prestressed, adjacent box beams. The bridge was built in 1984 and was assigned a sufficiency rating of 68.5 in the township inspection report. The ADT was reported to be 75. Very little traffic was observed during the time of the Penn State inspection. It was surmised during the Penn State inspection that minimal Gas Play was traversing the structure.

The bridge wearing surface and deck were both given ratings of 5 in the reviewed township report, which indicates that all structural elements are sound but may have some minor section loss. Findings from the reviewed township inspection report were very similar to observations made during the Penn State inspection. The deck was observed during the Penn State inspection to have exposed construction joints and some hairline cracks. The Penn State inspection also indicated that the wearing surface had heavy wear and smoothed surfaces with exposed aggregate, as shown in Figure 18a. A few minor popouts and surface spalls were also present. Settlement of up to $\frac{3}{4}$ inch (19.1 mm) of the approach slab, displayed in Figure 18b, was observed at the south abutment during the Penn State inspection. No assessment of parapet condition was given in the township inspection report and, during the Penn State inspection, they were observed to have a number of hairline vertical cracks and efflorescence, as shown in Figure 17.

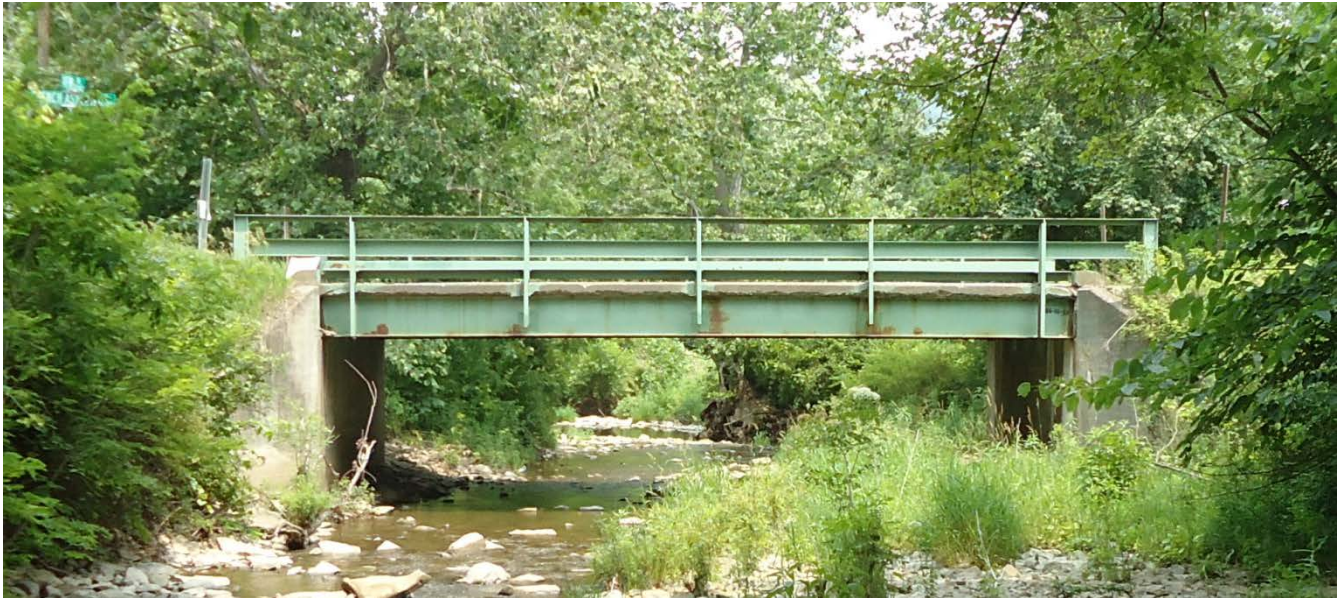
Figure 20. Bridge Seven Elevation

The seventh bridge, depicted in Figure 20, is located in Asylum, Pa., on State Route 2014. The 41-ft (12.5-m) long steel, multi-beam bridge was rehabilitated in 2006. The structure received a sufficiency rating of 72.9. The latest reviewed PennDOT inspection report, from 2009, listed the ADT at 184, with 9 percent being truck traffic. During the Penn State inspection no heavy trucks that appeared to be affiliated with the Gas Play were observed traversing the bridge. However, Gas Play vehicles were observed in the area.

Satisfactory ratings of 6, meaning some minor deterioration exists, were assigned to both the wearing surface and deck in the reviewed PennDOT inspection reports. The Penn State inspection indicated that the wearing surface had areas of rutting and pumping asphalt. A section of asphalt adjacent to the railing was missing, as shown in Figure 21a. The deck had several areas of edge spalling and delaminated concrete. Rebar at the south edge of the bridge was exposed and corroded, as shown in Figure 21b. The deck underside also had areas of spalling and longitudinal and transverse cracks with efflorescence. The metal railing of the bridge was rated a 4 in the reviewed PennDOT inspection reports, indicating poor condition with advanced section loss. It was observed during the Penn State inspection to have heavy corrosion and areas of complete section loss at connection plates to the deck, as shown in Figure 21c. Field observations during the Penn State inspection were largely in agreement with deficiencies noted in the reviewed PennDOT inspection reports.

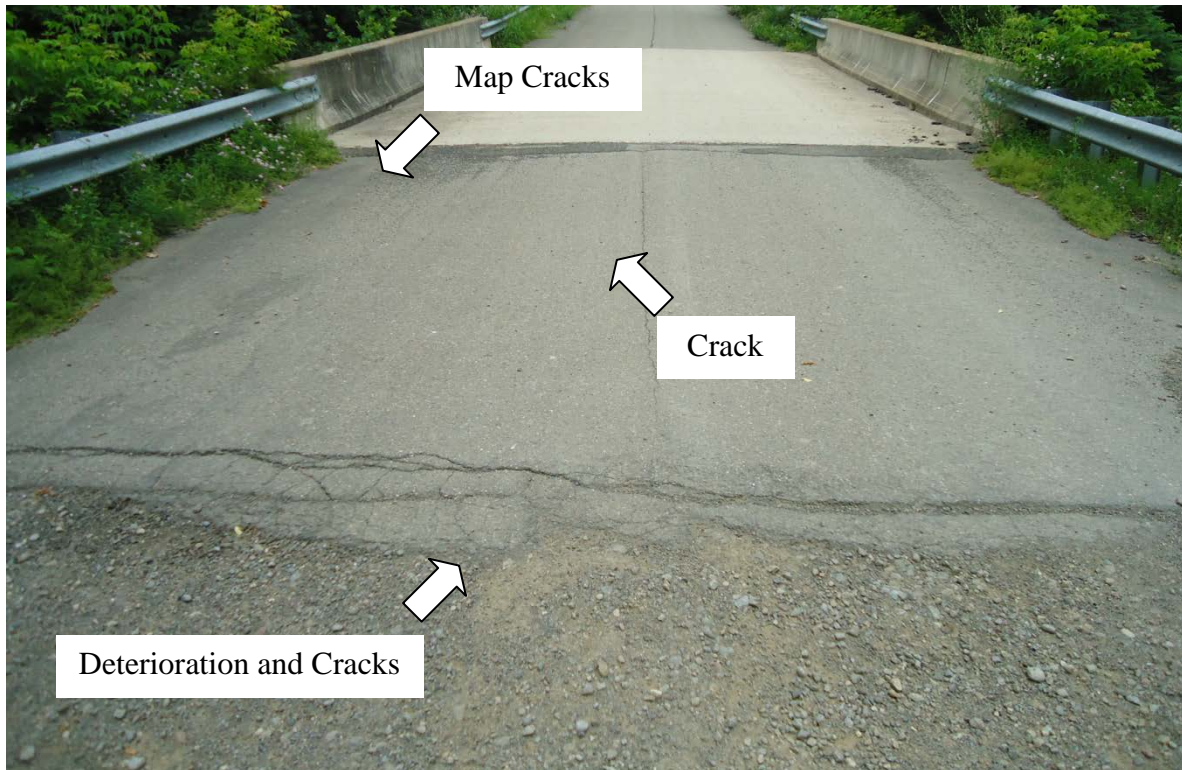
Figure 32. Bridge Six South Approach

Review of township inspection reports indicated that the approaches were assigned a rating of 5, meaning fair condition. Deficiencies that were discussed for the south approach included full-width transverse cracks and heavy deterioration. Map cracks and isolated transverse cracks were noted for the north approach.

The south approach consisted of approximately 25 ft (7.6 m) of asphalt paving transitioning to gravel for the remainder of the road. The Penn State inspections indicated that the gravel portion showed some minor rutting. The transition between gravel and asphalt, shown in Figure 32, was heavily deteriorated, with transverse cracks up to 2 inches (50.8 mm) wide. Longitudinal cracks along the road centerline and other location were observed. Some map cracking was present along the southbound lane edge.
