# Study of a Pipe-Scanning Robot for use in Post-Construction Evaluation during Horizontal Directional Drilling

<b>1. Report No.</b> UVA 2013-05	<b>2. Government Accession No.</b>	<b>3. Recipient's Catalog No.</b>	
<b>4. Title and Subtitle</b> Study of a Pipe-Scanning Robot for use in Post-Construction Evaluation during Horizontal Directional Drilling		<b>5. Report Date</b> June 2015	
		<b>6. Performing Organization Code</b>	
<b>7. Author(s)</b> Lindsay Ivey Burden and Frank Morris		<b>8. Performing Organization Report No.</b>	
<b>9. Performing Organization Name and Address</b> University of Virginia Thornton Hall Charlottesville, VA 22904-4742		<b>10. Work Unit No. (TRAIS)</b>	
		<b>11. Contract or Grant No.</b>	
<b>12. Sponsoring Agency Name and Address</b> US Department of Transportation Research & Innovative Technology Admin UTC Program, RDT-30 1200 New Jersey Ave., SE Washington, DC 20590		<b>13. Type of Report and Period Covered</b> Final 7/1/13 – 6/30/14	
		<b>14. Sponsoring Agency Code</b>	
<b>15. Supplementary Notes</b>

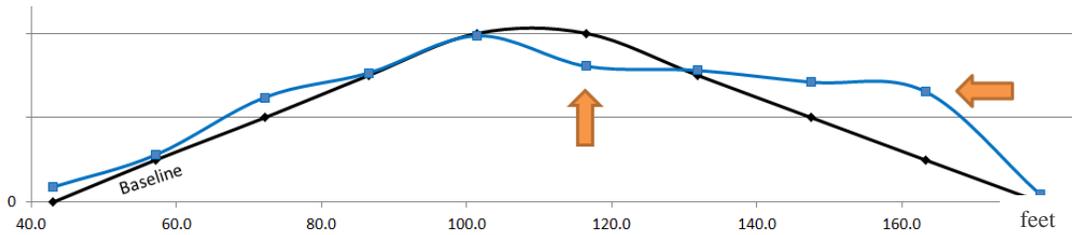
**Figure 32. Roadway Movement four months after project completion.**

A final set of elevations was logged four months after project completion so that long-term elevation results may be compared to FutureScan and GPR scans. Final elevation data was retrieved on site on March 2, 2014. Figure 32, an exaggerated cross-sectional view of the roadway, displays a heaving and settling trend: slight heave is shown on the ends of the pipe, and settlements are seen in the mid-section. The critical points, which appear at 115-feet and 165-feet from the north end of the pipe, experience 0.78-inches of settlement and 1.62-inches of heave, respectively. The range of settlements in the mid-section of the pipe is between 0.06-inches and

0.78-inches. The range of upheaves on the ends of the pipe is between 0.06-inches and 1.62-inches.

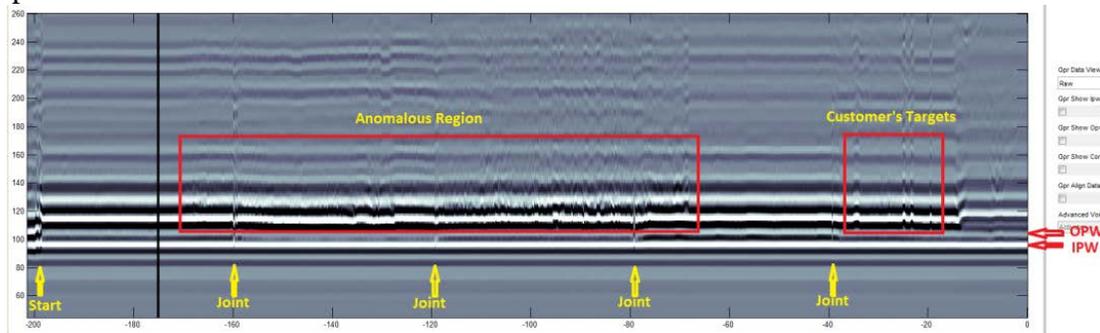
**Figure 34. FutureScan Radar Gram at 12 O'clock position (Yestrebky & Winiewicz, 2013).**

Five FutureScan runs were performed on site. Runs from the following clock angles were documented: 12 O'clock, 10 O'clock, 8 O'clock, 6 O'clock, and 2 O'clock. The various clock angles yield potential deficiencies that exist all the way around the outside of the pipe. An anomalous region was detected by the FutureScan technology during the runs. Figure 34, 35, 36, 37, and 38 are B-scans from the 12 O'clock, 2 O'clock, 8 O'clock and 6 O'clock runs. Distance (feet) is on the X-axis, and the Y-axis is the sequence (frequency of samples) of A-scans. Note that the A-scan is considered the signal variation in the Y-direction. So, the B-scan is a compilation of 512 samples observed in the A-scan. Between 55-feet and 115-feet south of the north outlet, a large anomaly exists. Compared to the control (black line), many changes in dielectric constant occur on the radar gram. The region is detected in the middle of the piping section, where the signal variation is out of phase relative to the surrounding region. From relative elevation data, this anomalous region also displayed heaving during drilling operations as well as settling shortly after drilling operations were complete. Heaving displayed uplifts between 0.33-inches and 0.72-inches in the noted anomalous region during drilling

operations. The maximum heave recorded was 0.99-inches. Settlements, 24-hours after drilling, displayed subsidence between 0.24-inches and 0.90-inches within the anomalous region. The maximum settlement recorded was 0.90-inches. There is a strong correlation between the anomalous region and the upper surface (heaving and settling) during the construction period. In both cases, the maximum heave/settlement values exist in or near the anomalous region. Note the outer pipe wall (OPW) and inner pipe wall (IPW) designations on the below figures. Figures 34, 35, and 48 suggest anomalies exist very close to the top outer pipe wall surface (See red outline in Figure 34). Note that these clock angles point in the direction of the ground surface; therefore, detected anomalies lie above the pipe. Anomalies detected above the pipe range from 1.3-inches to 4.6-inches in thickness. Figures 36 and 37 suggest anomalies exist further away from the outer pipe wall surface on the bottom half of the pipe, namely within the 1.5-inches to 4.5-inches. These anomalies exist below the pipe, for the clock angle points in the opposite direction of the surface. Overall, these results suggest that the casing is not centered in the open-cut. More void space is left below the pipe. Anomalies in both figures could be areas of void space or areas where the “filter cake” has thinned and annular overcut exists.

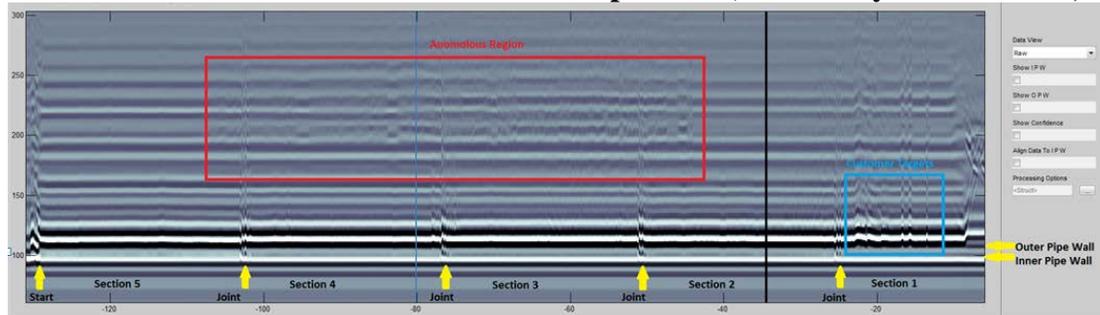
**Figure 36. FutureScan Radar Gram at 8 O'clock position (Yestrebky & Winiewicz, 2013).**

An example calculation is necessary to illustrate conversion from Y-axis (Sequence of A-scans) to units of length. By using such a conversion, distance to an anomaly may be tabulated as well as anomaly thickness. To illustrate the calculation, the 8 O'clock radar scan will be used as an example. The number of ticks on the Y-axis (27 picosecond samples of A-Scan) is counted from the outer pipe wall (OPW) to the beginning of the anomaly. In this case, 110 ticks are counted from the OPW to the bottom of the anomalous region ( $t = 110$  units).

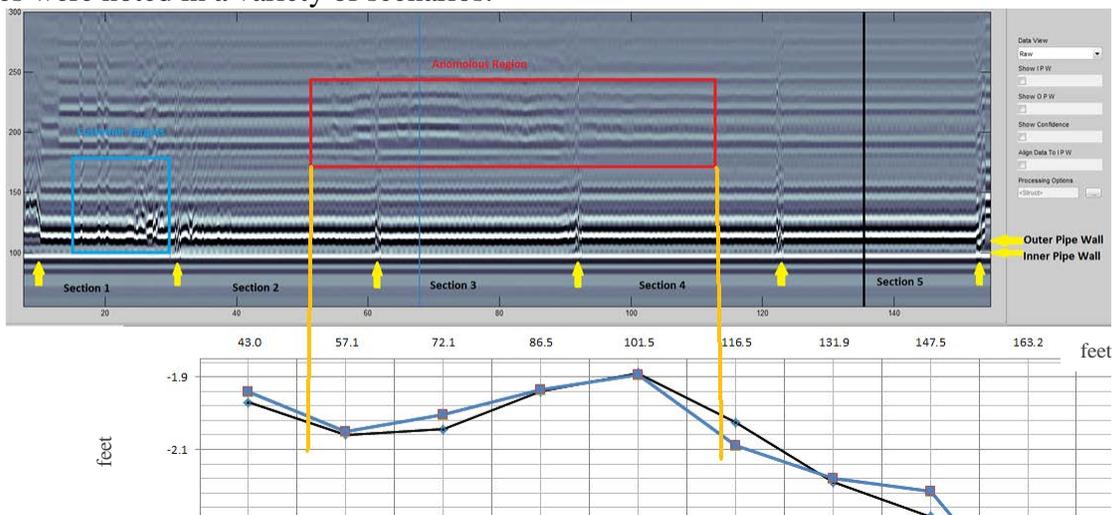
**Figure 39. Elevation data relative to anomalous region (4-months after project completion).**

Next, the scanning results at the time of the site visit (construction) are compared to the elevations recorded long after project completion. Four months after the project, an elevation transition is realized within the anomalous region seen in radar scans. Figure 39 is relative elevation data on the same scale as FutureScan radar scans. Settlements of up to 0.5-inches existing between 50 and 86-feet south of the north end. Heaving of the asphalt reaching approximately 0.80-inches exist, between 86 and 115-feet south of the north end. Beyond the detected anomalous region, 148-feet from the north end, a heave of 1.62-inches is observed. The detected anomalous region is subject to heaves and settlements after project completion. FutureScan defined a region, characterized by inversions of voltage, and large settlements and heaves were noted in a variety of scenarios.

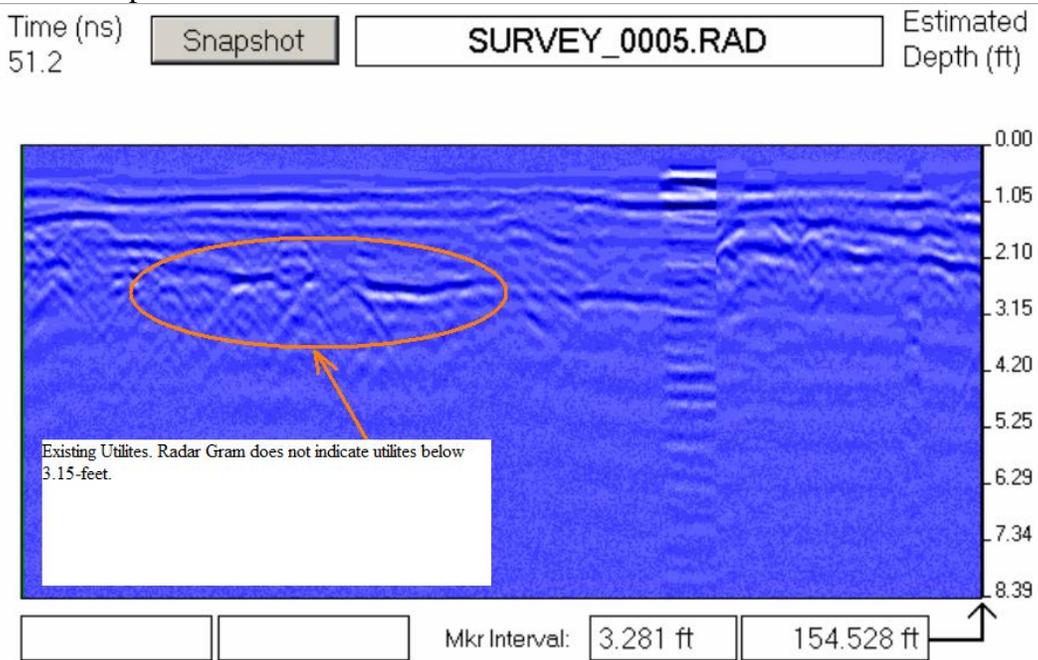
**Figure 40. GPR radar gram.**

The entire width of roadway plus the northern grassed area beyond the curb (target region) was surveyed with the GPR rolling mount system. Starting from the south curb and heading toward the north outlet, 154-feet of subterranean radar is shown below in Figure 40. The Y-axis displays depth in feet, and the X-axis displays distance in feet. The variation changes are shown in the figure relative to location (depth and distance travelled). GPR results are similar to the FutureScan B-scan plot in that inversions of voltage indicate anomalies on the radar scan. Neither the 18-inch casing nor the targets were detected in the GPR results. The 18-inch HDPE casing traverses down to 8-feet within the surveyed region, and no changes in dielectric constant took place throughout the entire run below 4-feet on the radar gram. Other existing utilities were detected throughout the run. The parabolic perturbations on the radar gram indicate existing utilities perpendicular to the GPR pathway. The target foam wrap region was not detected during these runs either. This indicates that the GPR detection system cannot see below 4-feet accurately for this project site, or that once the GPR detects existing utilities, the technology cannot display any deeper perturbations. Depth of detection could be a function of soil type. This theory will be explored for the VA-635 sites.

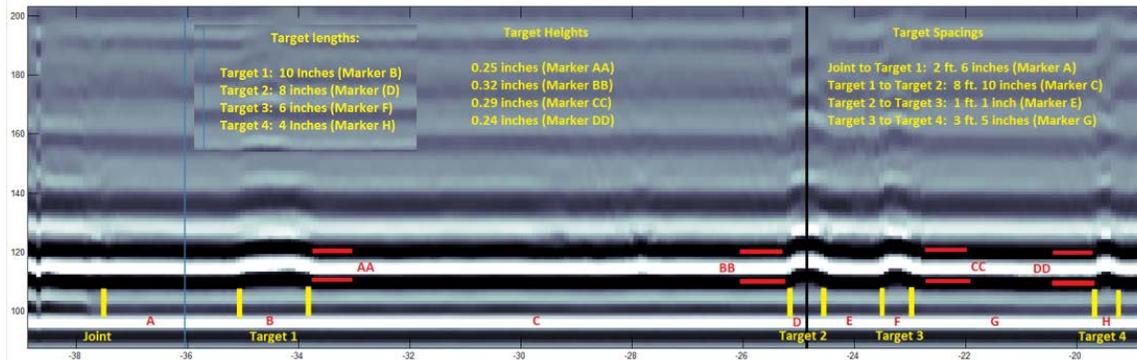
**Figure 41. FutureScan radar gram “zoom-in” on Target Region (Yestrebky & Winiewicz, 2013).**

FutureScan was capable of detecting all target voids, while GPR was not capable of detection below 3.15-feet. Figure 41 is the FutureScan radar gram display for only the target region (20 to 40 feet from the north outlet). The X-axis displays distance from the north outlet, and the Y-axis displays the sequence of variations of the A-scan. FutureScan was capable of detecting all target voids during the initial run. Lengths and thicknesses, similar to the ones installed, were detected

on the scan. Note that the predicted length, thickness, and location was stated by CUES, Inc. on the scan itself.

Although FutureScan was successful in detecting target anomalies, error did exist in the spacing of the final results. The reason for error in spacing was due to the measuring origin and the manual counting method. Because the manual counter was used, the wheel measurements did not align with the coaxial cable spool counter. The feed coming out of the spool was not aligned with the manual counter, which was directly relayed to the acquisition. The reason for error in target length is due to the radar scanner being longer than the target it’s measuring. If the targets were all greater than 12-inches, then the radar scanner could measure the targets to a more accurate degree. Due to the fact that all targets were under 12-inches and the scanner itself was 12-inches, it was difficult to accurately measure the target length. Table 9 shows the differences in the actual results and FutureScan results (See the highlighted columns). Table 10 calculates the error in spacing, target length, and target thickness.

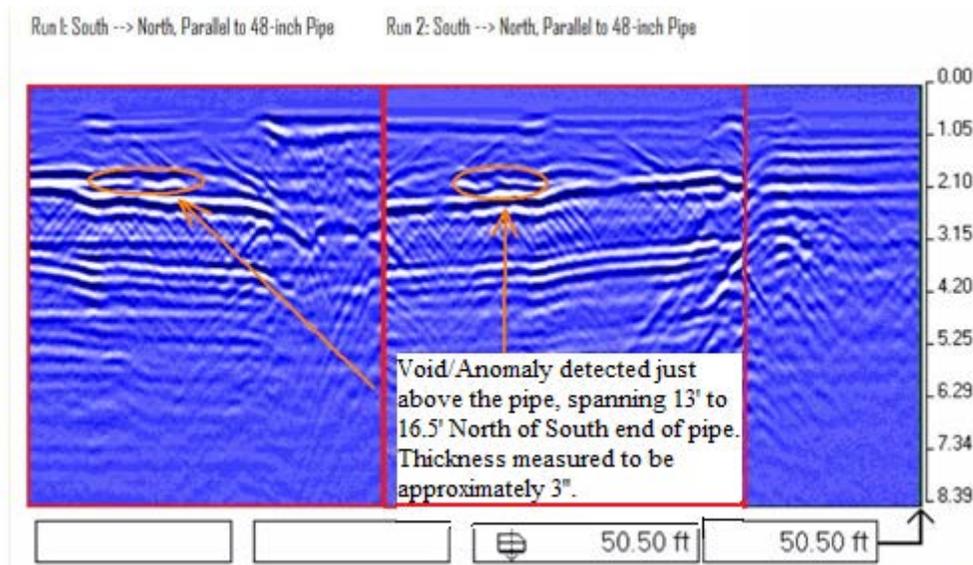
**Figure 44. VA-635 48-inch Triple-Wall Polypropylene Pipe (PP).**

The GPR results for VA-635 are deemed successful in locating anomalies closer to the asphalt surface. GPR results for project site VA-635 are shown below in Figures 44 and 41. These figures are for the same runs performed on the triple-wall 48-inch polypropylene pipe. The first figure (Figure 44) outlines anomalies existing close to the outer pipe wall surface, whereas the second figure (Figure 45) outlines anomalies that lie close to the asphalt surface. In Figure 44, anomalies are detected above the pipe between 13-feet and 16.5-feet (downstream) north of the south outlet. The anomaly is quite large and within 1-inch from the outer pipe wall surface. The anomaly, in this case, is shown to be between 2 and 3-inches thick. Because compaction did not take place during construction, large voids or anomalies are expected. Also, punctures in the pipe were noted during construction in this region (Hoppe, 2011). So, a breach in the pipe wall is a possible defect.

Figure 44 is the essentially same as Figure 45, but a single anomaly closer to the surface is noted. Relative to other measurements on the radar gram, this anomaly seems to be 2 to 3-inches in thickness, spanning between 14'-4'' and 15'-3'' north of the south outlet of the pipe. The length of the anomaly spans approximately 8-inches. In this scenario, GPR is capable of measuring voids, anomalies, and disturbed soils close to the surface. The antenna is close to its' targets with no other interference and is capable of detection, unlike the Burnt Chimney project site conditions.

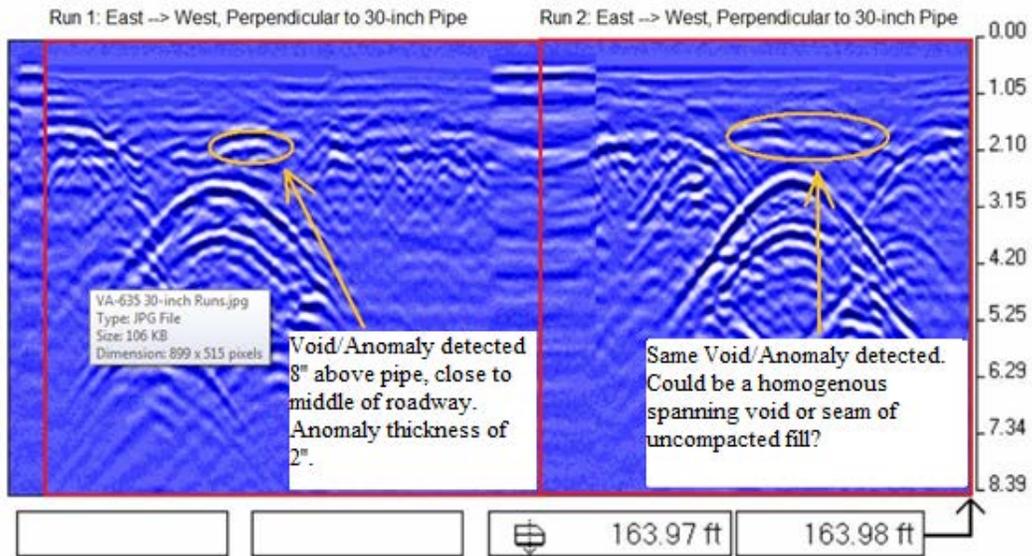
**Figure 46. VA-635 30-inch Dual-Wall Polypropylene Pipe (PP).**

GPR was tested making perpendicular passes at the existing 30-inch polypropylene pipe on VA-635. Perpendicular runs at the asphalt surface were made, and the GPR cart system was turned 180-degrees to make sequential passes a few feet beyond the utility. Inconsistent results were achieved when making parallel passes; results were not decipherable. An anomalous region is shown in Figure 46, existing approximately 8-inches above the outer wall. The length of the region spans 8-inches and is approximately 2-inches thick. The anomaly could be a homogenous spanning void or a seam of poorly compacted soil.

In the case where there is not much soil cover on top of the pipe, GPR is capable of measuring soil anomalies above the pipe. Two (2) feet of soil cover exists on top of the 30-inch piping system, and GPR was capable of viewing this region for anomalies.

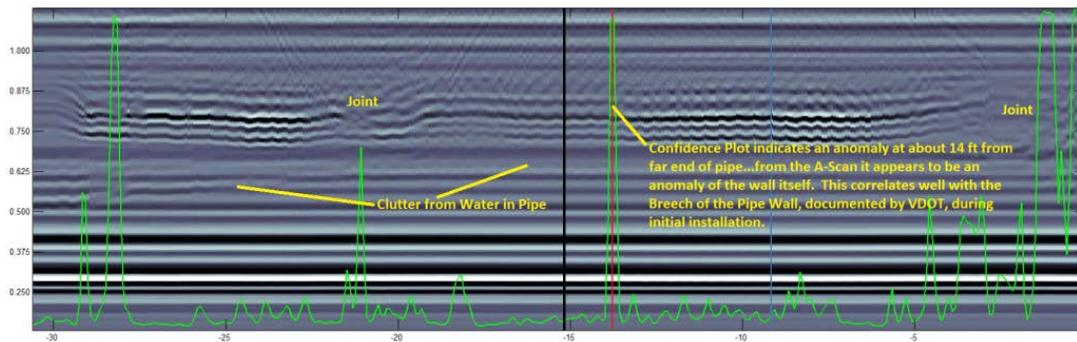
**Figure 47. FutureScan Radar Gram at 12 O'clock position for VA-635 48-inch PP pipe (Yestrebky & Winiewicz, 2014).**

FutureScan results align with GPR results, pertaining to the anomaly near the 48-inch PE pipe wall. The anomaly at the outer pipe wall surface, between 13-feet and 16.5-feet downstream, was detected by GPR. FutureScan detects the anomaly at approximately 14-feet downstream in Figure 44. A well-defined breach in the pipe wall is noticed in FutureScan data, depicted in Figure 47. During the construction phase of the project, indentations were noticed by Virginia Department of Transportation engineers (Hoppe, 2011). Compaction issues closer to the asphalt surface were not detected by FutureScan. However, FutureScan and GPR results align, relative to the anomaly closer to the outer pipe wall surface.

Because water was in the pipe during scanning, voltage inversions appeared misplaced on the radar gram. This is the reason that FutureScan could not detect compaction or void issues close to the asphalt surface. Cluttered inversions appeared closer to the asphalt surface due to the nature of the wet pipe. Expected signals would have been anomalies approximately 1-foot from the outer pipe wall as displayed in Figure 45.

Scanning signals tend to leak out of the back the antenna, and this causes a error signal (clutter) in the radar return (Yestrebky, Tom, Personal Communication, April 9, 2014). With a constant water depth, the clutter signal can be subtracted on-site; however, water depth was not constant during data acquisition due to the pipe being backed up with water (Yestrebky, Tom, Personal Communication, April 9, 2014). Clutter cancelling systems exist, but initial signals must be reduced immediately after acquisition. Digital phase shifters and attenuation must be utilized as an initial element to the signal receiving system to reduce undesirable signals (Grazzini, et al., 2007). GPR does not experience the signal leakage and back-reflection issue because leakage signals point in the direction of the sky.

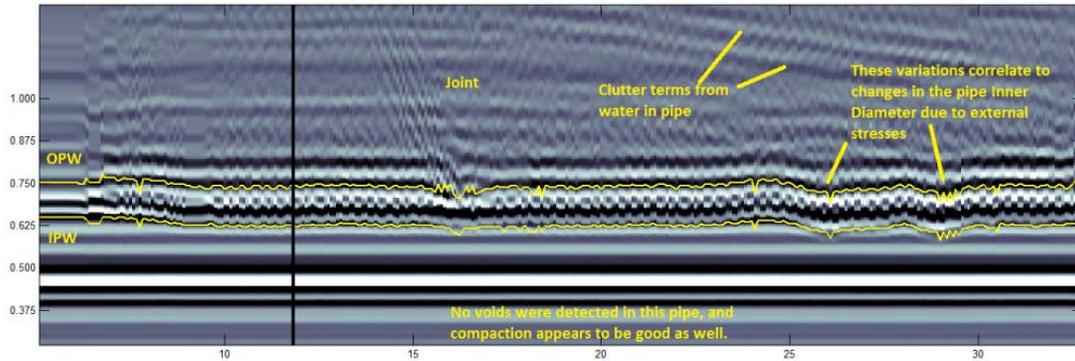
**Figure 48. FutureScan Radar Gram at 12 O'clock position for VA-635 30-inch PP pipe (Yestrebky & Winiewicz, 2014).**

FutureScan was unsuccessful in locating soil anomalies for the 30-inch PP pipe, for the same cluttering occurred during field trials. Water was readily flowing in the PP pipe during the testing period, so clutter inversions existed on the radar gram. Several inches of water existed in the pipe during the site visit. GPR detected an anomaly approximately 8-inches from the OPW surface, and FutureScan was incapable of detecting the same anomaly. Figure 48 displays the clutter terms that prevent anomaly detection, pertaining to the 30-inch piping system underneath VA-635
